# Lower Naches River Geomorphic Atlas

Prepared for  
**Yakima County Water Resources Management Division**

Prepared by  
**Northwest Hydraulic Consultants**  
Seattle, WA

September, 2015

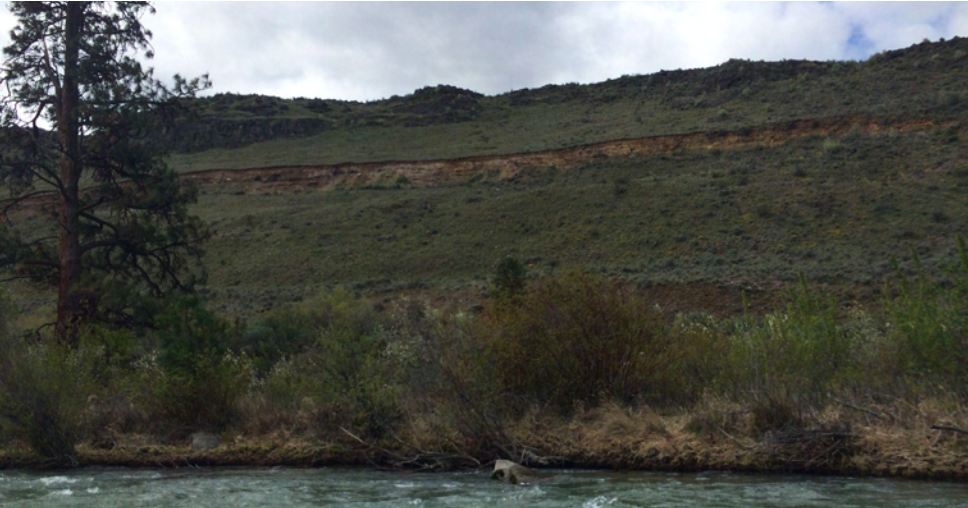
Slump in right valley wall near RM 16.

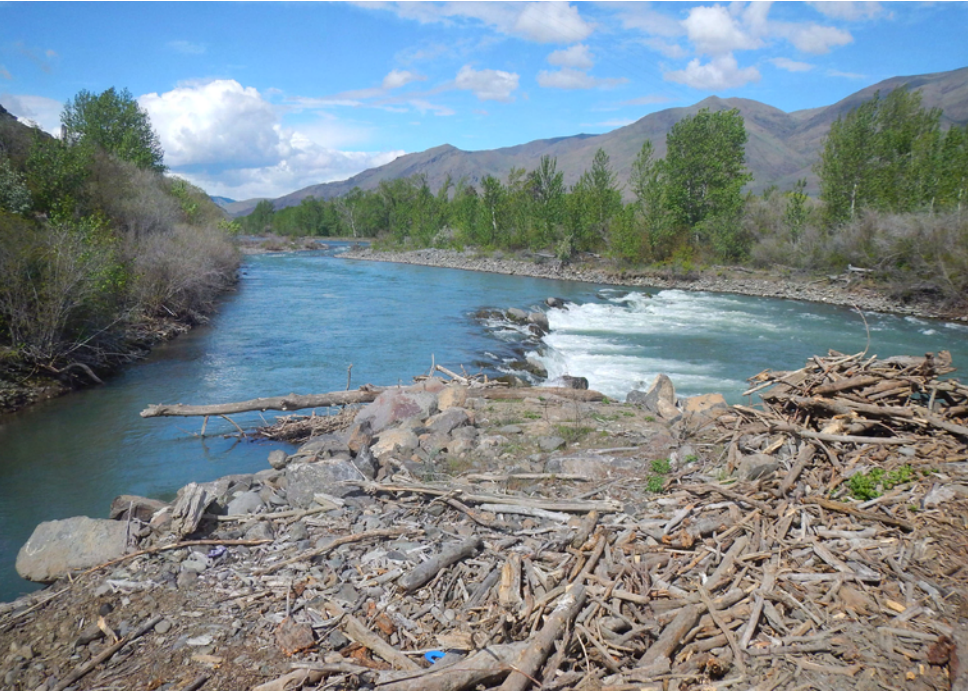
Water diversion at RM 14.5.

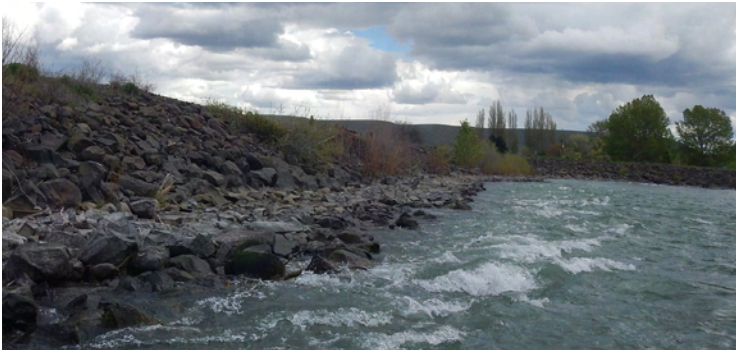
Thalweg held against upstream portion of N7 levee near RM 14.0.

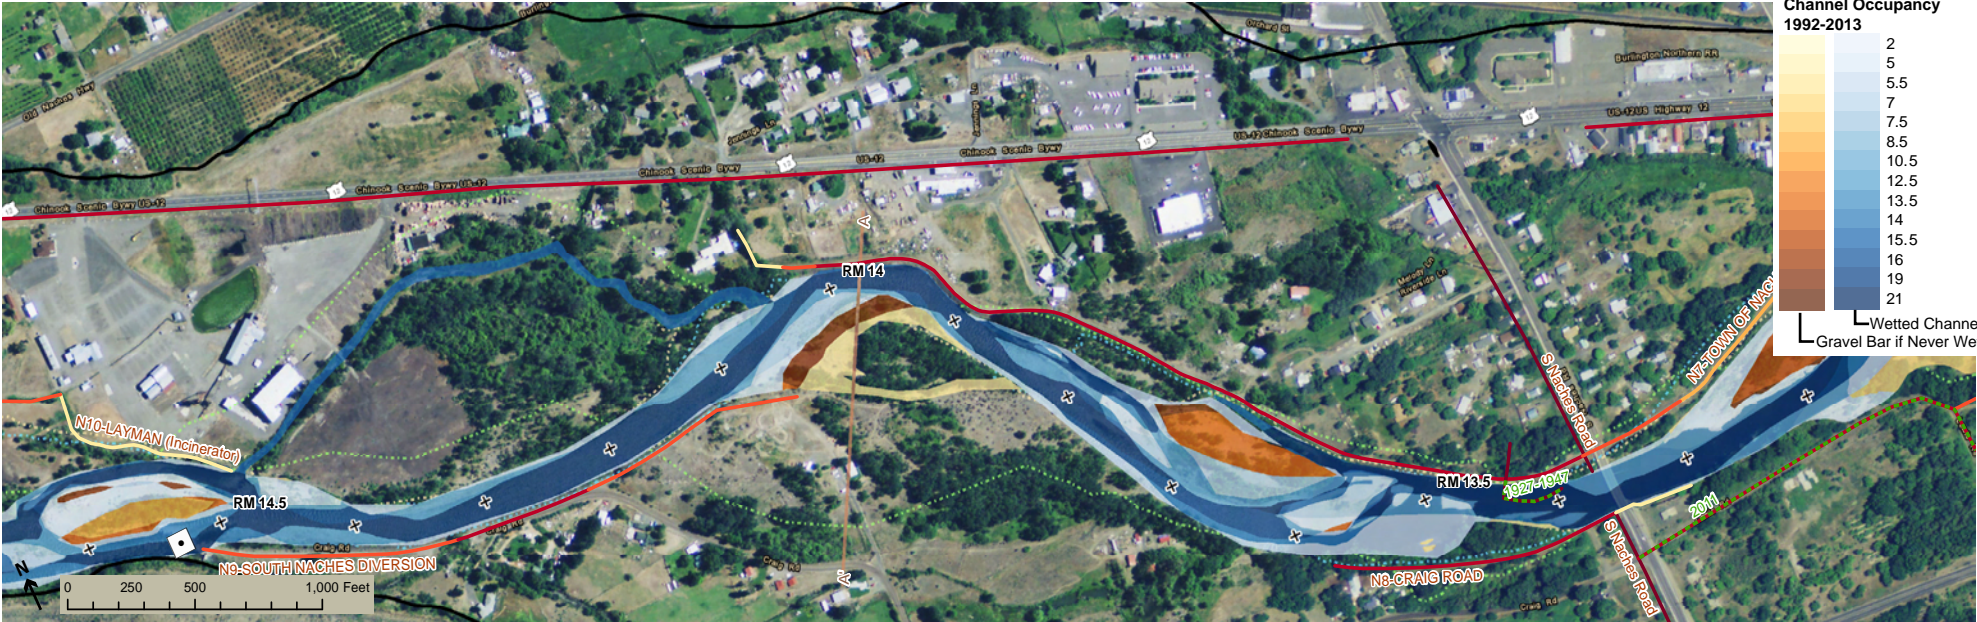
Low floodplain area blocked by downstream portion of N9 levee and private berm (left of side of photo), which are planned to be removed in 2016.

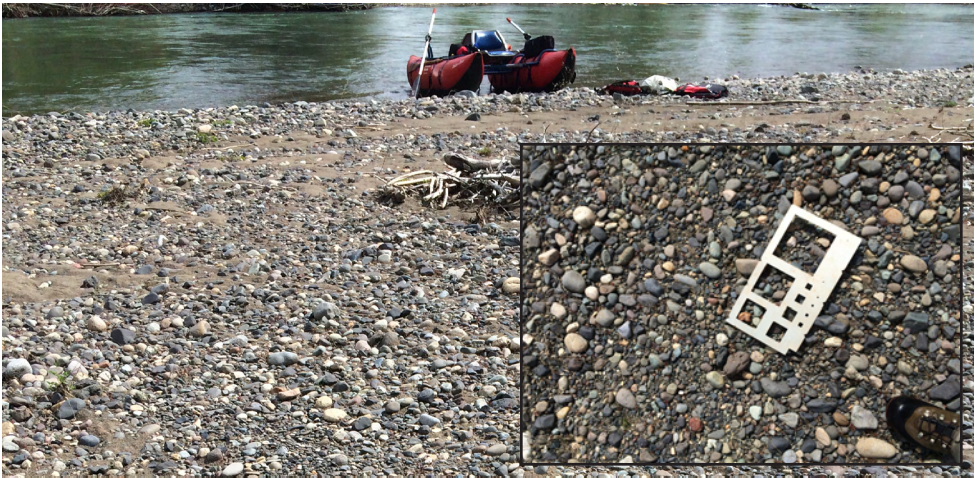
Sandy gravel dominates material deposited in right bank bar at RM 12.4

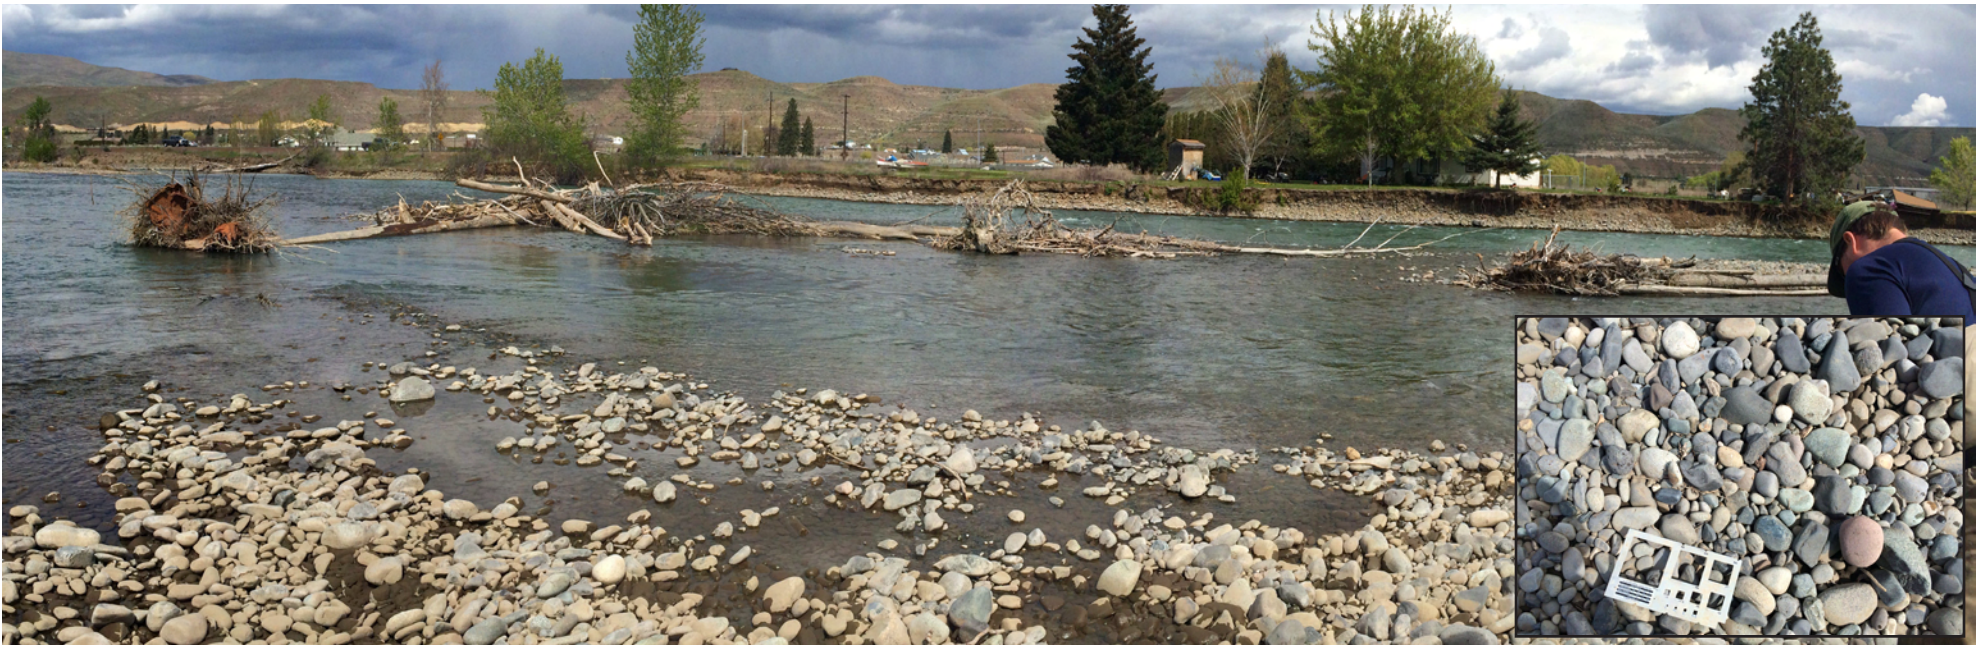
Overview of pebble count location and detail of sampled deposit. Also note pronounced erosion of gravel & cobble alluvium from the left bank between RM 12.6 and 12.5.

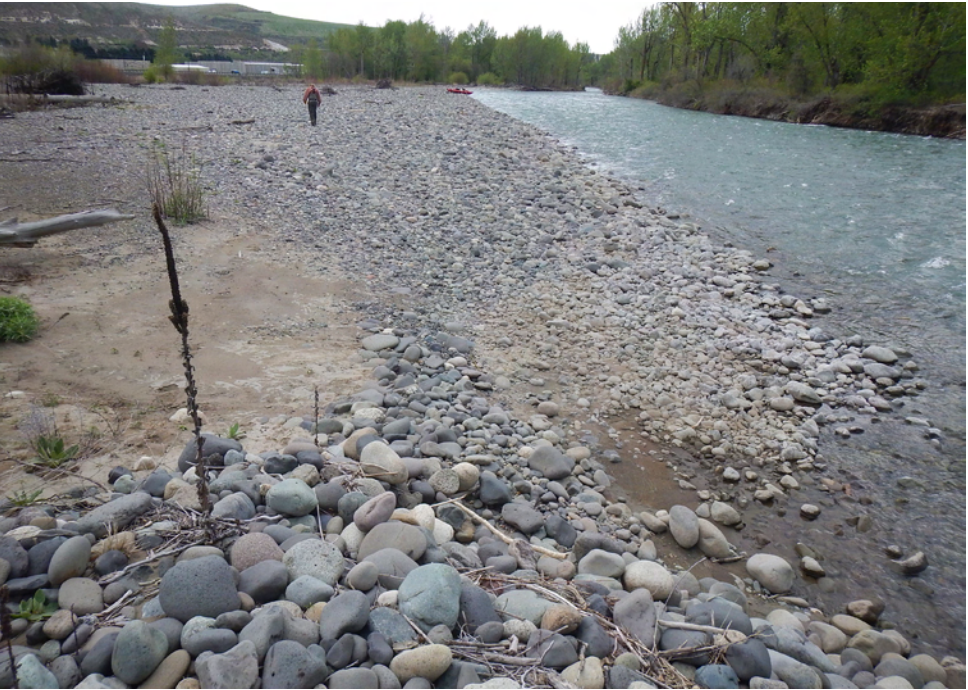
Plug of cobble-dominated sediment filling the 2011 main channel. View is downstream from RM 11.35 to RM 11.15.

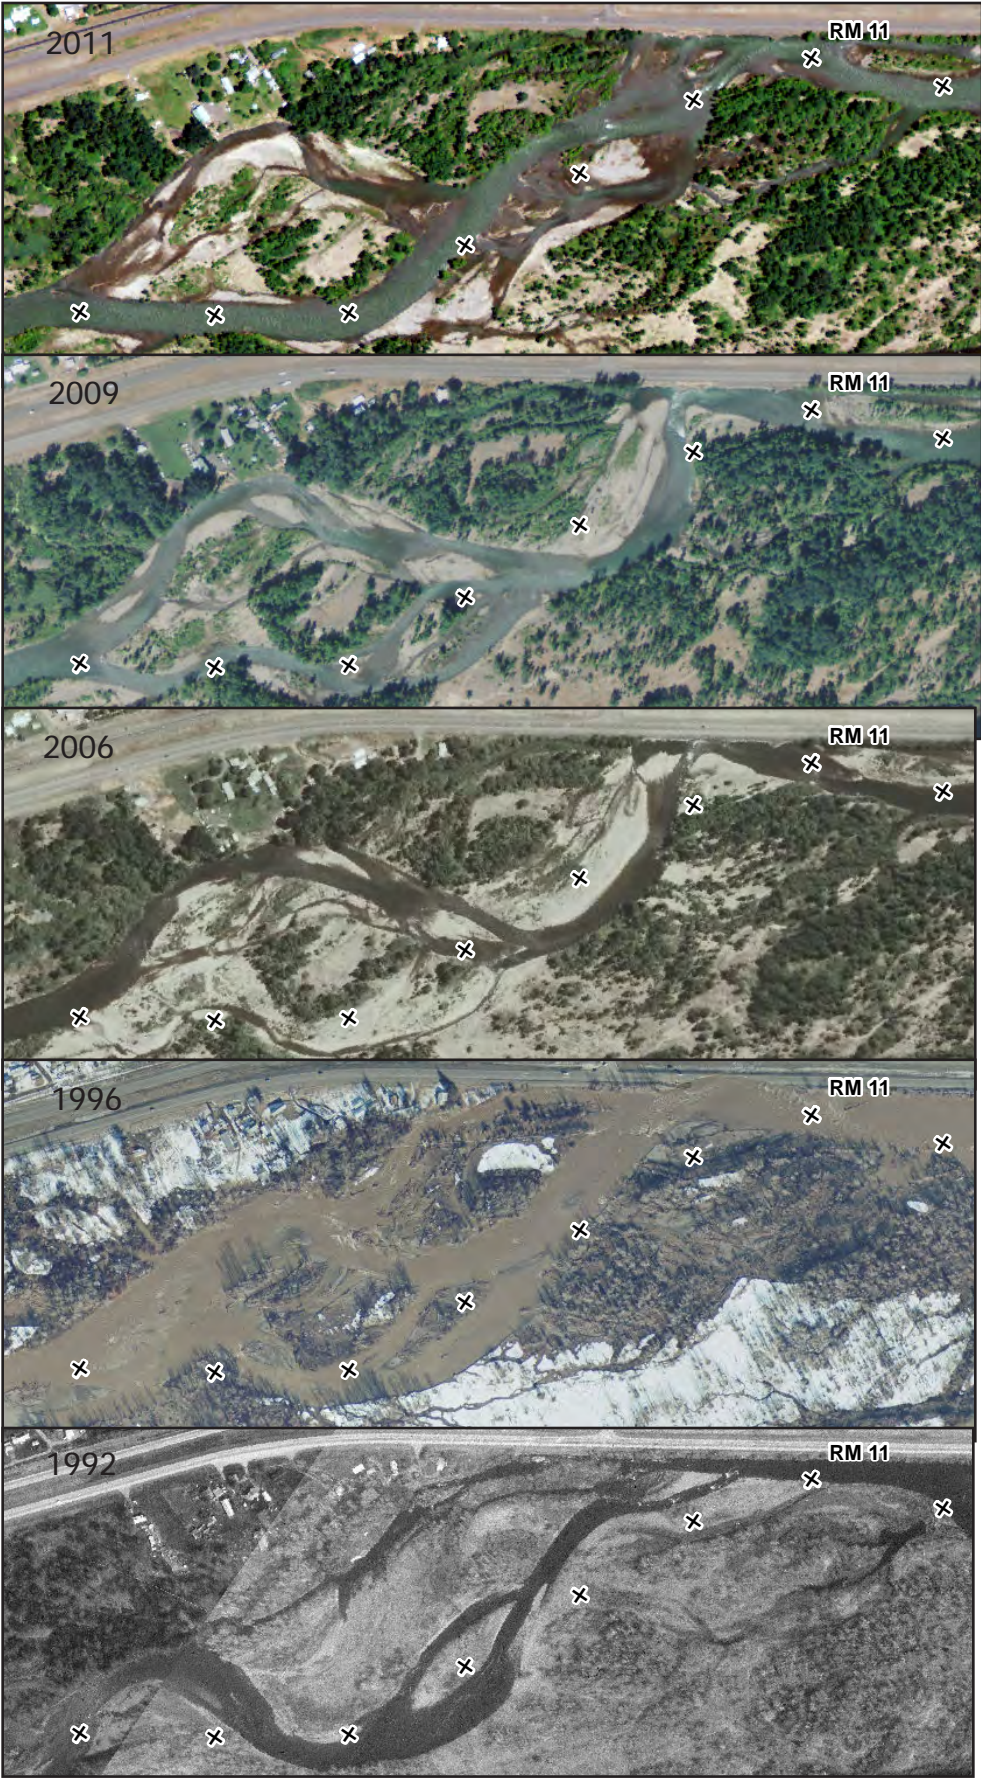
Sequence of aerial photos showing multiple avulsions between RM 10.9 and RM 11.6.

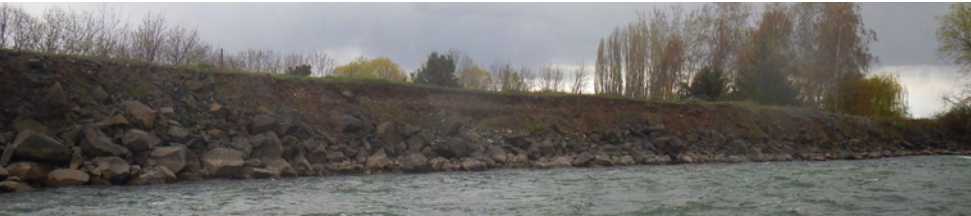
- Scour along the upstream avulsion path has severely damaged the revetment protecting the N4 levee
- The downstream 1996 avulsion channel remains unstable, with rapid channel migration rates and constant shifting of large bar complexes.

Failing revetment along avulsion path near RM 8.6.

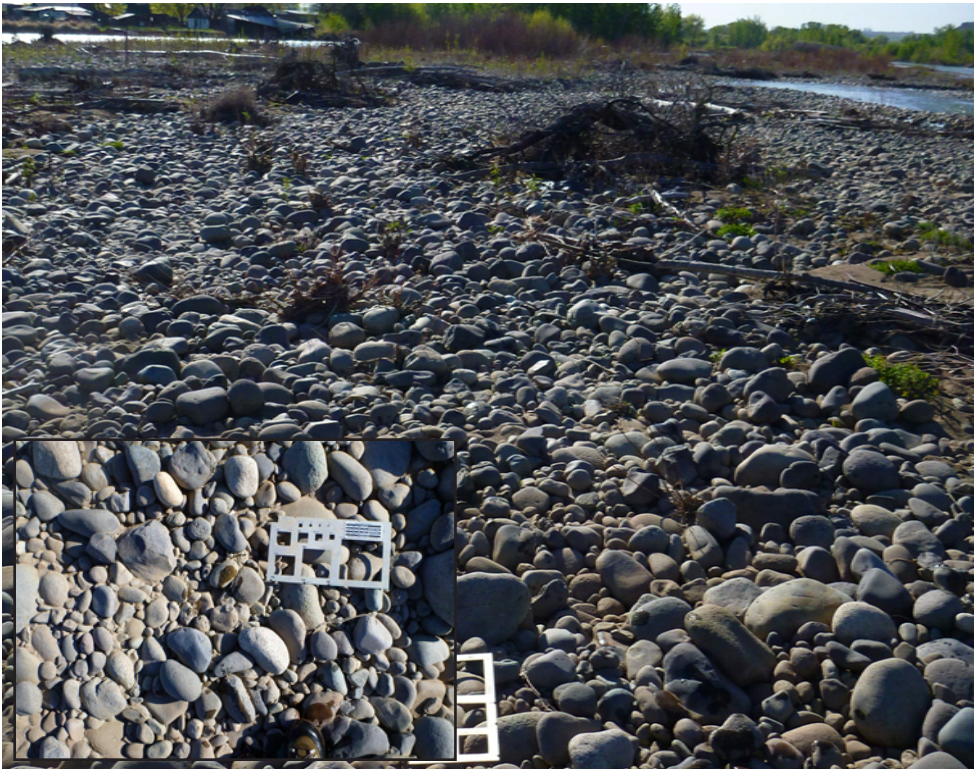
Over-wide aggrading channel between RM 8.5 and RM 8.4.

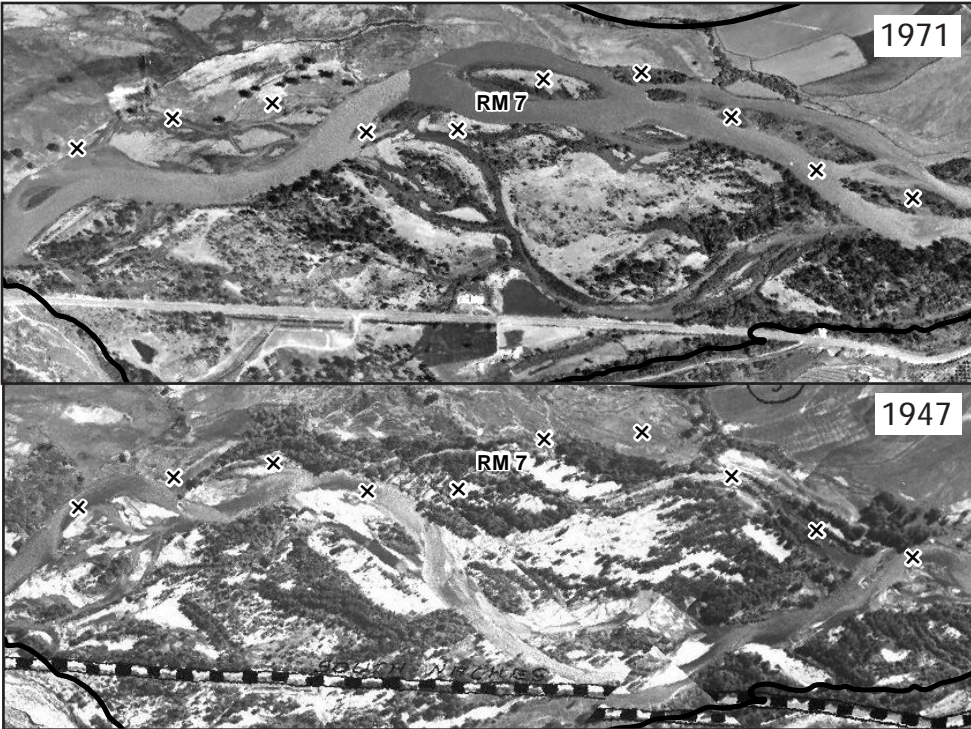
Historic Aerial photos showing historic engagement of right bank floodplain area and mid-century avulsion of main channel from right to left side of the geomorphic floodplain.

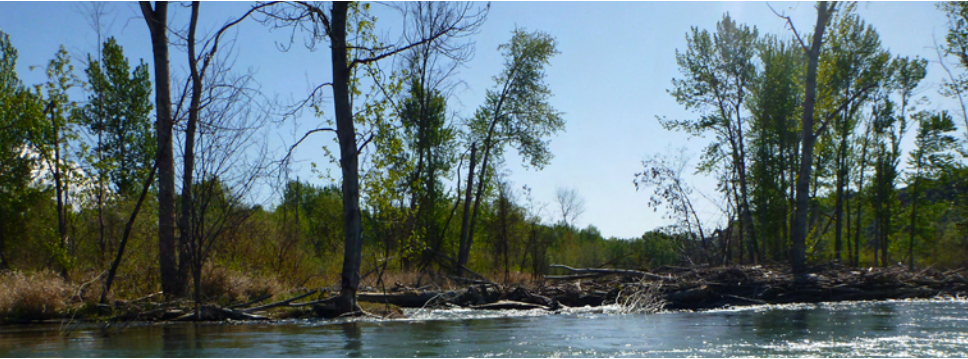
Growing avulsion channel at RM 5.3 (left bank).

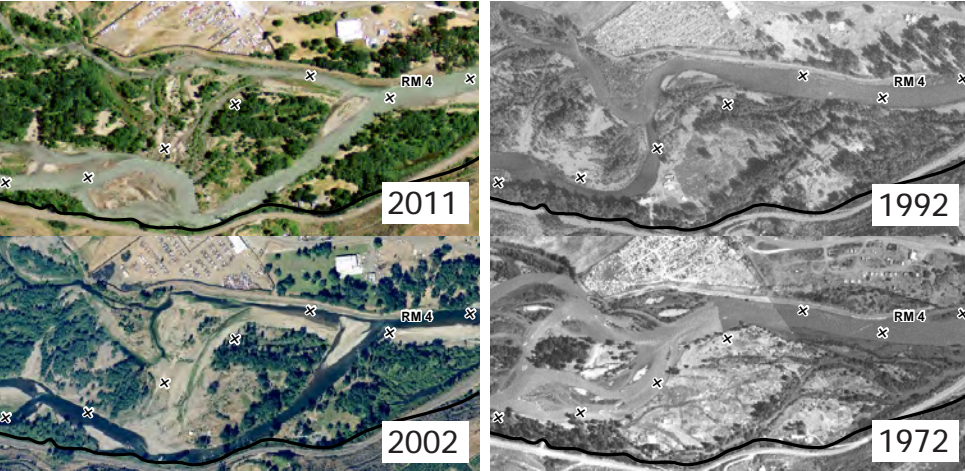
Sequence of historic aerial photos showing persistent sedimentation and avulsion at RM 4.4.

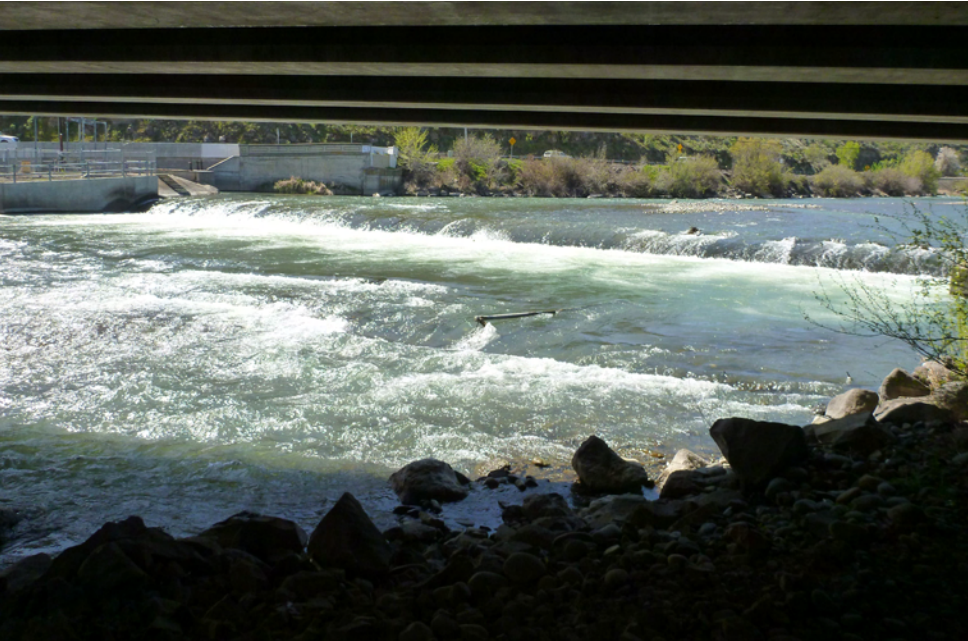
Nelson Dam viewed from under the Highway 12 Bridge.

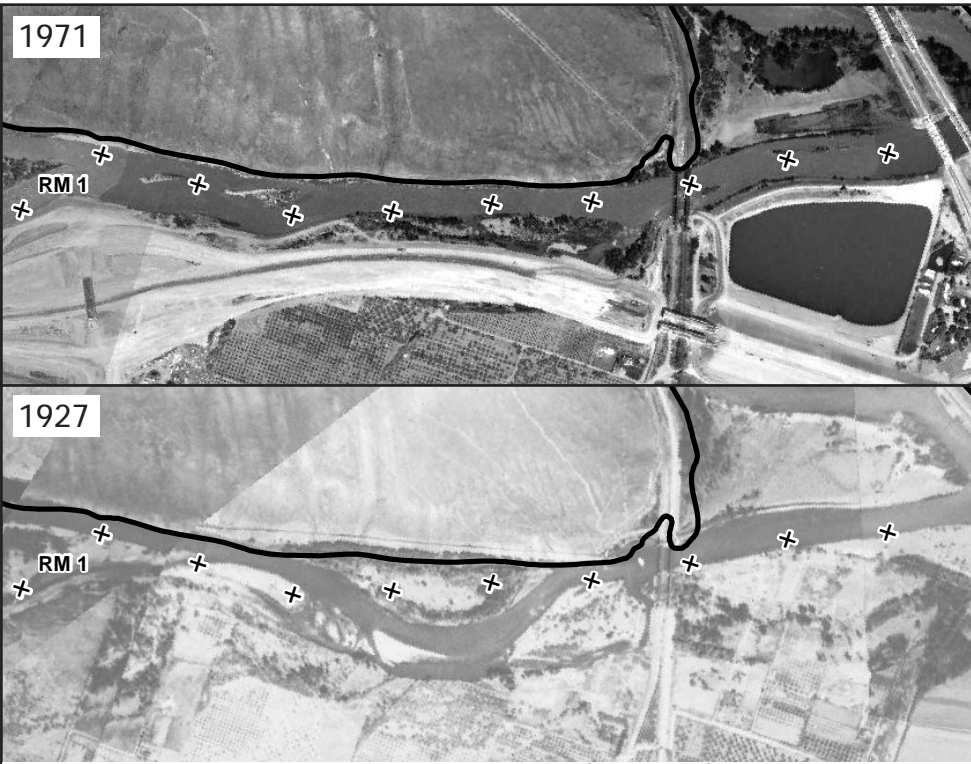
Historic Aerial photos showing early and dramatic confinement of the reach. Note sedimentation upstream of the Railway bridge in 1927.

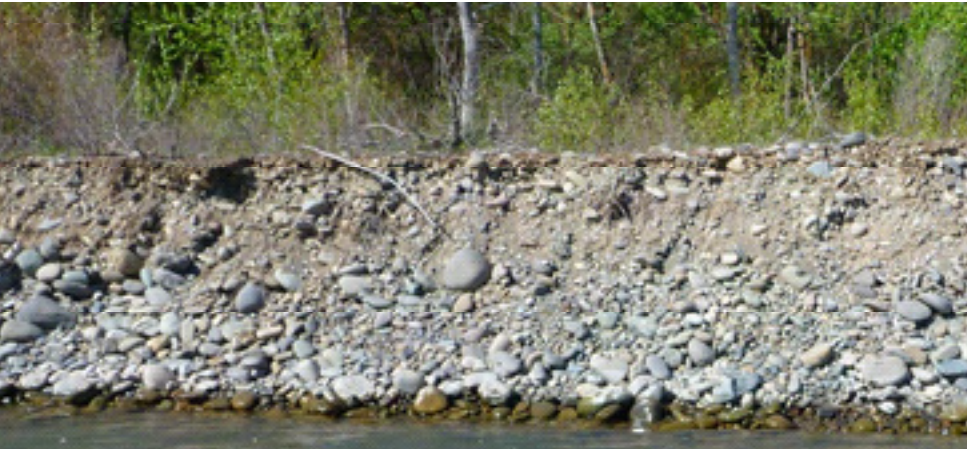
Example of typical coarse alluvium supplied by eroding banks.
