Technical Report No. SRH-2010-08

Yakima River Geomorphology and Sediment Transport Study: Gap to Gap Reach, Yakima, WA

U.S. Department of the Interior
Bureau of Reclamation
Technical Services Center
Denver, CO

November 2010

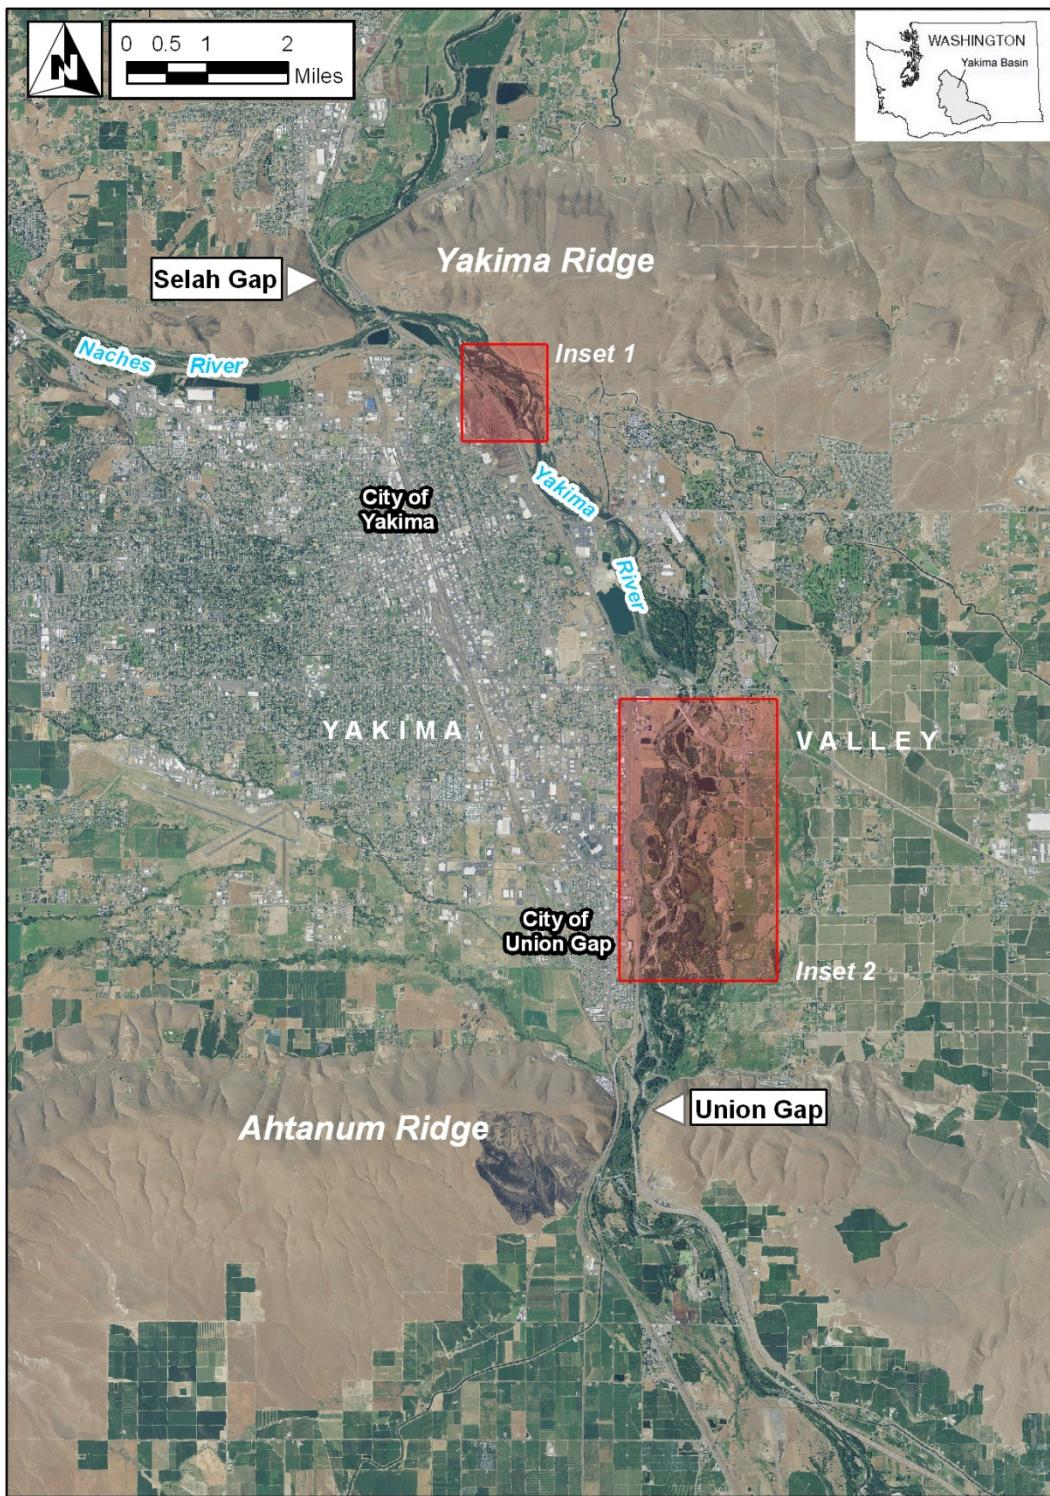
Figure 1: Location map of the Gap to Gap reach. Flow is from north to south. Insets for the highlighted areas are shown in Figure 2

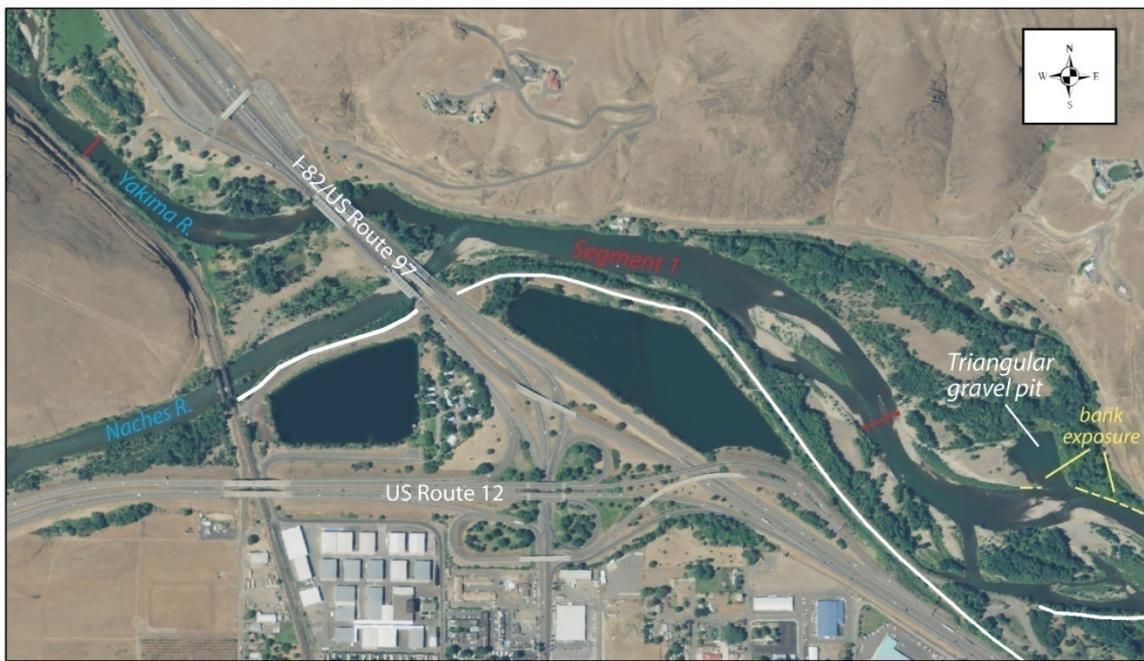
Figure 7: Segment 1 location map, 2009 aerial photography. White lines indicate levees. Flow is from left to right.

Segment 1 extends from Selah Gap to the triangular gravel pit and can be described as a braided to anabranching system with semi-stable islands and a vegetated floodplain (Figure 7). The majority of levees in this segment were built between 1927 and 1949 and exist along the right bank; the river is naturally confined along its left bank by bedrock and colluvial deposits. Much of the highway and gravel pits were in place by 1966 photography and some of the vegetation was also cleared to mine the underlying gravel. Only the triangular pit has been partially reclaimed by the river; the other larger and deeper gravel pits along the right bank remain behind levees and revetments. Although these areas were flooded during the 1996 flood, the berms surrounding the gravel pits were not breached. Gravel splays on mid-channel bars and lateral bars are apparent and show that bars are remaining active in the current flow regime. Major channel changes however have not been observed recently and thus this segment is described as one with minor changes during the last 5 years.

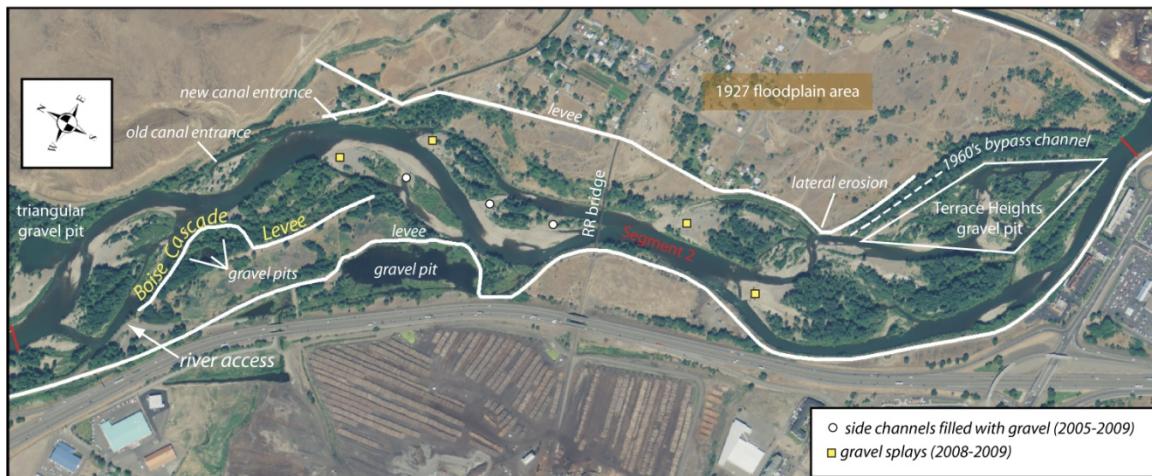
Figure 8: Segment 2 location map, 2009 aerial photography. Flow is from left to right.

Channel change in this segment has been significant since 2005; many observations were made of fresh gravel splays, fill and abandonment of secondary channels, channel avulsion, bar progradation and deposition of large woody debris. Upstream of the railroad bridge, many of the side channels had filled with gravel between 2005 and 2008 aerial photography. Changes downstream of the railroad bridge included greater volumes of water flowing into the left channel upstream of the Terrace Heights gravel pit and gravel deposition and bar building at the heads of mid-channel islands or lateral bars. From field observations, it is apparent that this segment has been very dynamic during the past 5 years and is one of the most heavily modified segments historically due to the large gravel pit that occupied the majority of the channel during the 1960s.

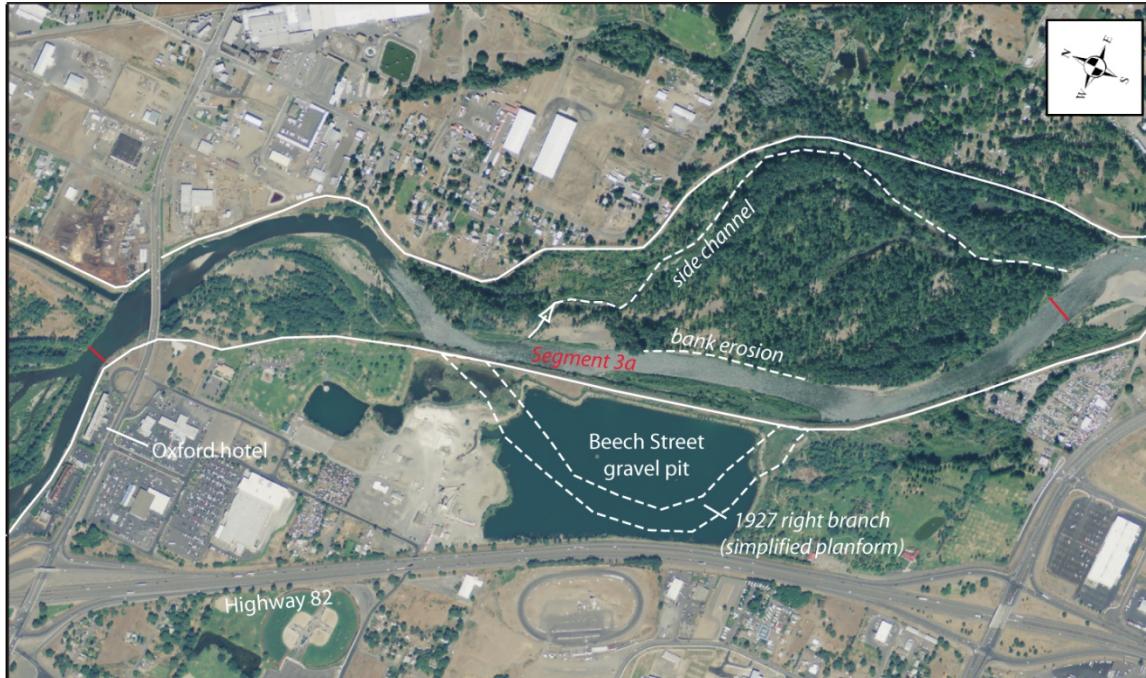
Figure 9: Segment 3a location map, 2009 aerial photography. White lines indicate levees. Flow is from left to right.

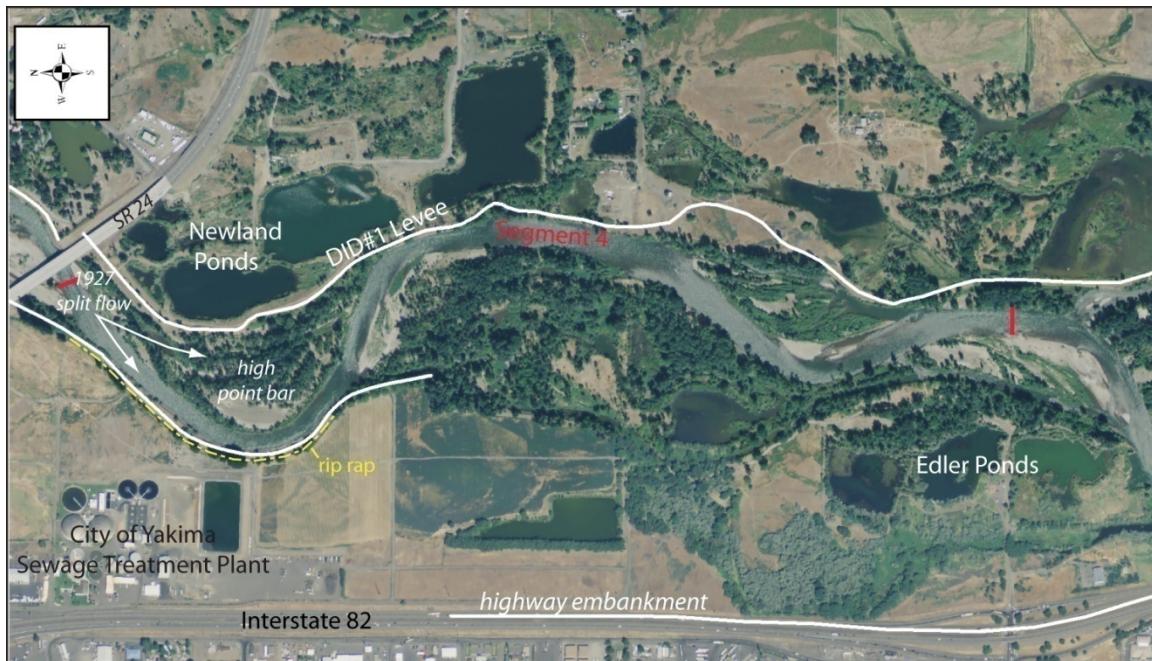
Figure 11: Segment 4 location map, 2009 aerial photography. White lines indicate levees. Flow is from left to right.

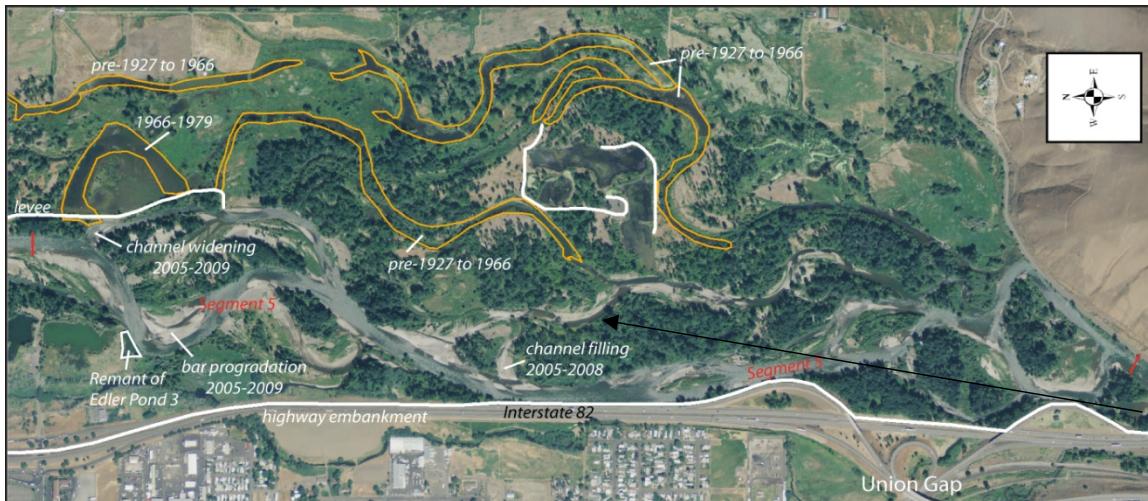
Figure 12: Segment 5a location map, 2009 aerial photography. White lines indicate embankments and levees. Flow is from left to right.

Segment 5a extends from the Edler Ponds area to just upstream of the Interstate 82 bridge (Figure 12). This segment is the longest and most dynamic segment in the Gap to Gap study area and has maintained an anabranching channel morphology throughout the historical period (1927-2009). Levees and revetments are located at the upstream end of the study segment in the eastern floodplain and along Interstate 82 in the western floodplain; however, they do not constrain the floodplain as narrowly as in other segments. Channel changes have been significant historically and mainly occur through the process of channel avulsions. Lateral erosion is also apparent in some locations, which in some cases is a precursor to channel avulsions by either eroding into a pre-existing abandoned channel or by creating a highly sinuous meander geometry, which the river then cuts off. In 1927, the main channels were located in the eastern portion of the younger floodplain; by 1949, avulsion to a new channel on the western side of the

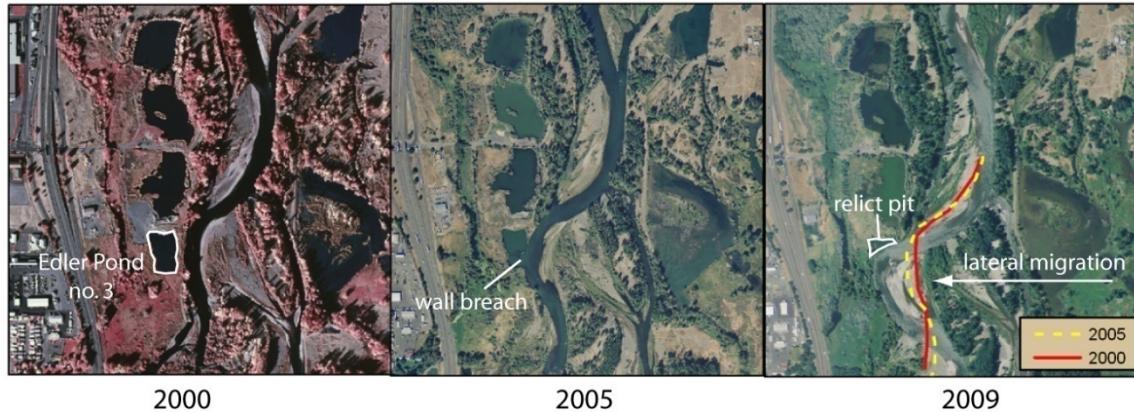
Figure 18: Historical photo sequence showing pit capture of Edler Pond no. 3.

enough for multiple channel changes to have occurred between the two sets of photos; Dunne et al (1976) documents that these avulsions were initiated by breaches in the dikes surrounding the gravel pits during the 1971 flood. These pits were mostly filled in with sediment by 1979 photography. The 1978 flood may have been a major cause of the rapid infilling of the pits. By 1992, the river had eroded into the remainder of the upper gravel pit and abandoned its channel for one further to the east close to a small gravel pit in the floodplain. This small gravel pit appears to have filled in with sediment by 2000.

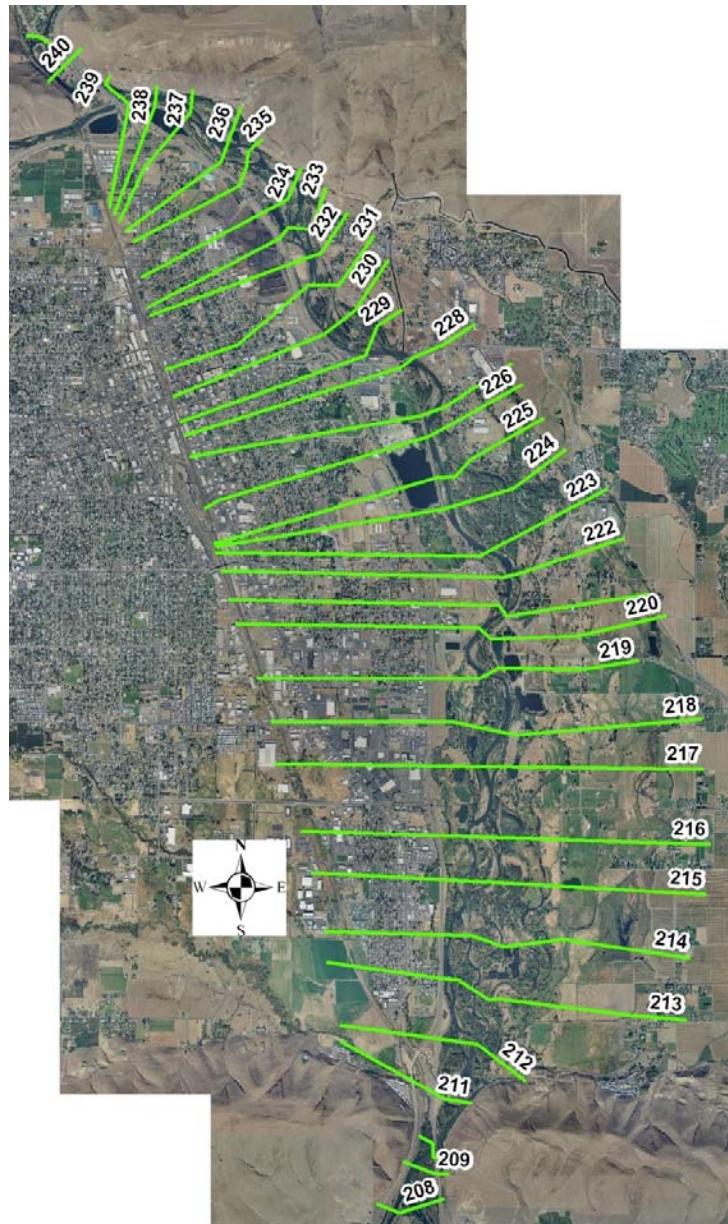
Figure 27: 1969 cross section alignments overlaid on aerial photography (2005). These alignments were provided by Yakima County and used to determine 2005 elevations for comparison.

In order to investigate vertical changes along the Yakima River in the study area, channel survey data were compared between 1969 and 2005. Survey data from 1969 were collected by the Army Corps of Engineers while 2005 cross section and thalweg data were derived from LiDAR and a bathymetric survey. 1969 cross sections were digitized from the scanned cross section plots. Cross section alignments and vertical corrections for the 1969 survey were provided by Yakima County (Appendix C). Alignments of the 1969 cross sections were used to extract data from the 2005 bathymetric survey and LiDAR data represented by a raster in a GIS. These alignments are shown in Figure 27. The cross section data were compared by vertically adjusting the 1969 data (using corrections provided by Yakima County and cross section data points generated by Reclamation) and horizontally matching known landmarks such as highways and levees between 1969 and 2005 survey data sets. Several of the cross section alignments were not able to be matched well and are noted in the results.

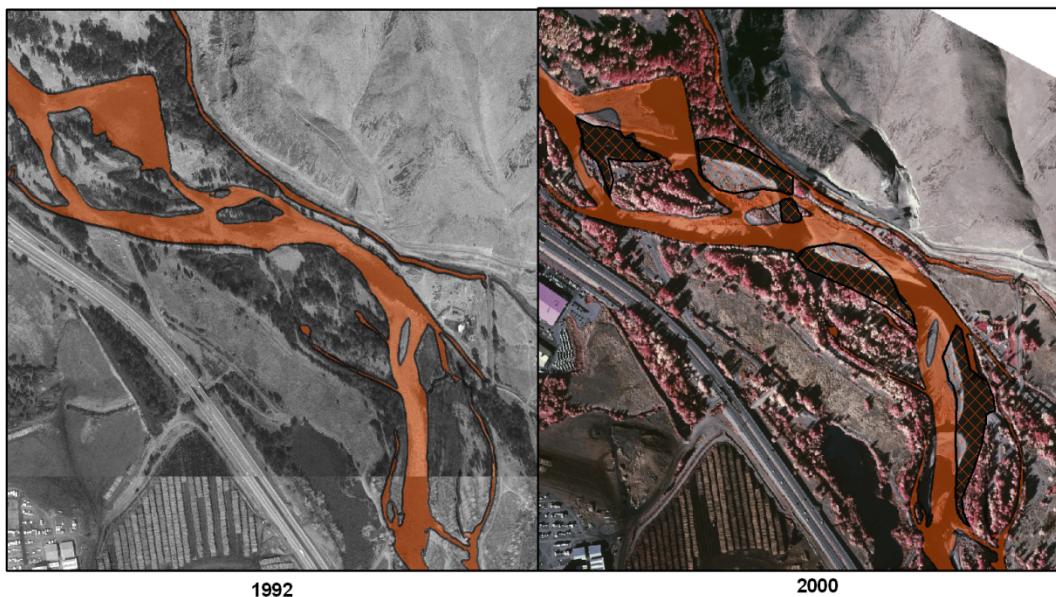
Figure 33: Effects of the 1996 flood in segment 2. 1992 channel is shown in orange; cross hatched polygons on 2000 aerial photograph show areas modified by the 1996 flood.

The 1996 flood also exerted significant channel change in the Gap to Gap reach with most of the changes in segments 2 and 3b. In segment 2, bar deposition and lateral erosion upstream of the railroad bridge forced the channel into new positions; 1996 flood photography also shows the channel in these new locations during the flood (Figure 33).

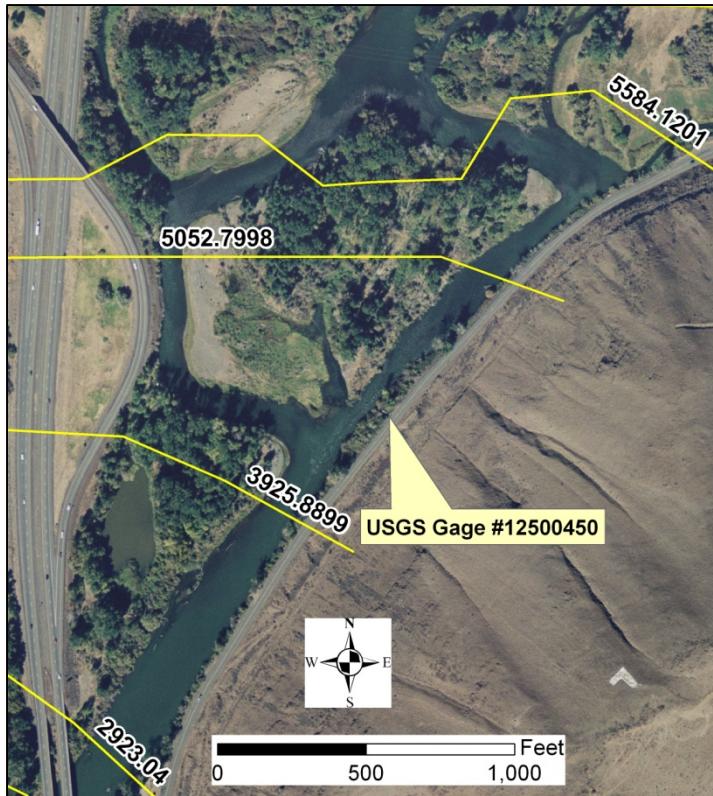
Figure 58: Photograph showing the location of cross section 5052.8, the upstream extent of the influence of Wapato Dam.

Two discharges were run in the HEC-RAS model, 2,500 and 28,000 cfs, with and without the dam in place. It is assumed that the entire discharge spills over the dam. Figure 57 shows the results of this analysis, and it is determined that the upstream influence of Wapato Dam is not dependent on discharge and extends to the island near the USGS gage (Yakima River above Ahtanum Creek, #12500450), river station 5052.8. A photograph shows the location in Figure 58.

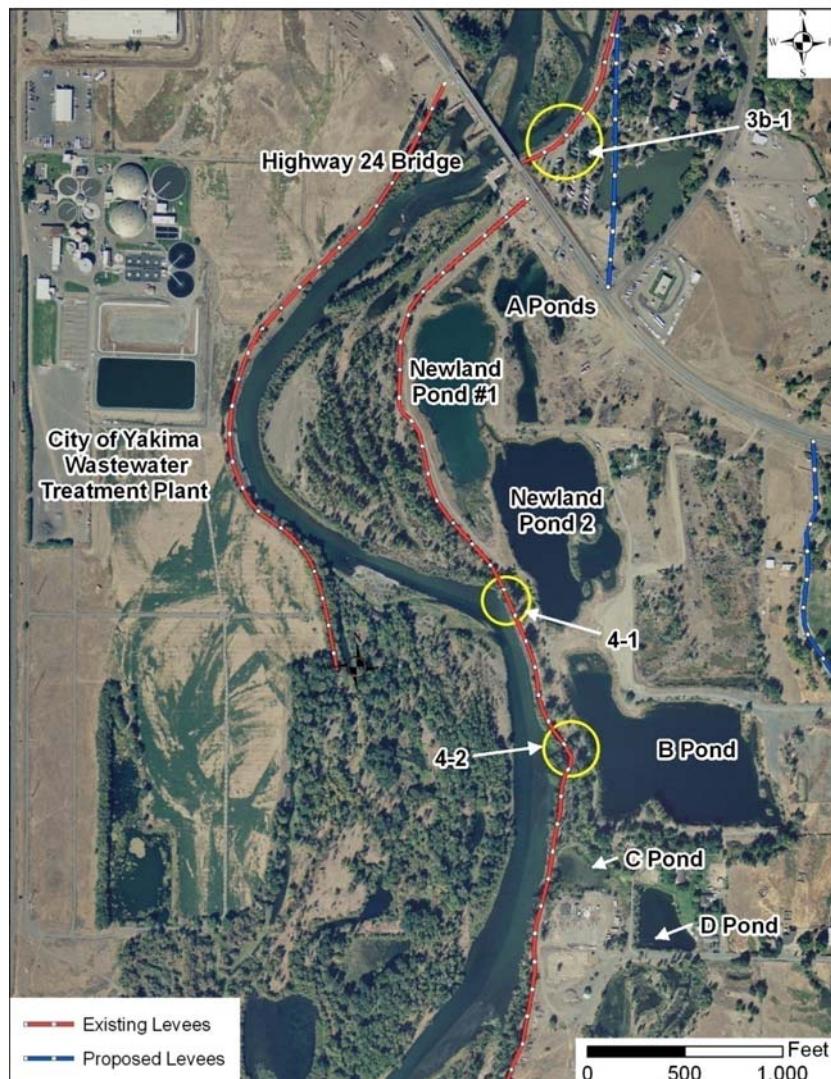
Figure 85: Site map of the Newland Pond area. Flow is from north to south in the photo.

Newland Pond #1 (Figure 85) is located on the inside bend just downstream of SR24 Bridge. This pond has a maximum depth of 30 ft and an average depth of 11.9 ft (WADNR, 2004). While a split flow channel existed in this area in 1927, the eastern branch channel was located within the floodplain and east of the levee as it exists currently. Following levee removal, it will be possible for the main channel to avulse into this pond, which would disrupt sediment continuity for a significant period due to the depth of the pit. The integrity of SR 24 Bridge would come into question should an unplanned avulsion occur into this pit. An upstream migrating head-cut would likely occur, severely degrading the channel bed and possibly undermining the bridge piers. Similar erosion patterns were observed during an avulsion of the Yakima River into the Selah pits in February 1996 (Norman et al., 1998). A plan should be in place to prevent a sudden avulsion into Newland Pond #1. Smaller and shallower pits, labeled the “A Ponds” (Figure 85) are not expected to capture enough gravel to be problematic. The existing channel is likely low enough in elevation to maintain a regular surface connection in the event of an avulsion but may be subject to aggradation due to decreased energy through the channel following an avulsion. This type of situation may be

Following the levee setback, Newland Pond no. 2 (Figure 85) and an adjacent gravel pit in segment 4 (B Pond) are likely to be captured (points 4-1 and 4-2). The time span over which capture may occur depends largely on the future hydrology as well as the method

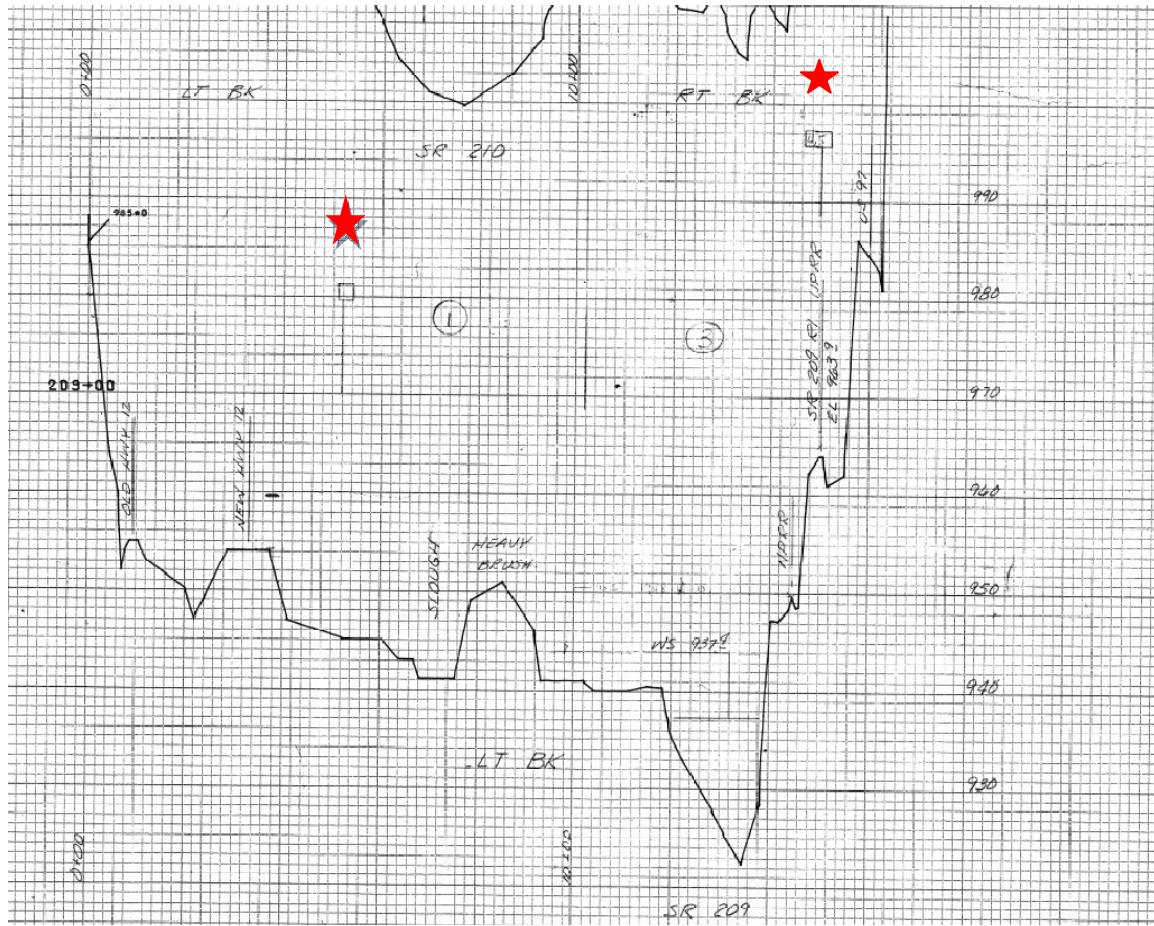
Figure 2 – Cross Section # 209

The hand drawn symbols on the plot show the locations of the instruments in the field, and intermediate lines shown turning points or inflection points in the cross section. From this cross section it can be determined the extent of the cross section that was determined through field methods (area between colored stars), and the extent by photogrammetry. On all cross sections, at least one specific ground elevation is given, and one or several surface water elevations are given. The Legend also references field books in which the survey data were recorded, both Yakima County and Denver Technical Services Center asked the Corps Seattle District if they could locate the referenced field books. After several attempts and through several different parts of the Corps – Survey, Emergency Management, Planning – those field books could not be located.

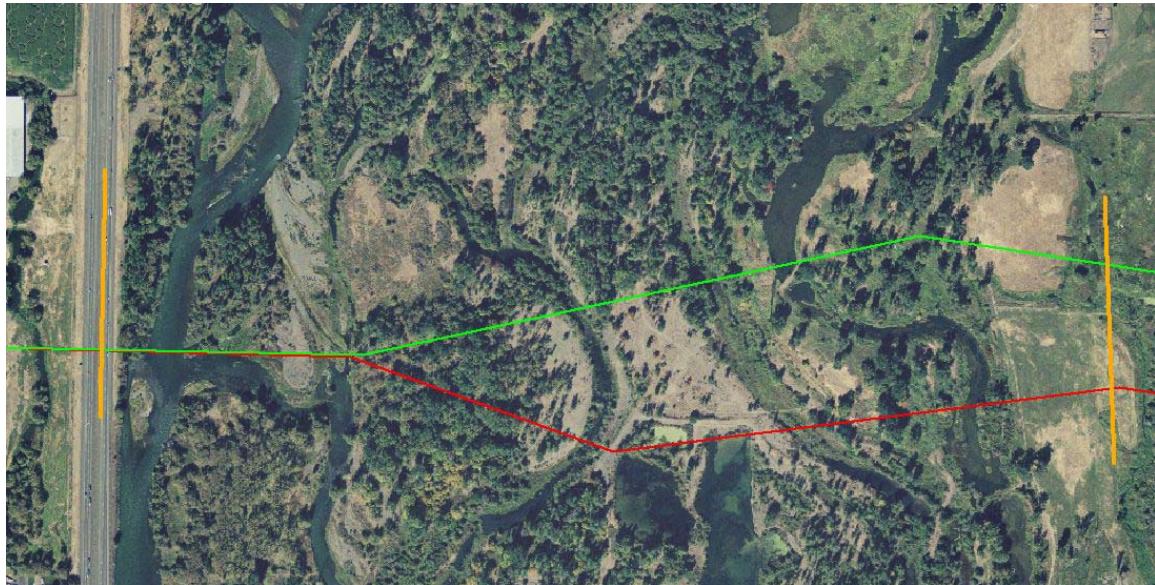
Figure 7 – Alignment of cross section 214 overlain on 2005 photo. Green line is alignment from Corps Study, red line is new alignment based on fitting the cross section plot to topography.

cross section alignment developed by GIS both are too far upstream to include the Union Farm levees. Also note that the alignment above does not cross the main channel of the river at a right angle, as would be necessary for numerical flow models. Using the information in the cross section plot, a new alignment was developed after several iterations; both the new alignment and the cross section comparison are shown below.
