Yakima River Geomorphology and Sediment Transport Study: Gap to Gap Reach, Yakima, WA

U.S. Department of the Interior
Bureau of Reclamation

- Study performed and report prepared by:
 - Robert C. Hilldale (Hydraulic Engineer)
 - Jeanne Godaire (Geomorphologist)
 - Bureau of Reclamation, Technical Service Center
 - Denver, CO

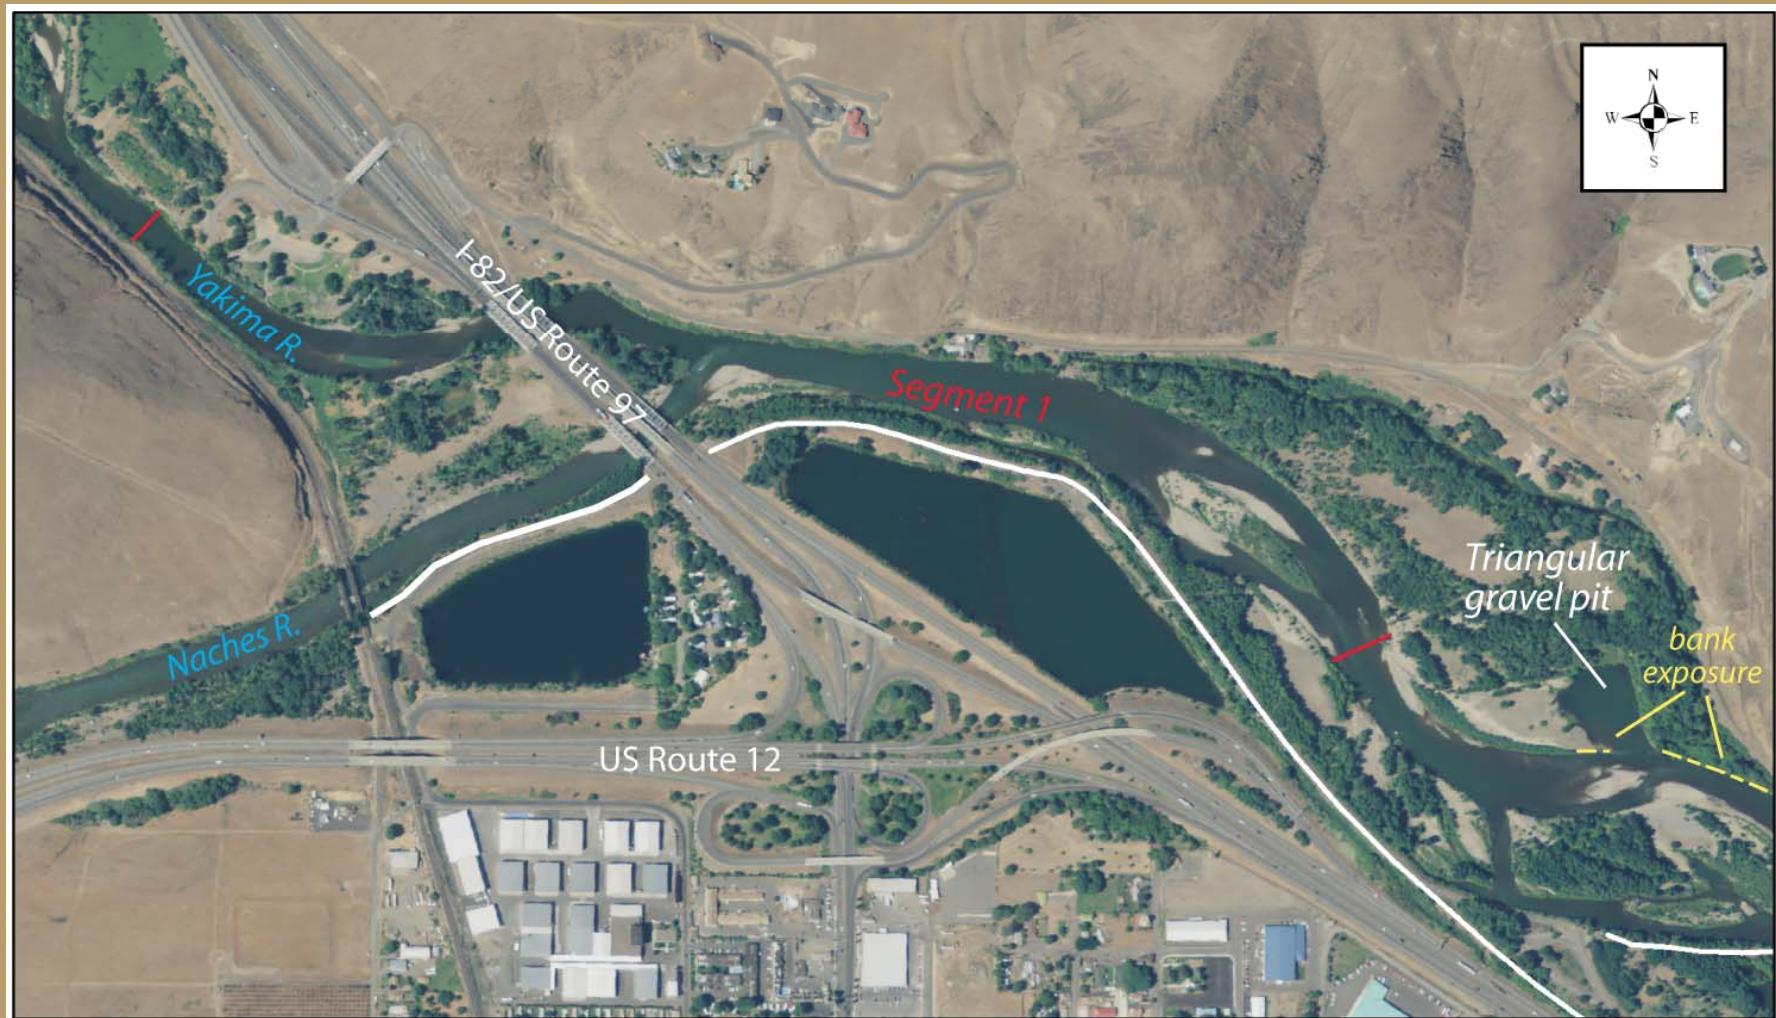
Segment 1

Yakima R. above Naches to triangular pit

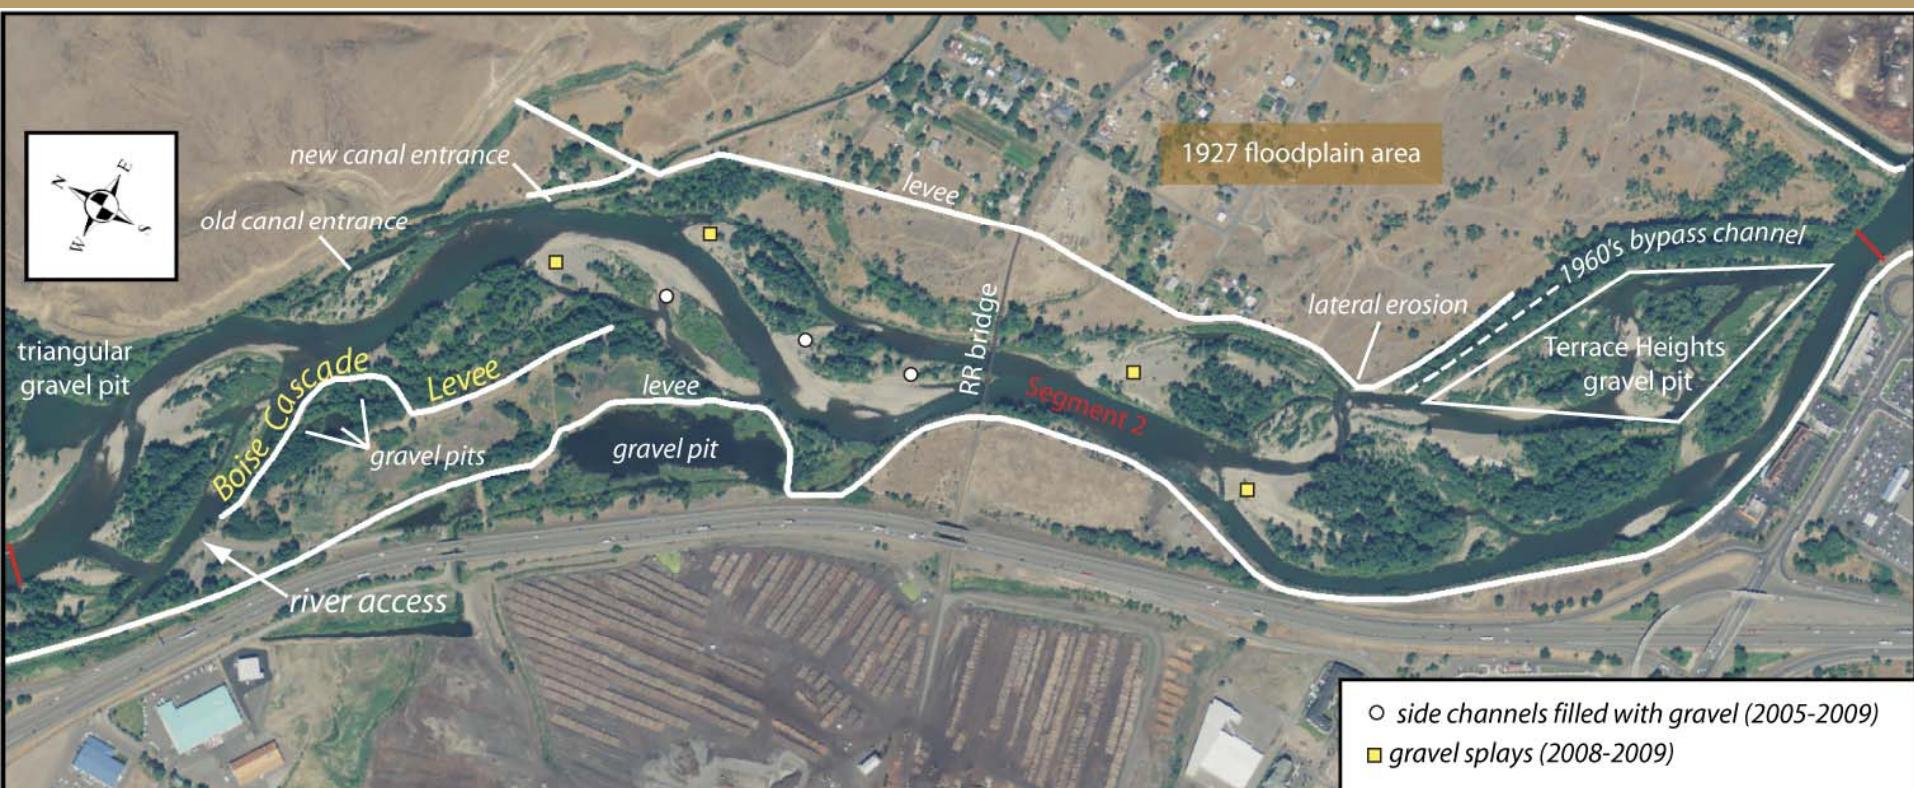
Segment 2

triangular pit to Terrace Heights pit

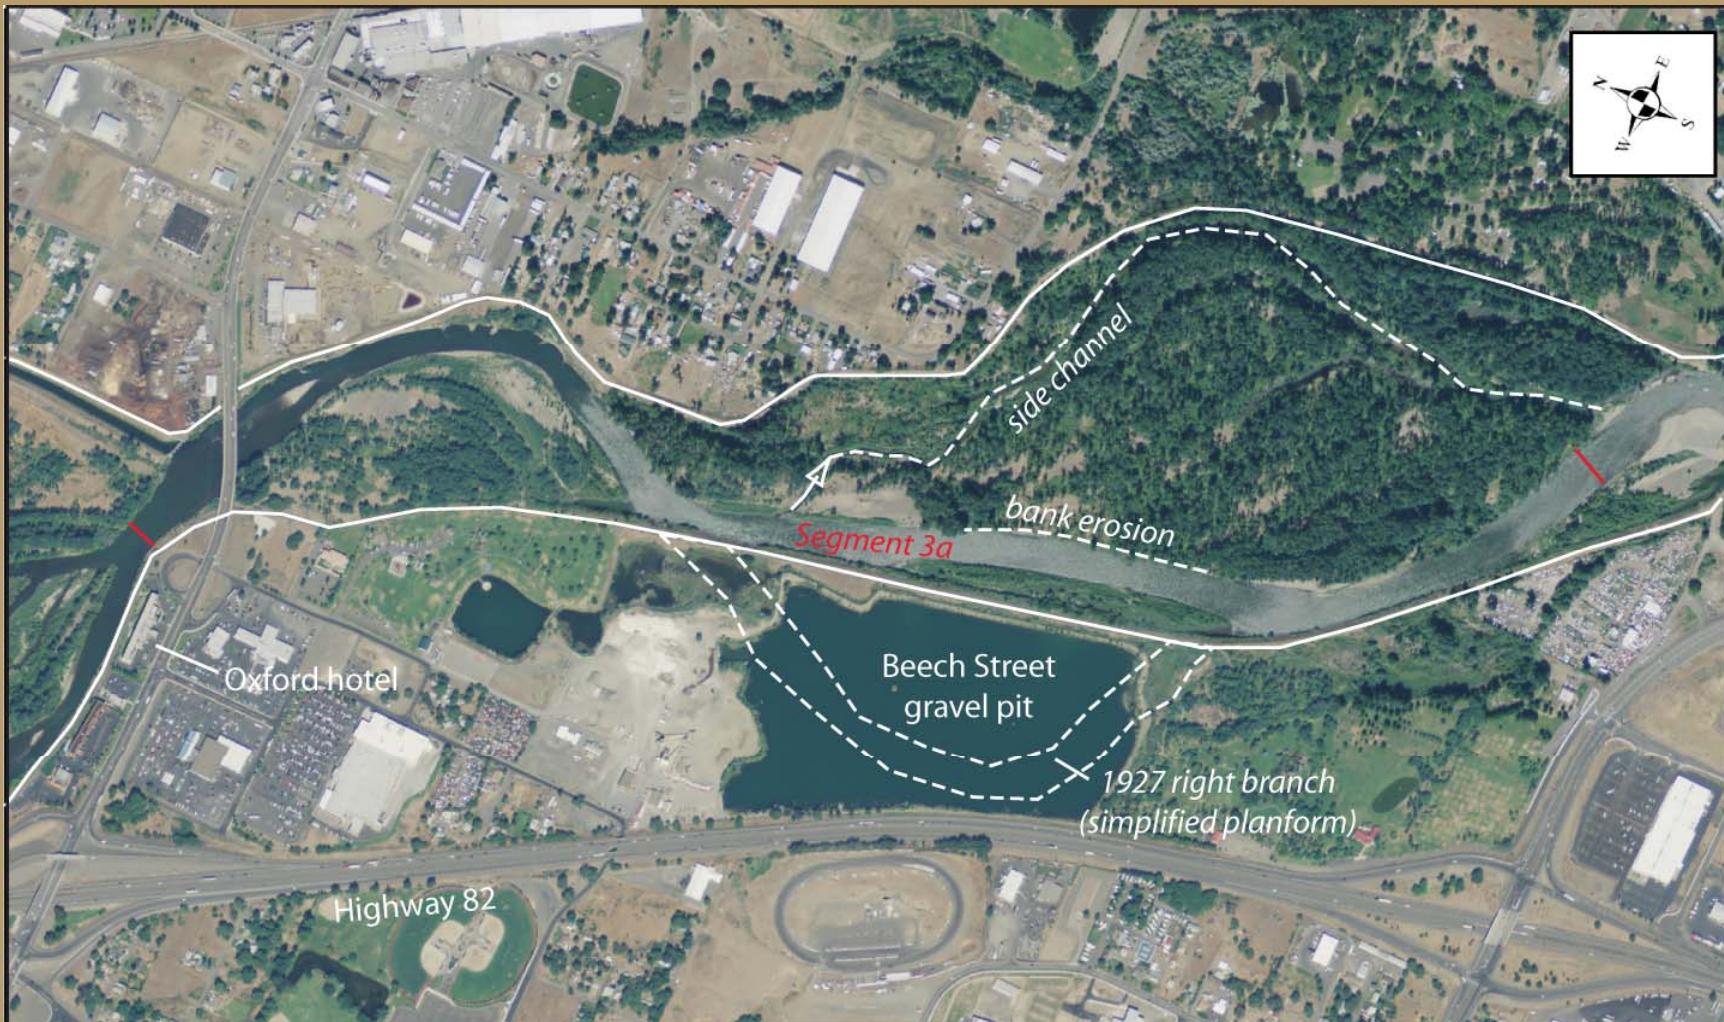
Segment 3a

Terrace Heights gravel pit to Old SR24

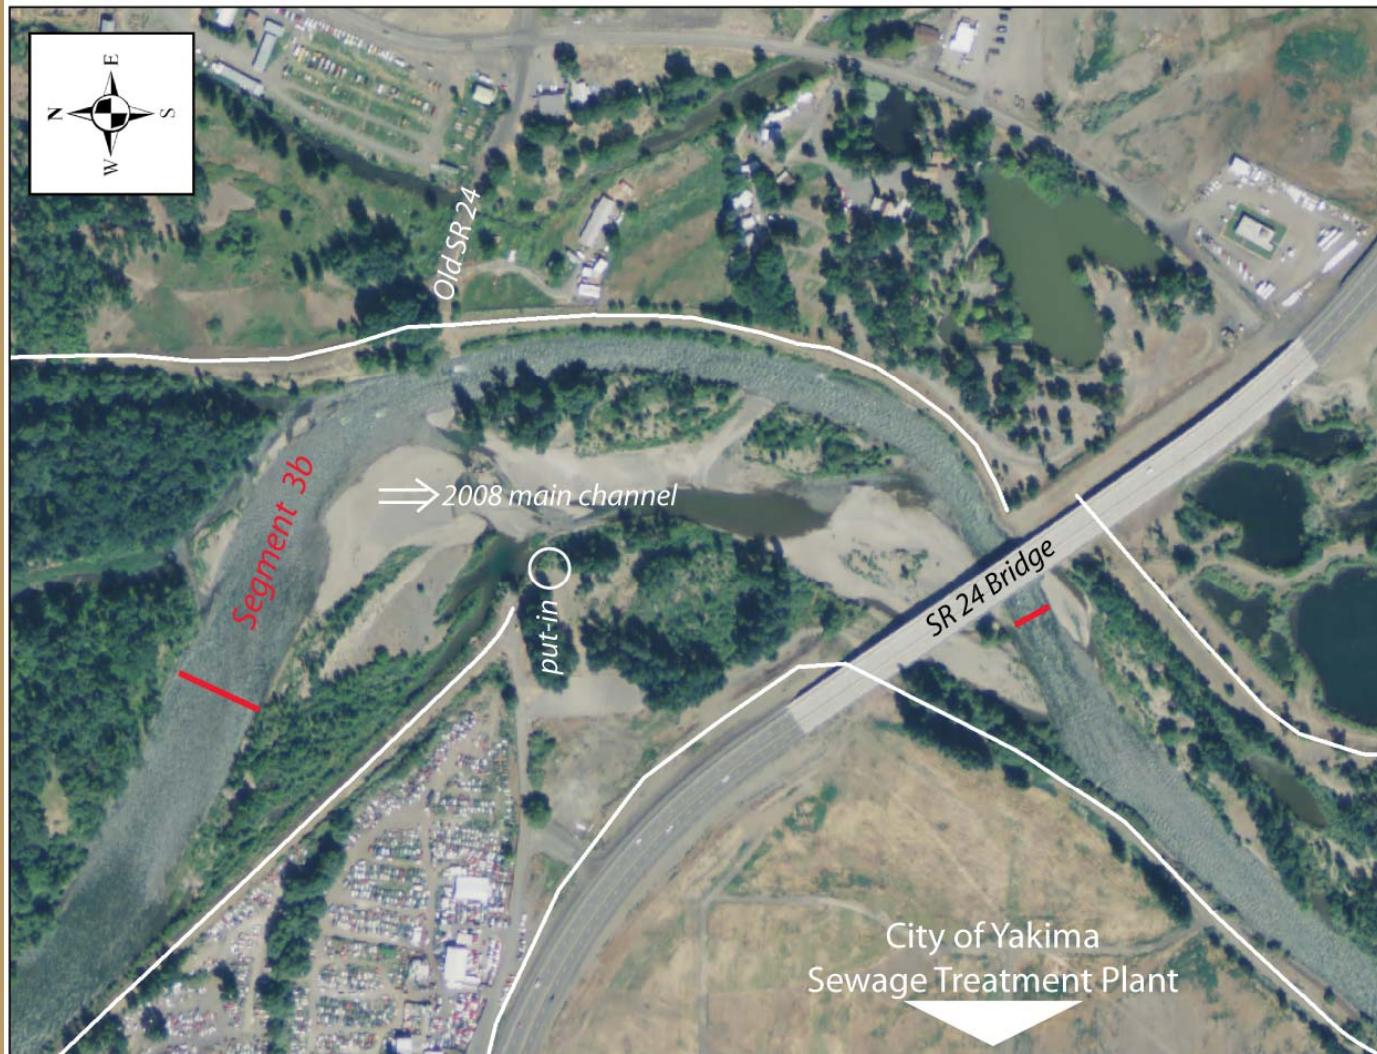
Segment 3b

Old SR24 to SR24 Bridge

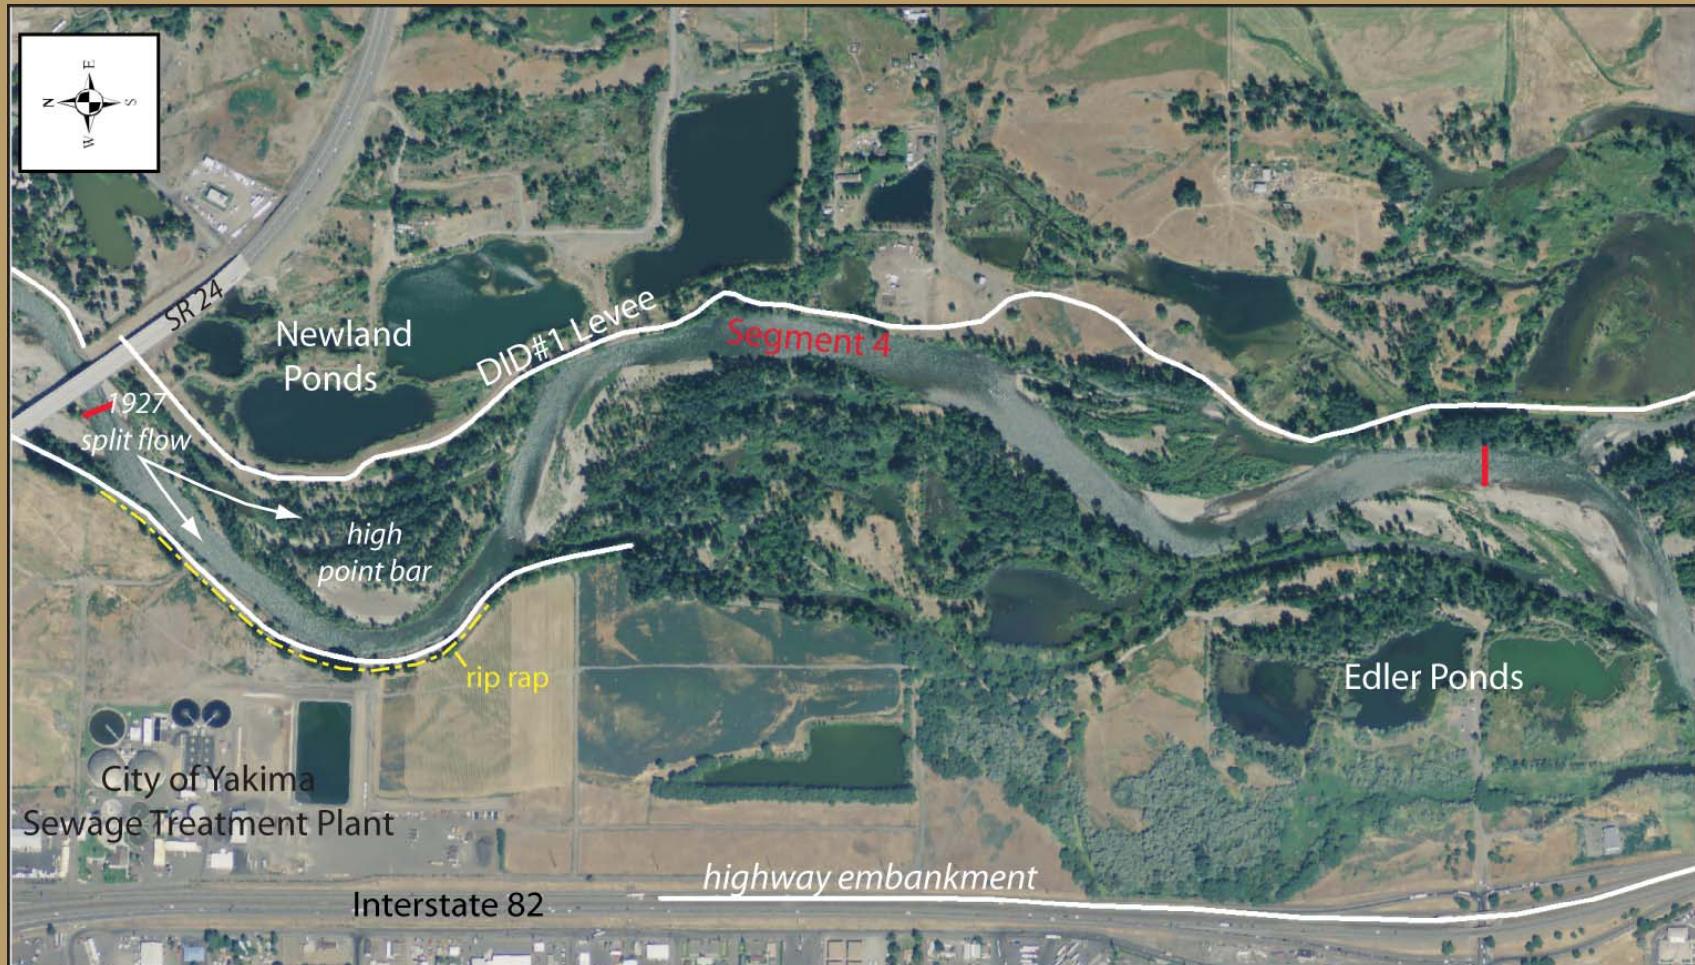
Segment 4

SR24 Bridge to Edler Pond no. 2

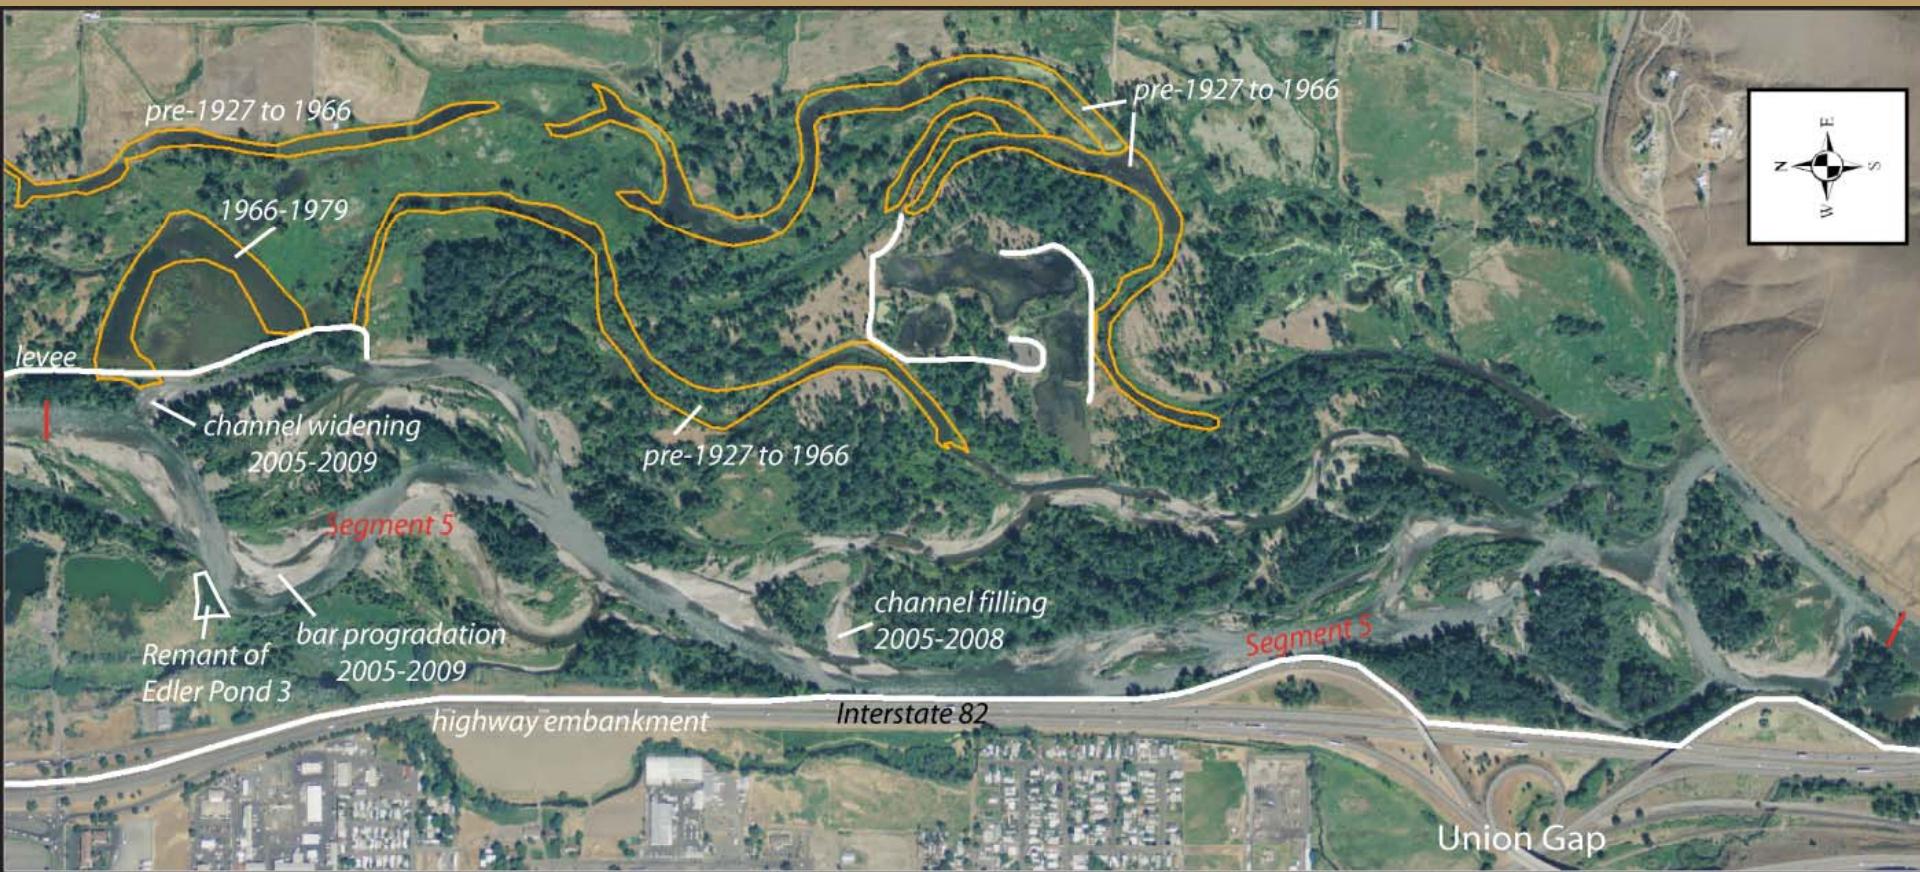
Segment 5a

Edler Pond no. 2 to Union Gap

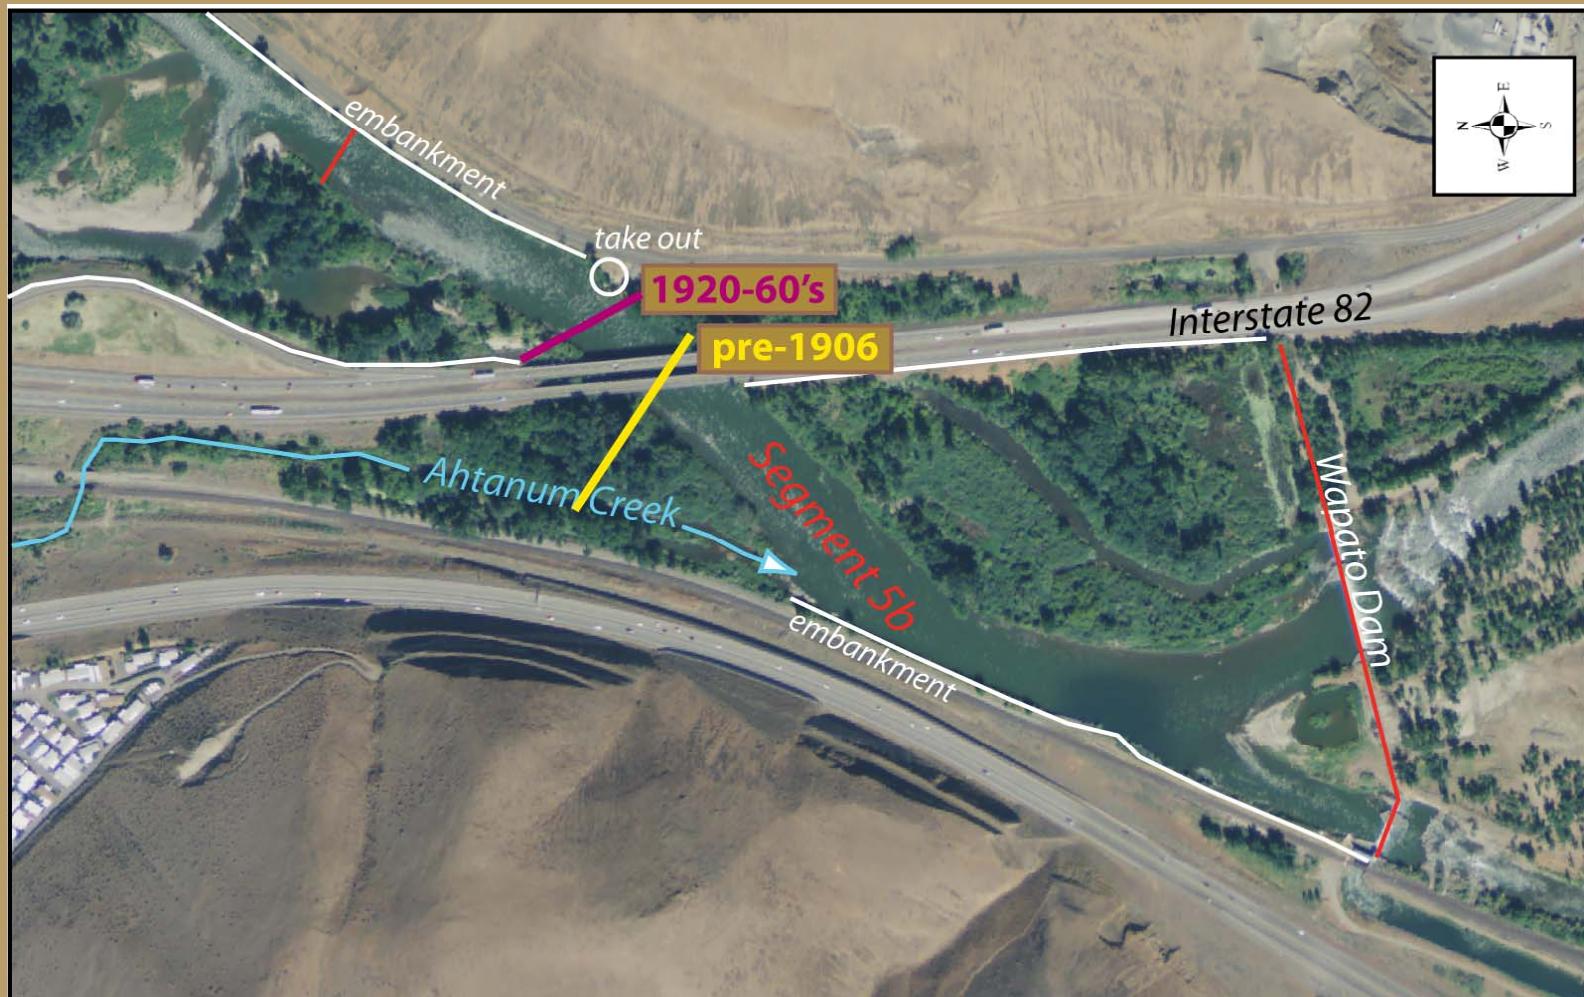
Segment 5b

Union Gap to Wapato Dam

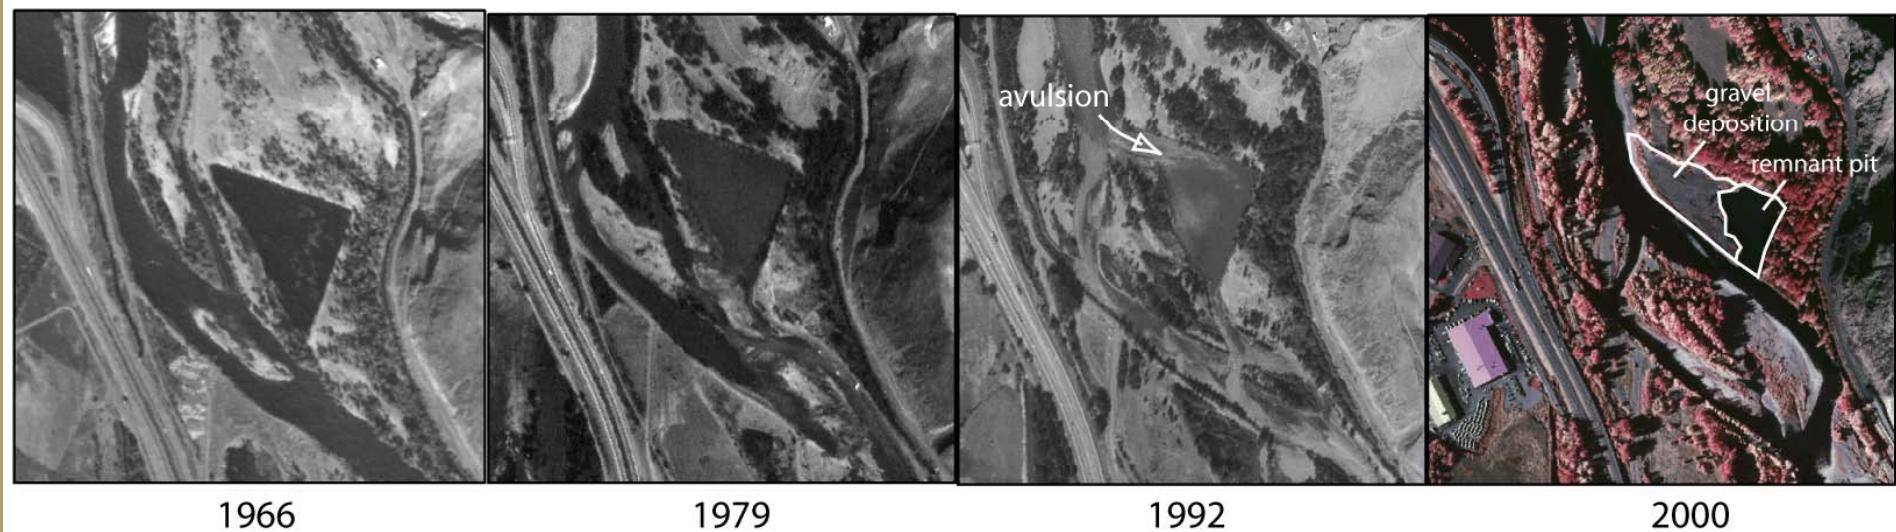
Triangular gravel pit

- *Channel avulsion, pit filling and abandonment*
- *Remnant pit*

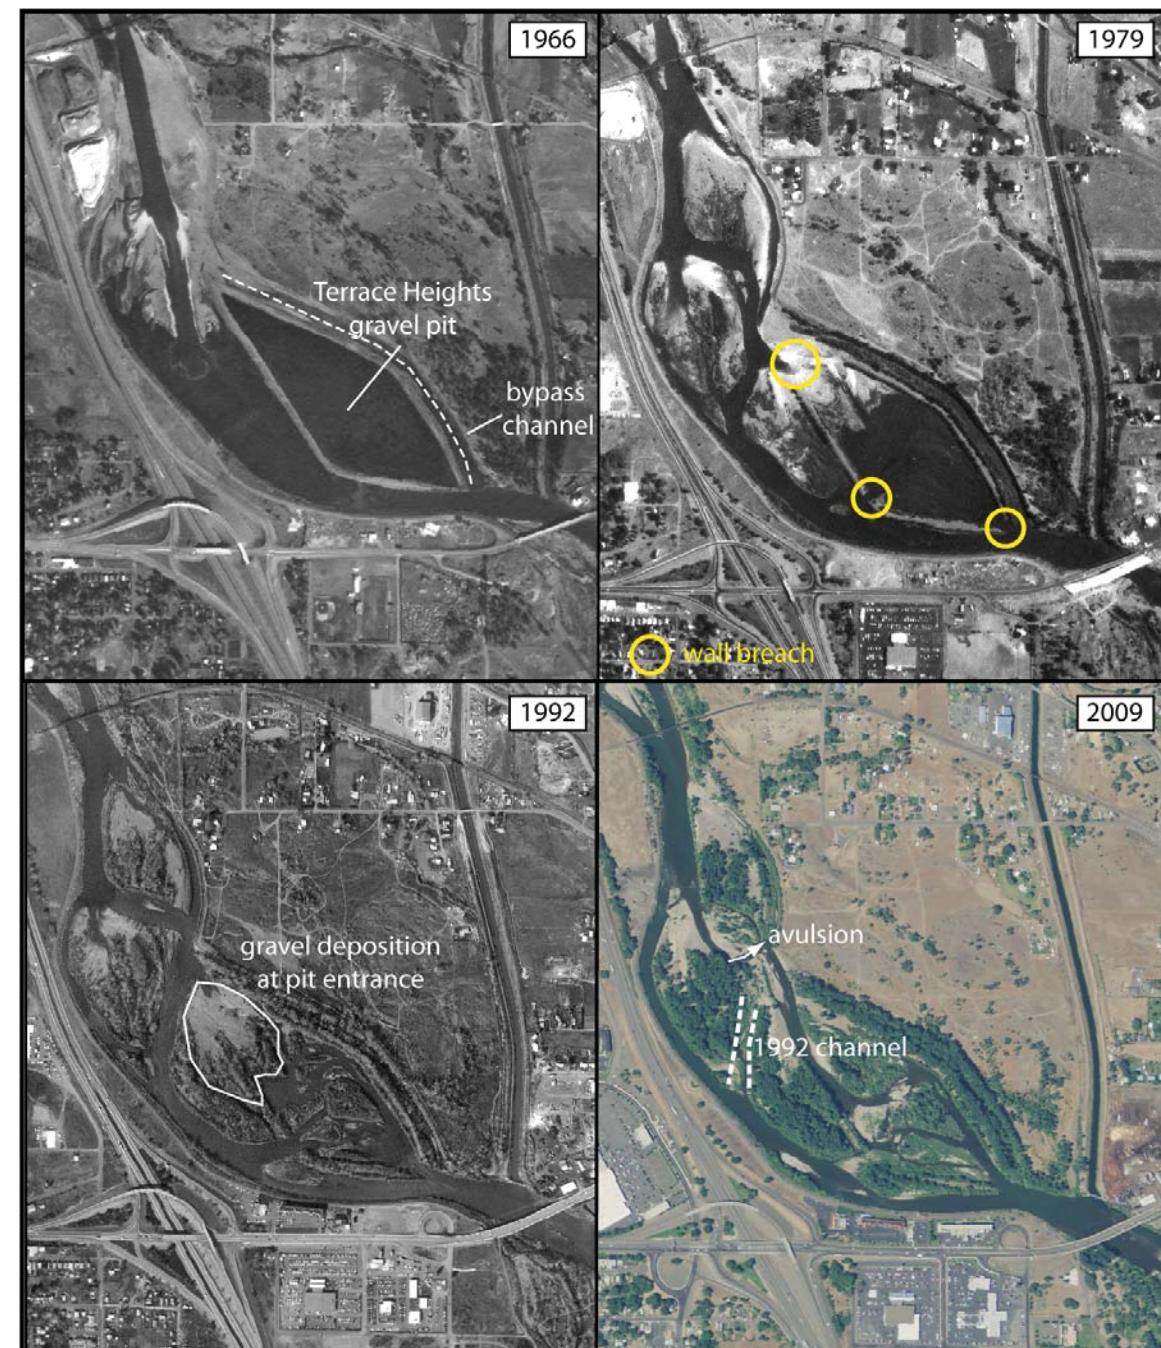
Terrace Heights gravel pit

- Channel excavation through river deposits (1966)
- Multiple wall breaches (1966-1979)
- Gravel deposition at pit entrance and within pit (1979-1992)
- Channel avulsion at head of pit; formation of complex channel network (1992-2009)

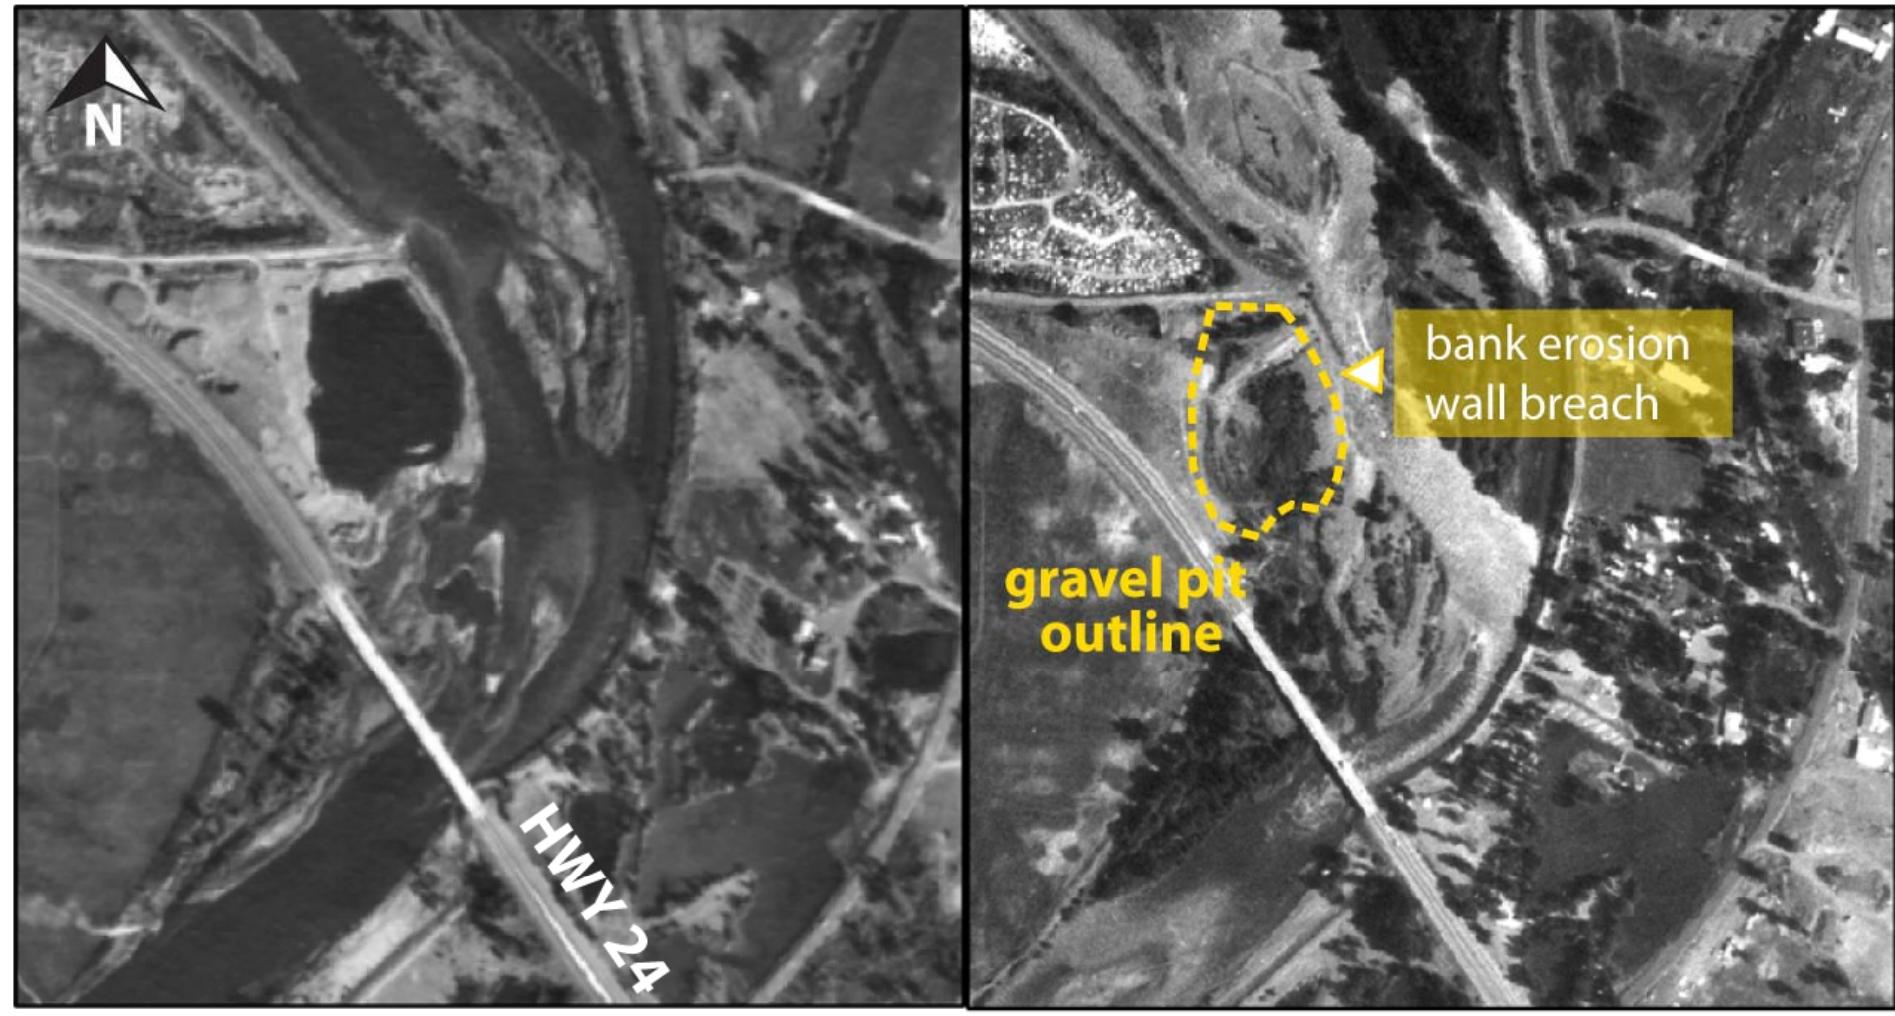
SR 24 gravel pit

--wall breach, pit filling

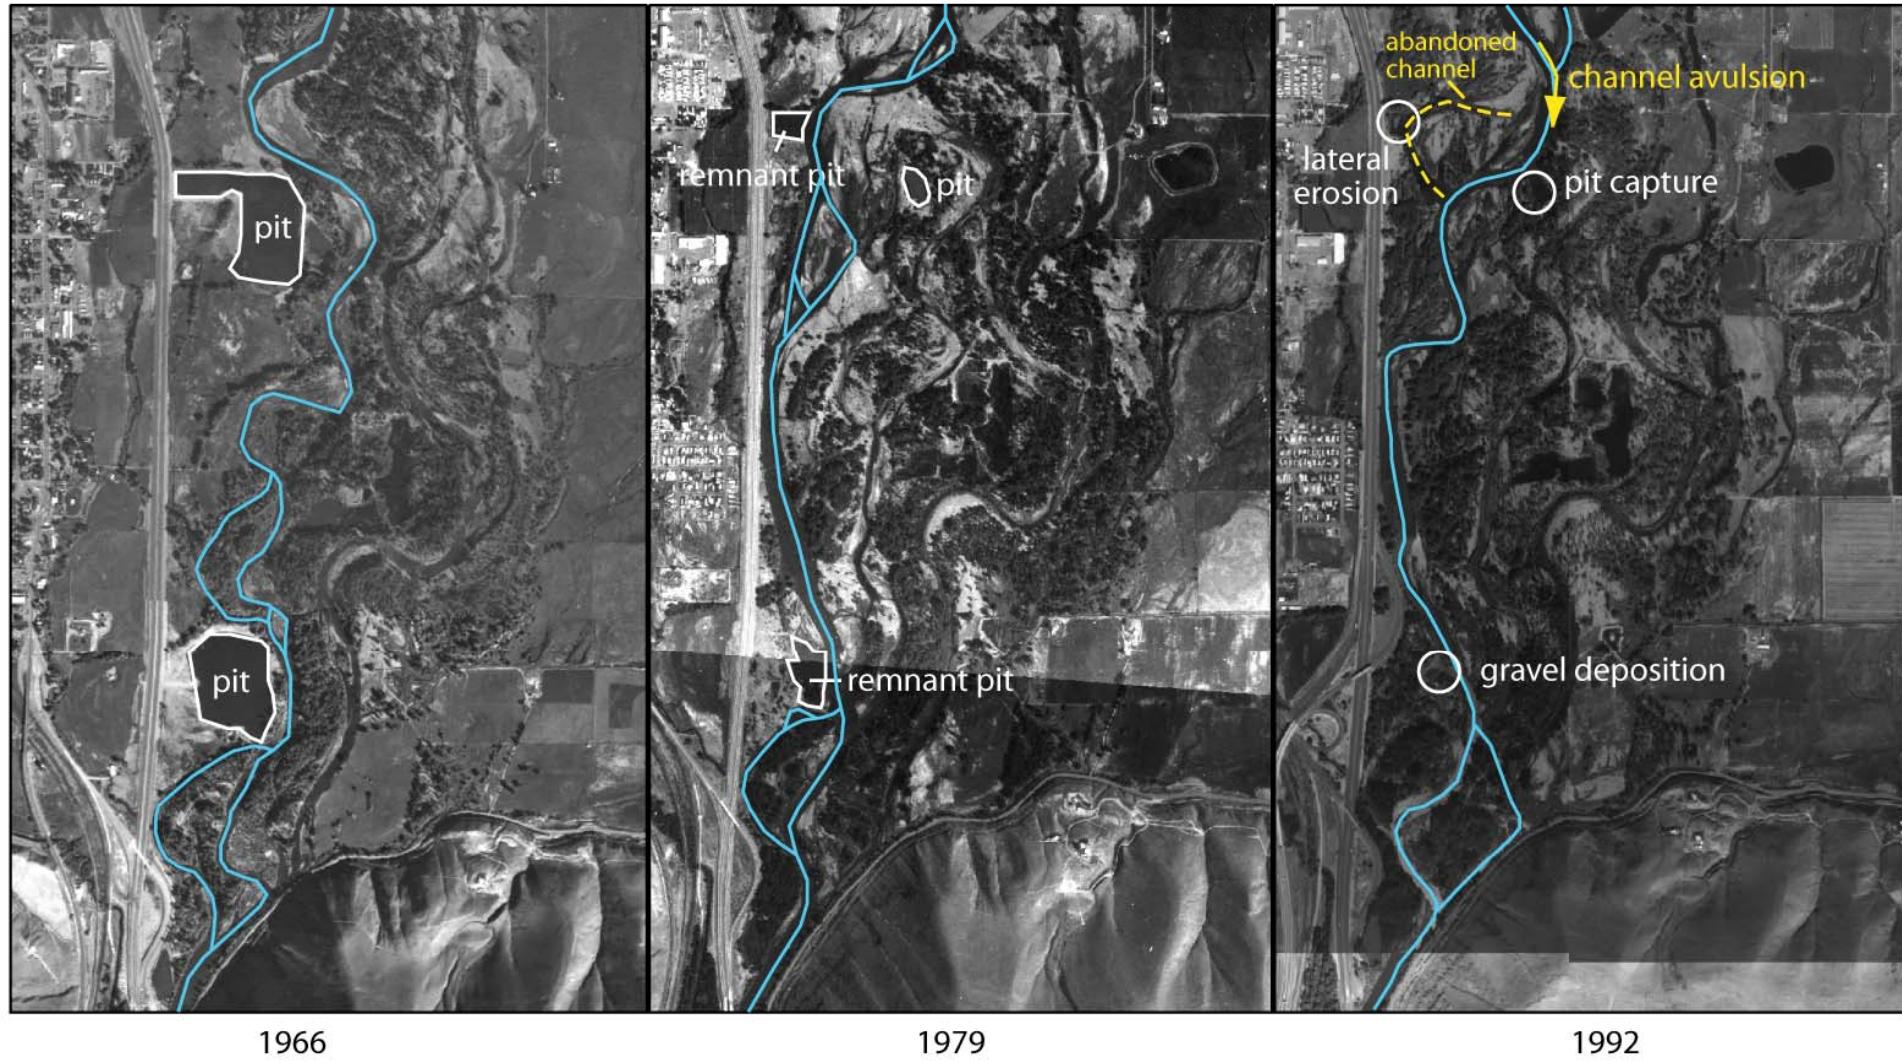
Reach 5b gravel pit captures --channel avulsion, headcutting

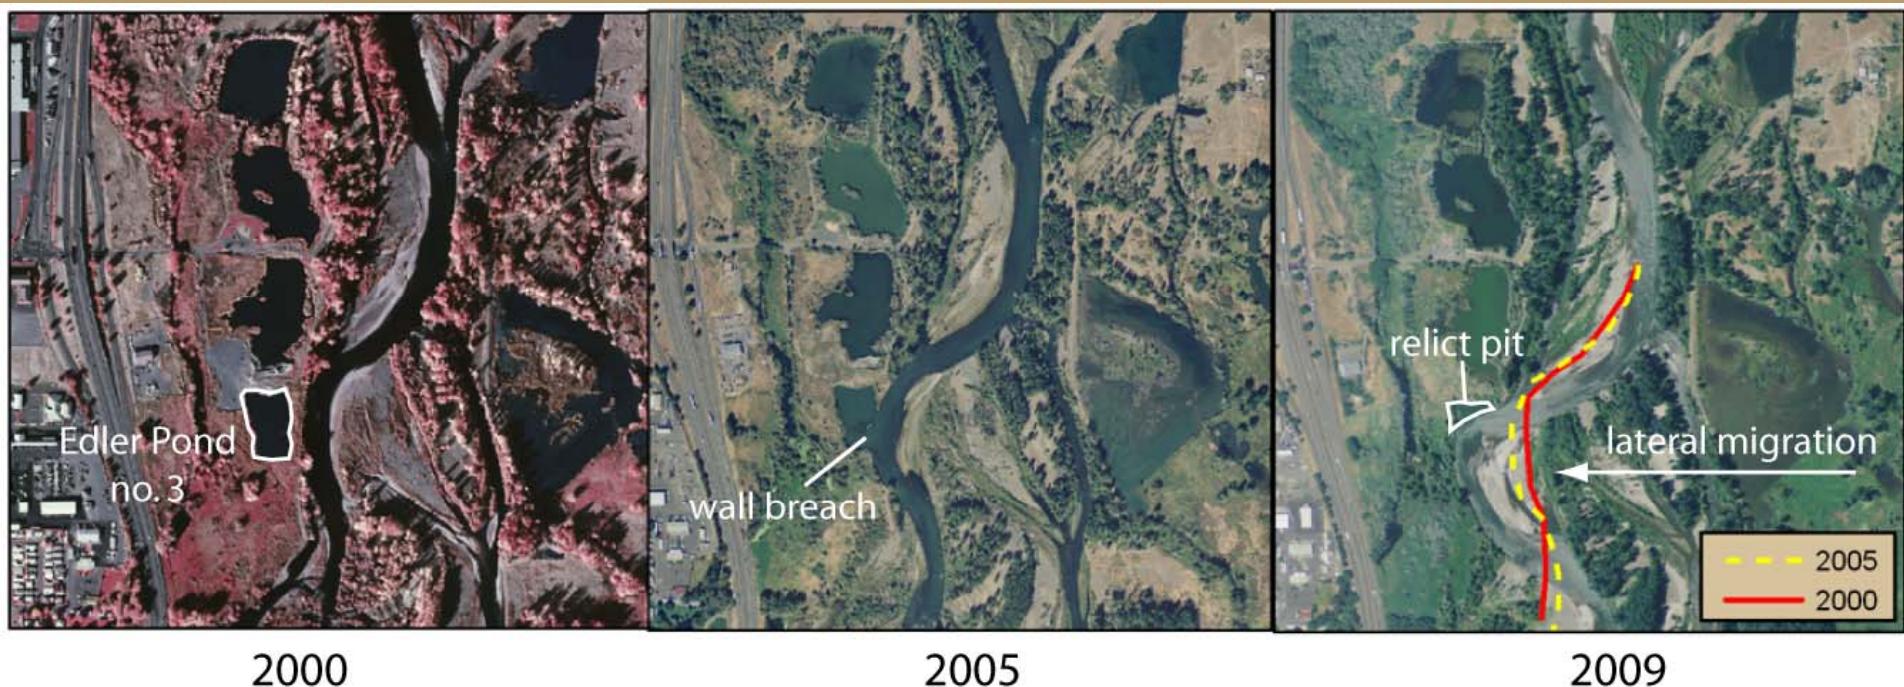
Edler Ponds

- wall breach in April 2002
- lateral erosion, pit filling
- point bar progradation

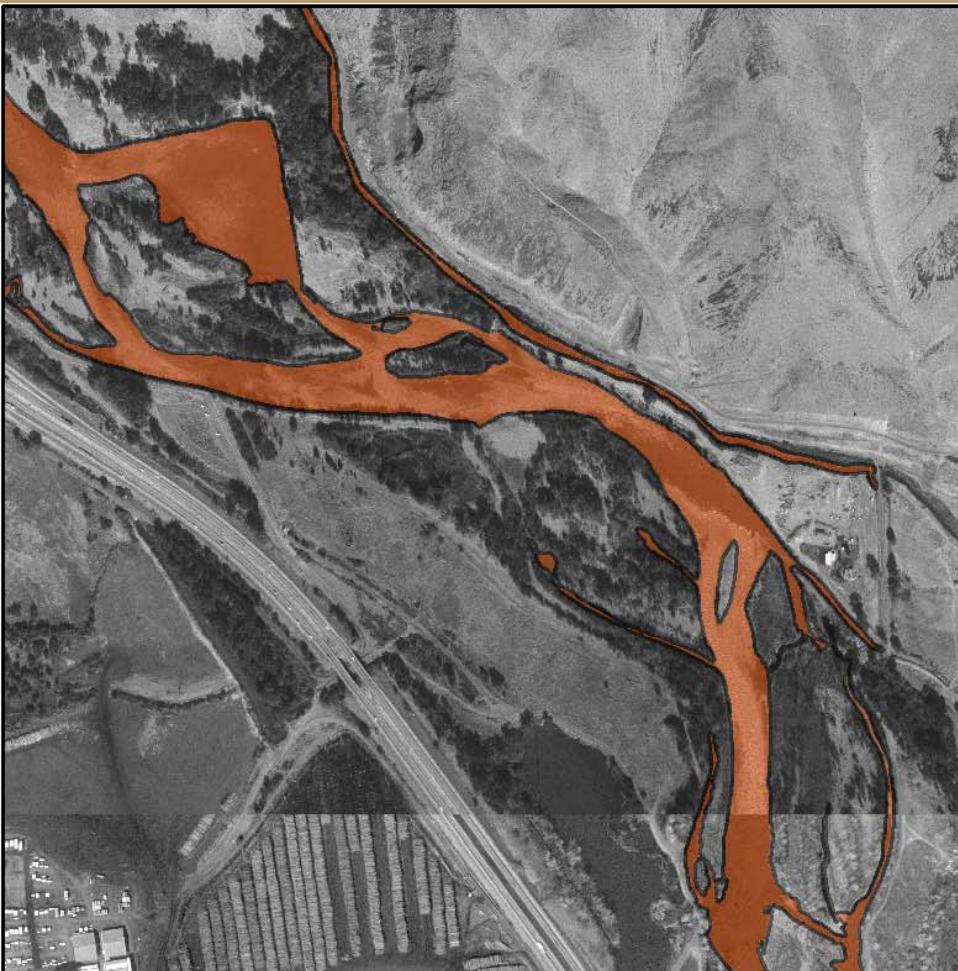
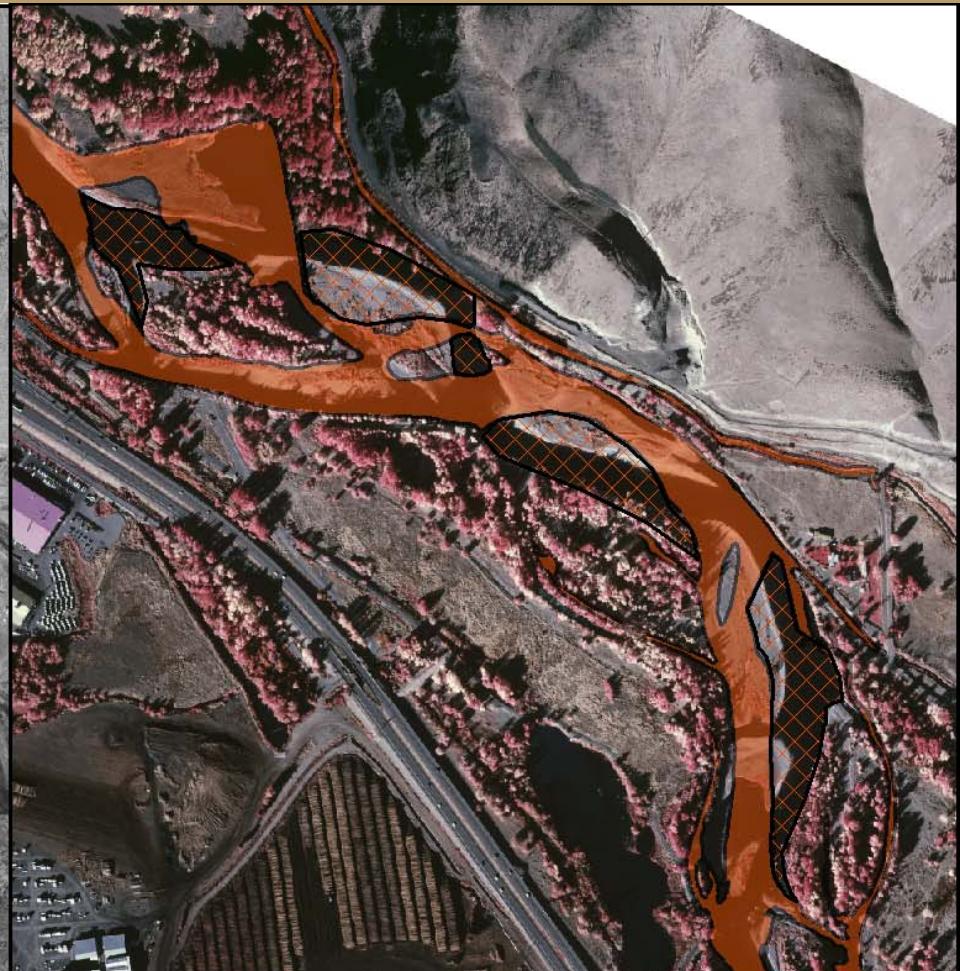
1996 flood effects in segment 2

--multiple channel avulsions

--bar formation and erosion

--increase in main channel sinuosity

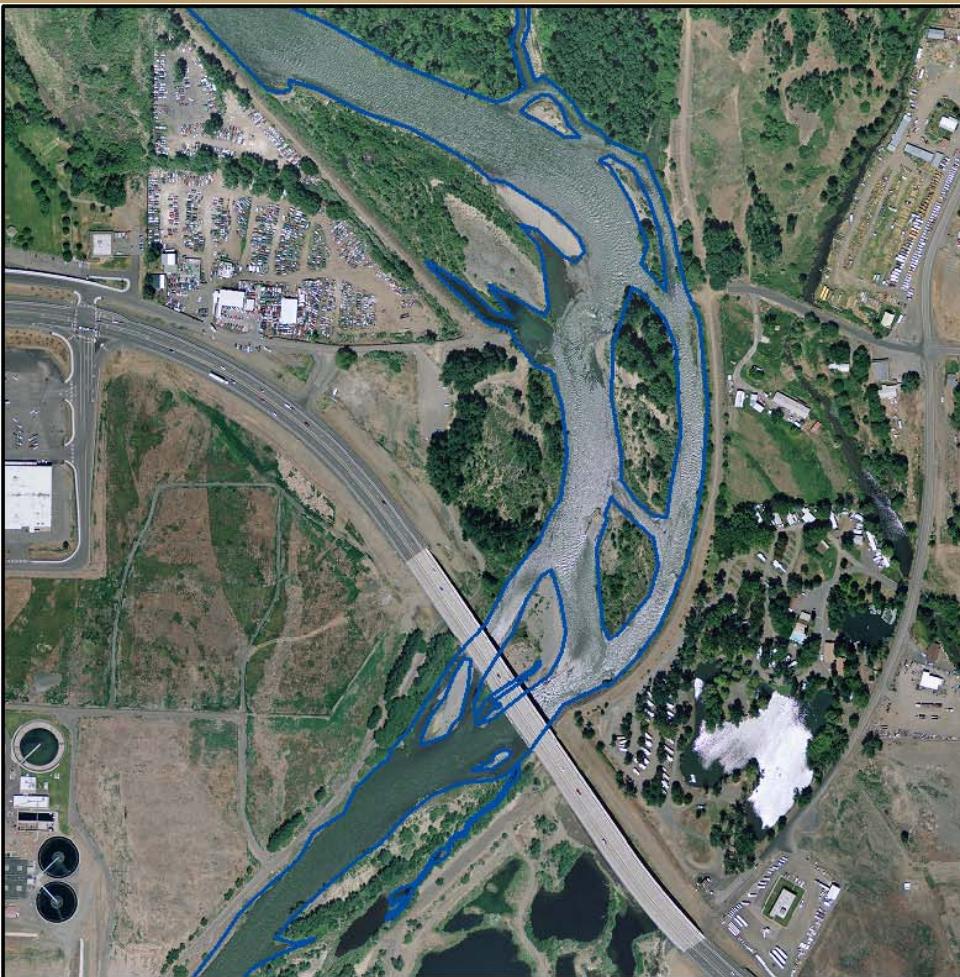
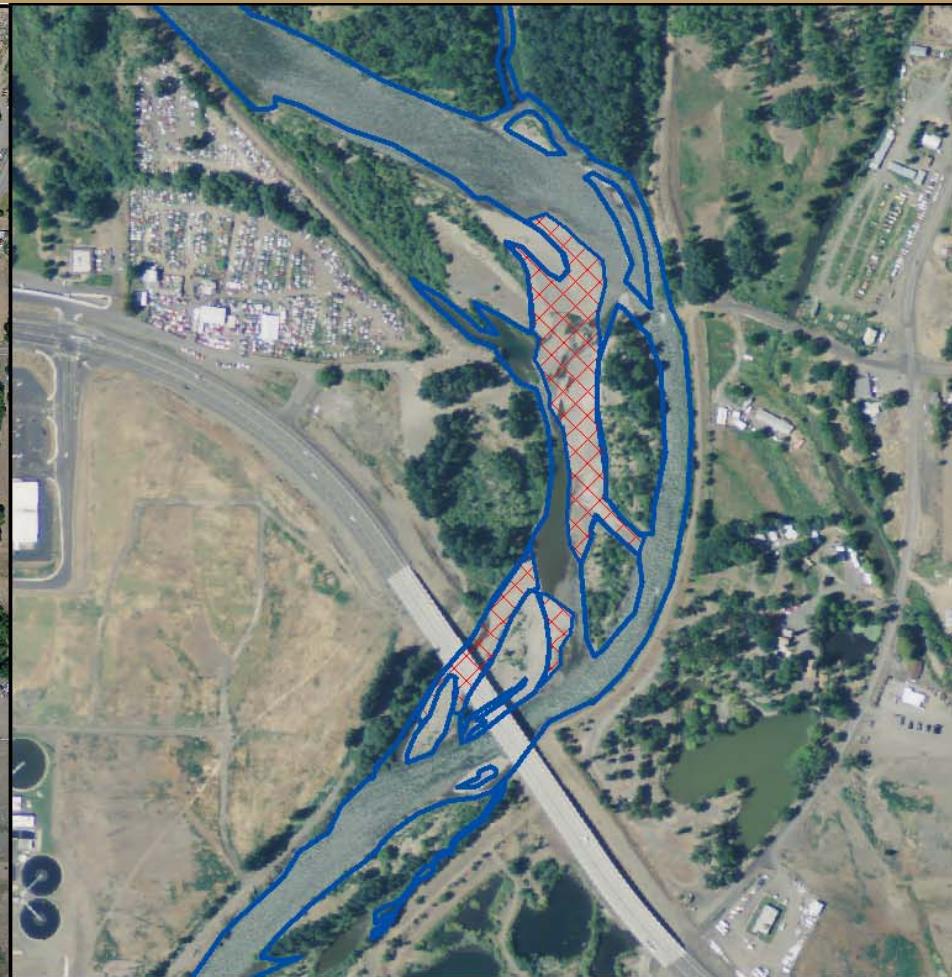
2009 flood effects at SR24 Bridge

--channel avulsion and filling
