Yakima River Geomorphology and Sediment Transport Study: Gap to Gap Reach, Yakima, WA

U.S. Department of the Interior
Bureau of Reclamation

- Study performed and report prepared by:
 - Robert C. Hilldale (Hydraulic Engineer)
 - Jeanne Godaire (Geomorphologist)
 - Bureau of Reclamation, Technical Service Center
 - Denver, CO

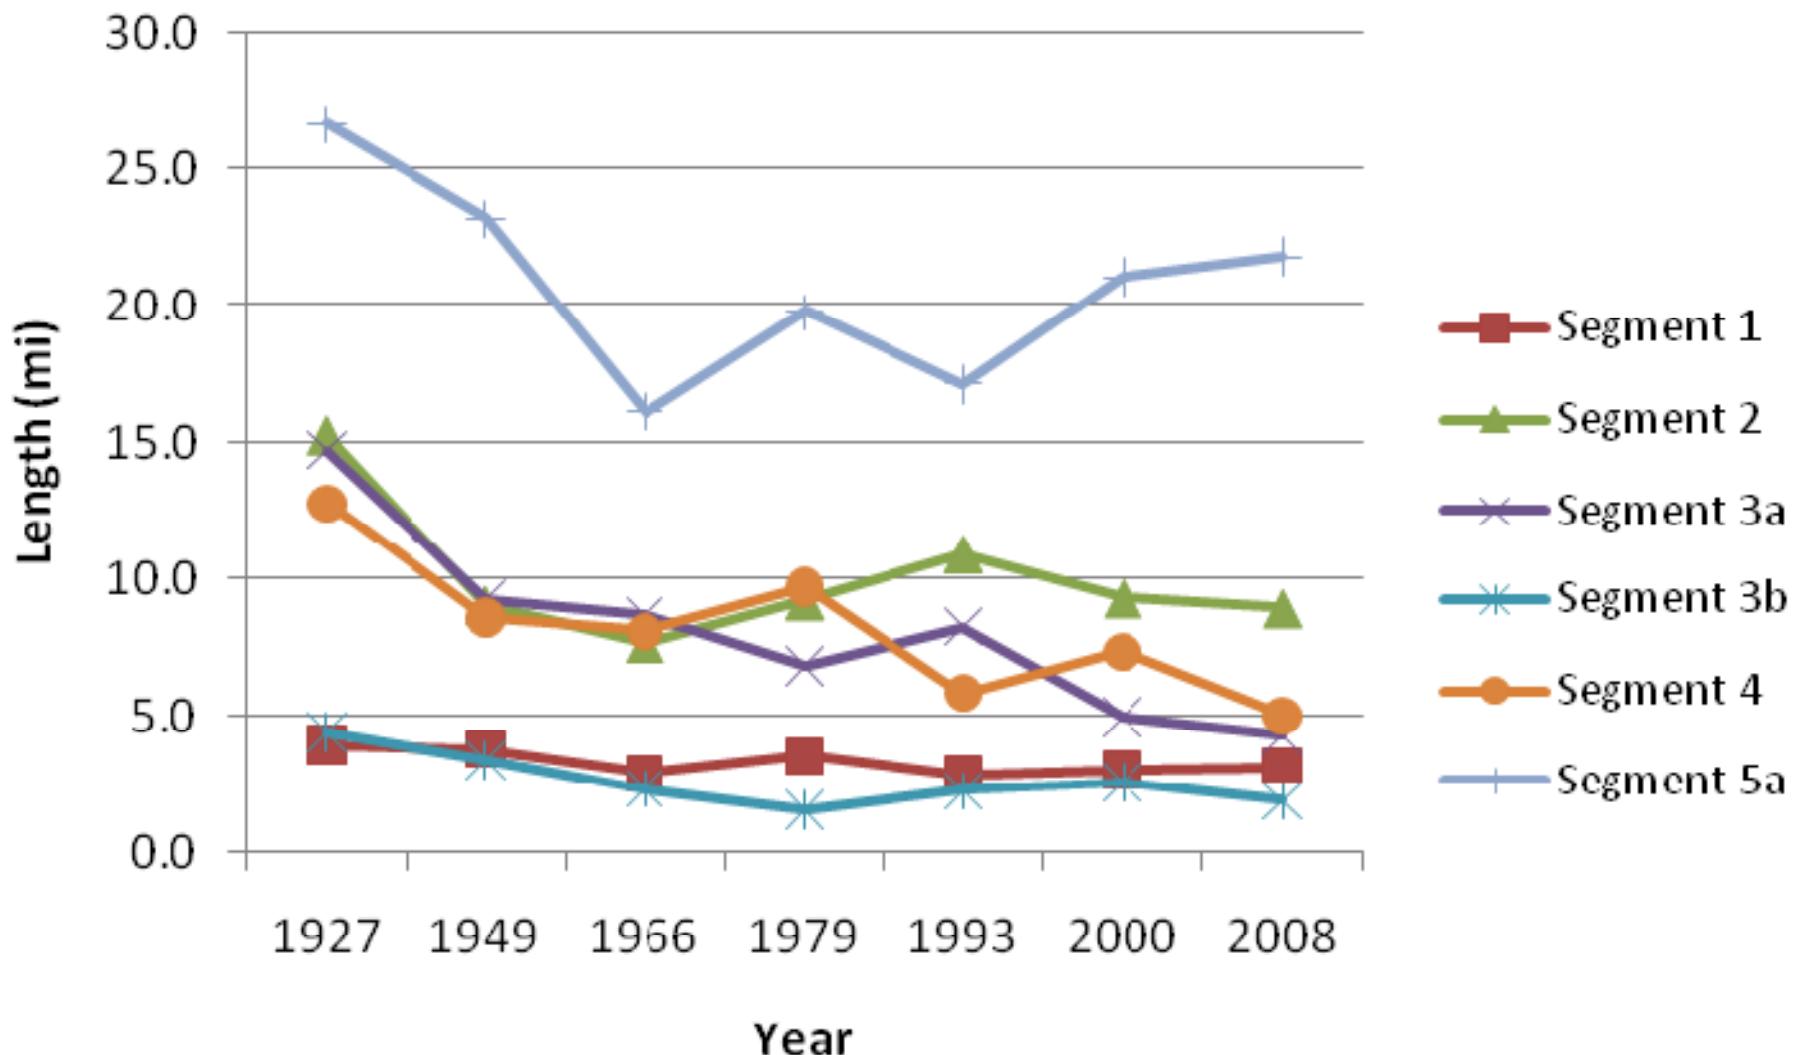
Channel complexity

Total channel length

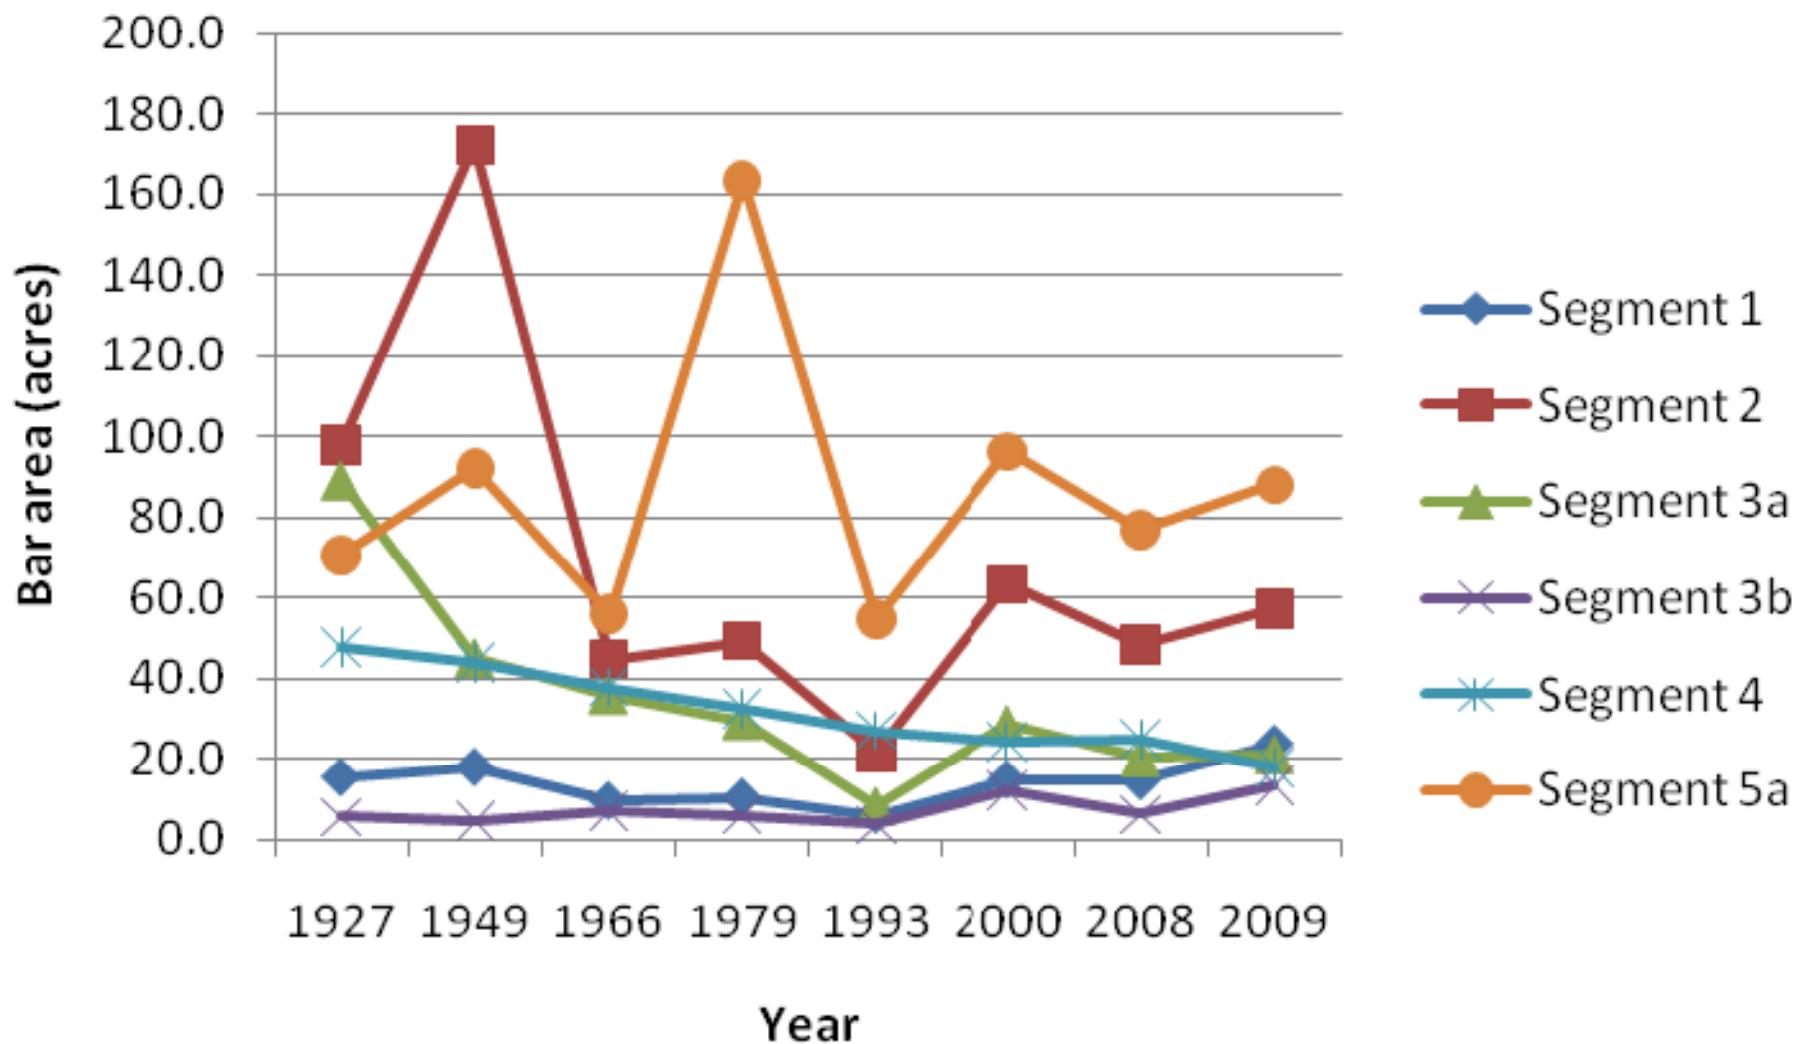
Unvegetated bar area by segment

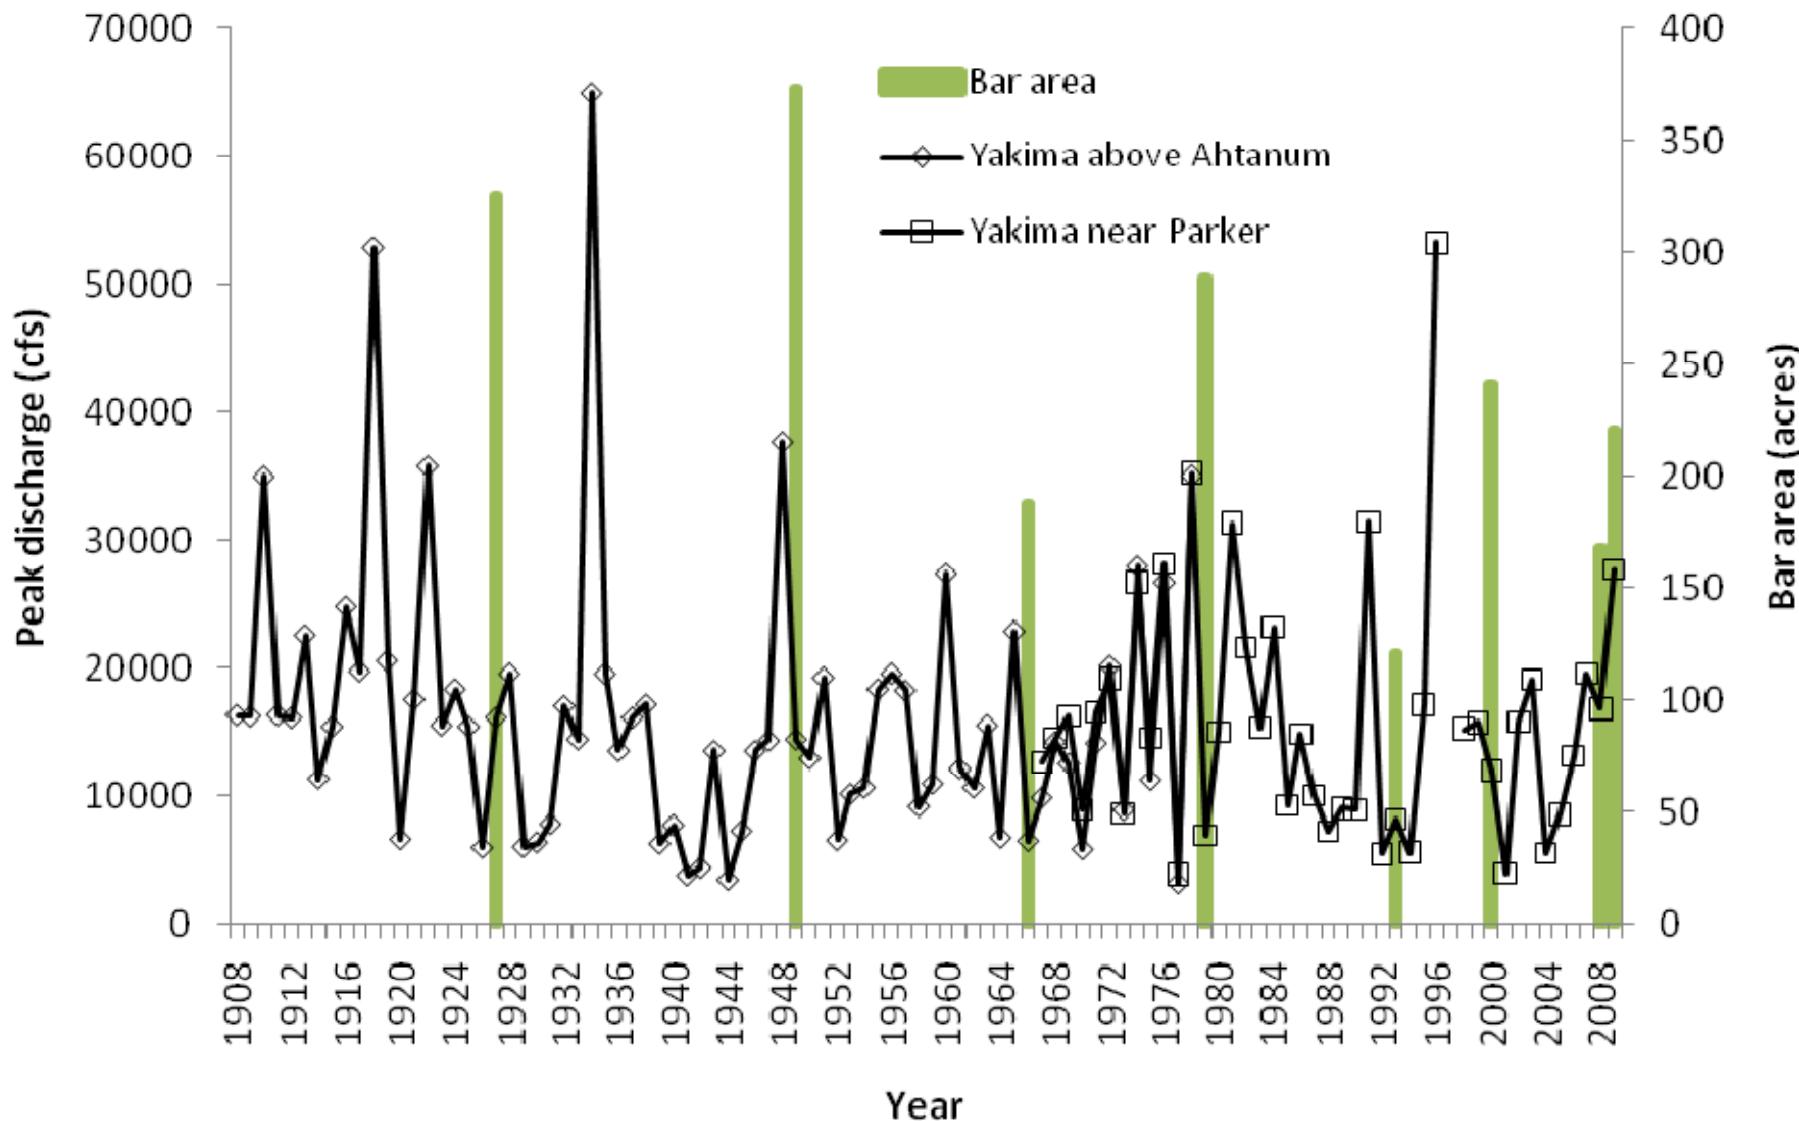
Unvegetated bar area & hydrology

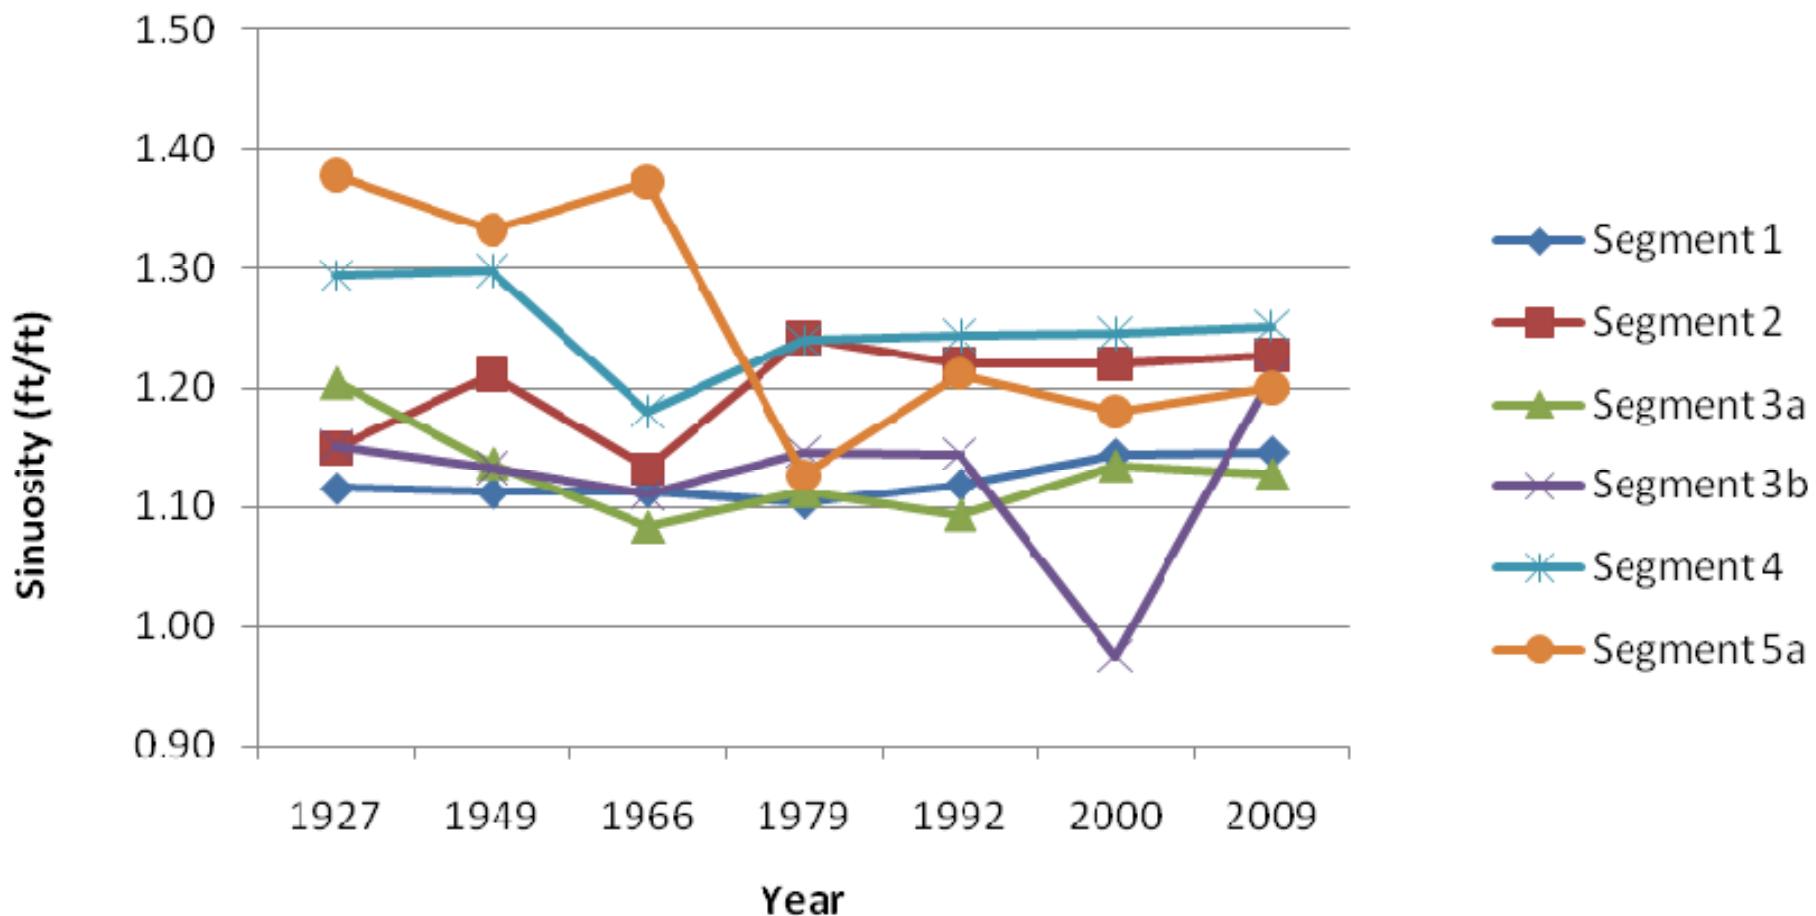
Main channel sinuosity

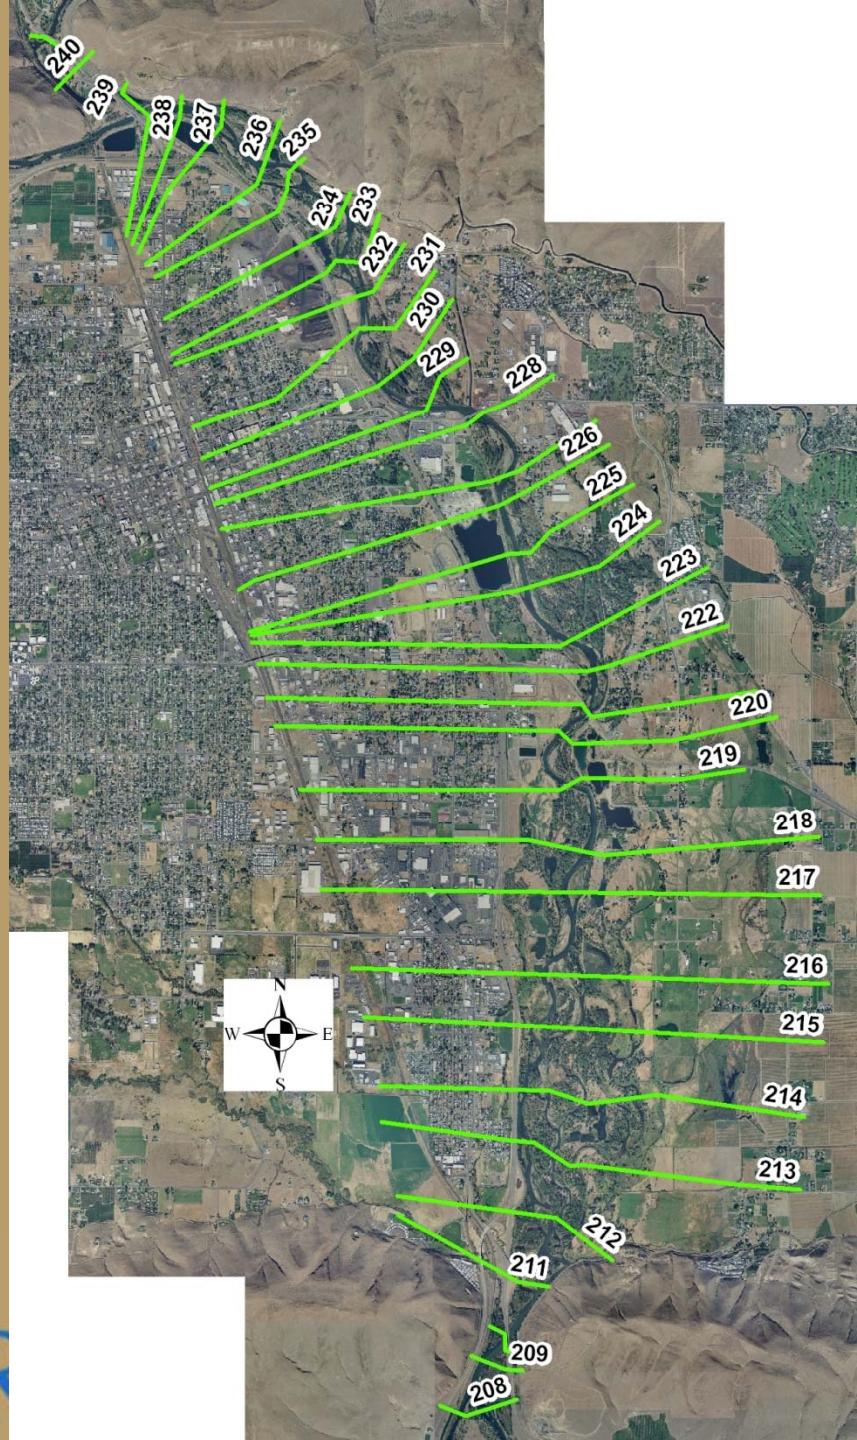
Channel survey comparison 1969-2005

- 1969 channel survey
 - USACE survey
 - Alignments and vertical corrections provided by Yakima County
- 2005 channel survey
 - LiDAR data
 - Data extracted for 1969 alignments
- Only floodplain area within levees included in analysis

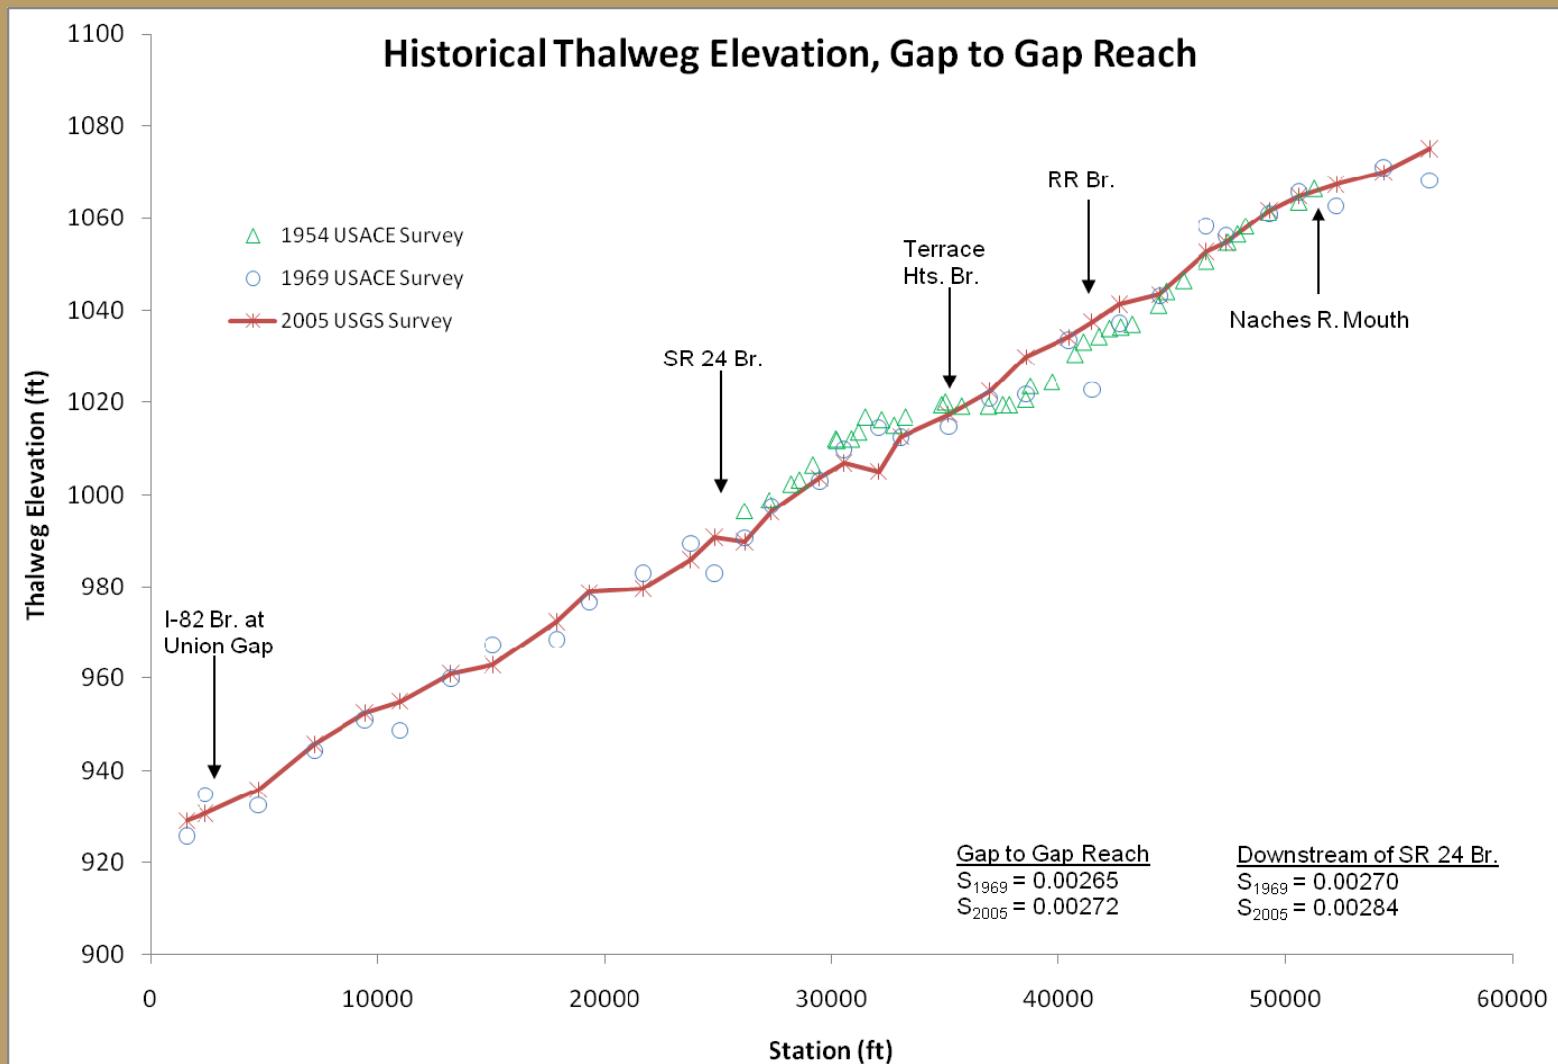
Longitudinal profile 1969-2005

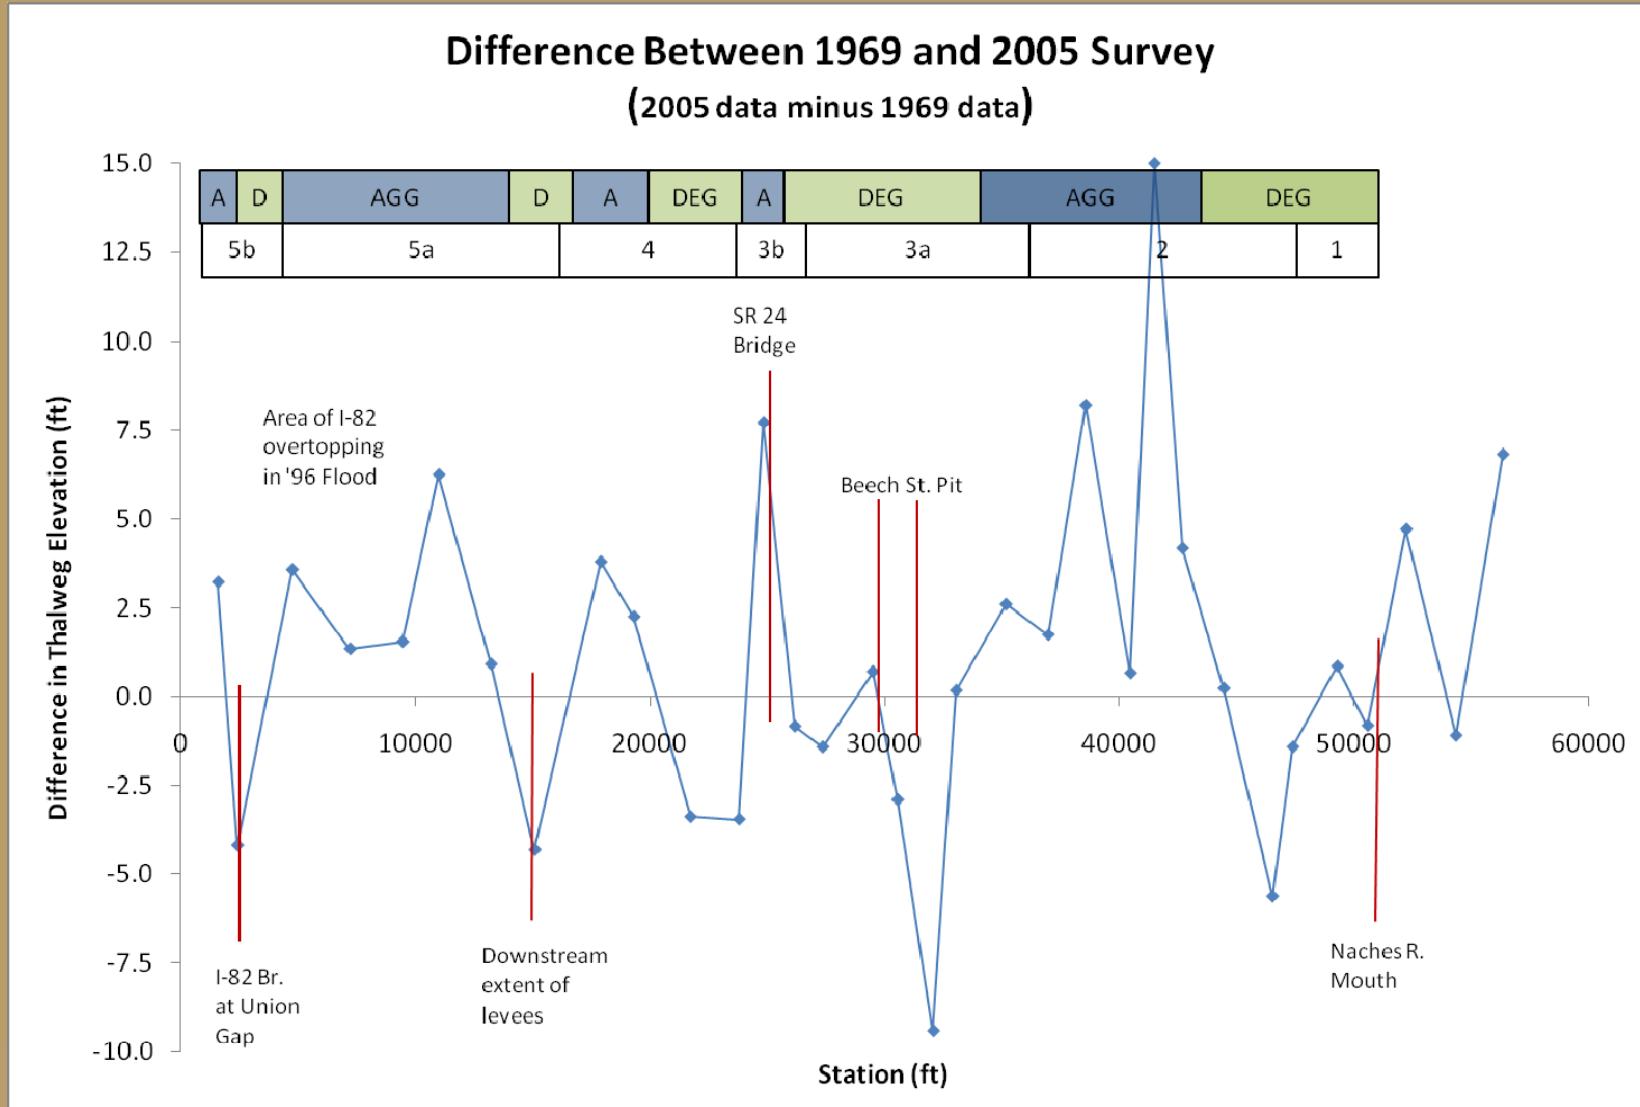
Thalweg difference plot

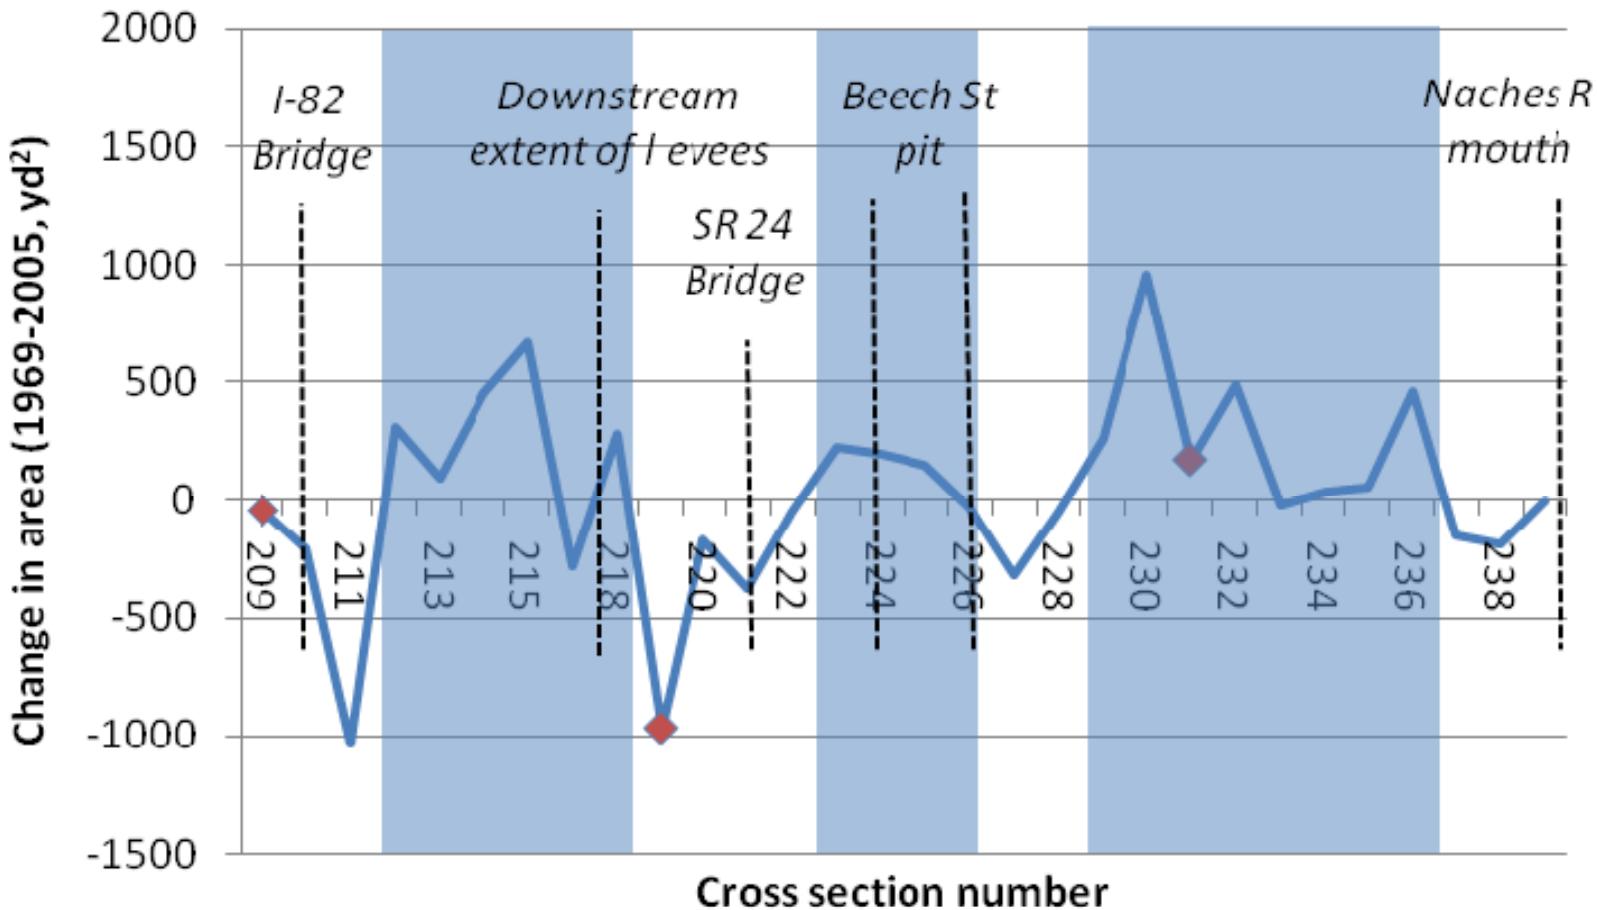
Cross sectional area changes

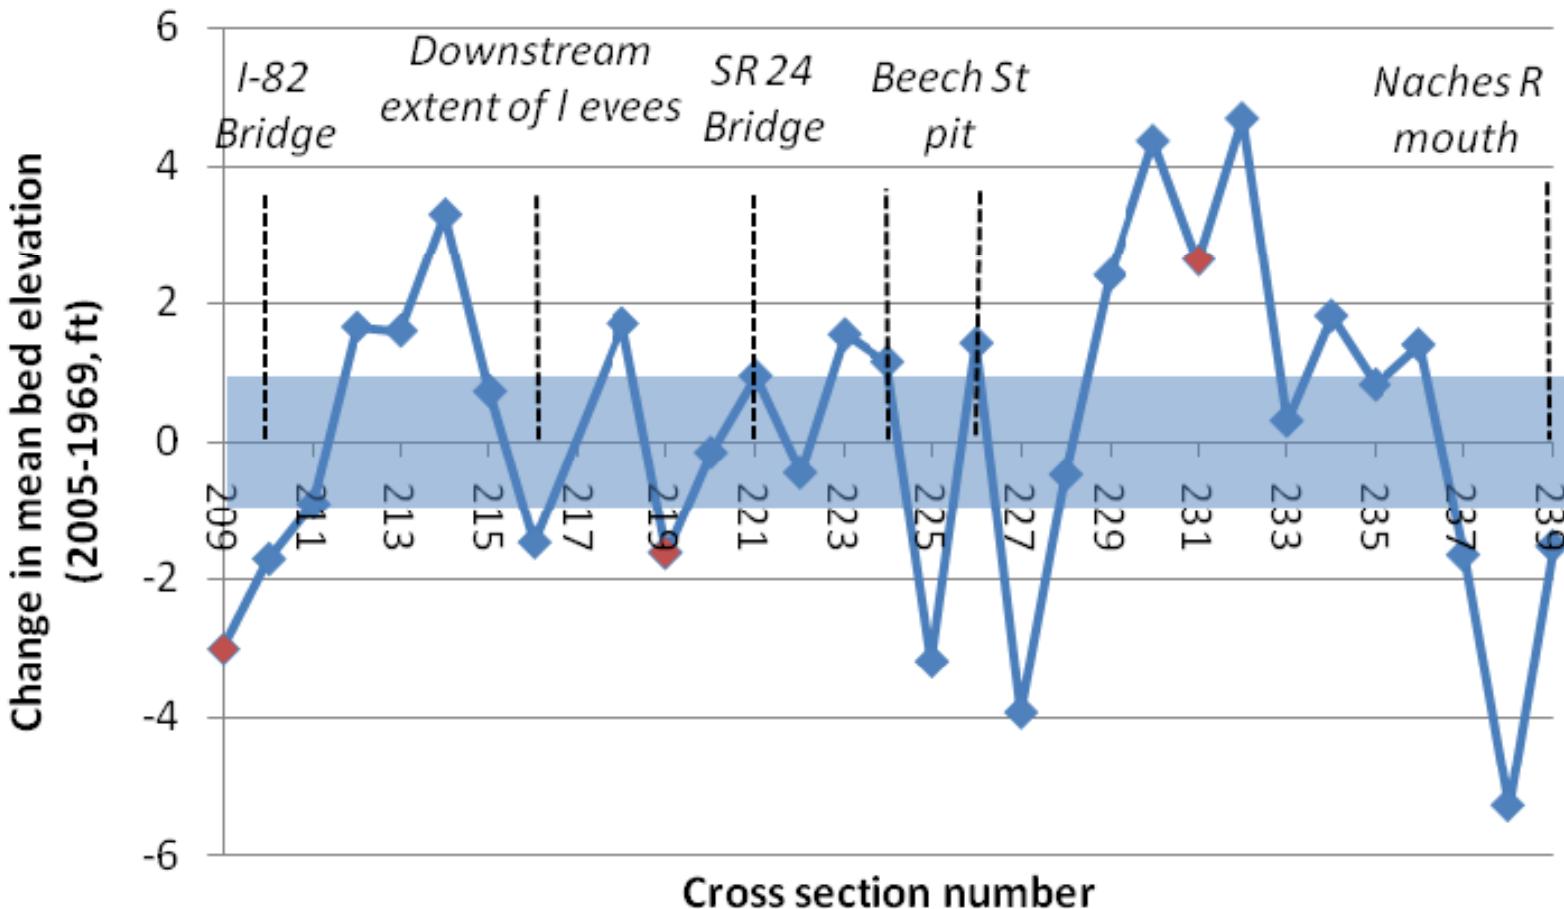
Mean bed elevation changes

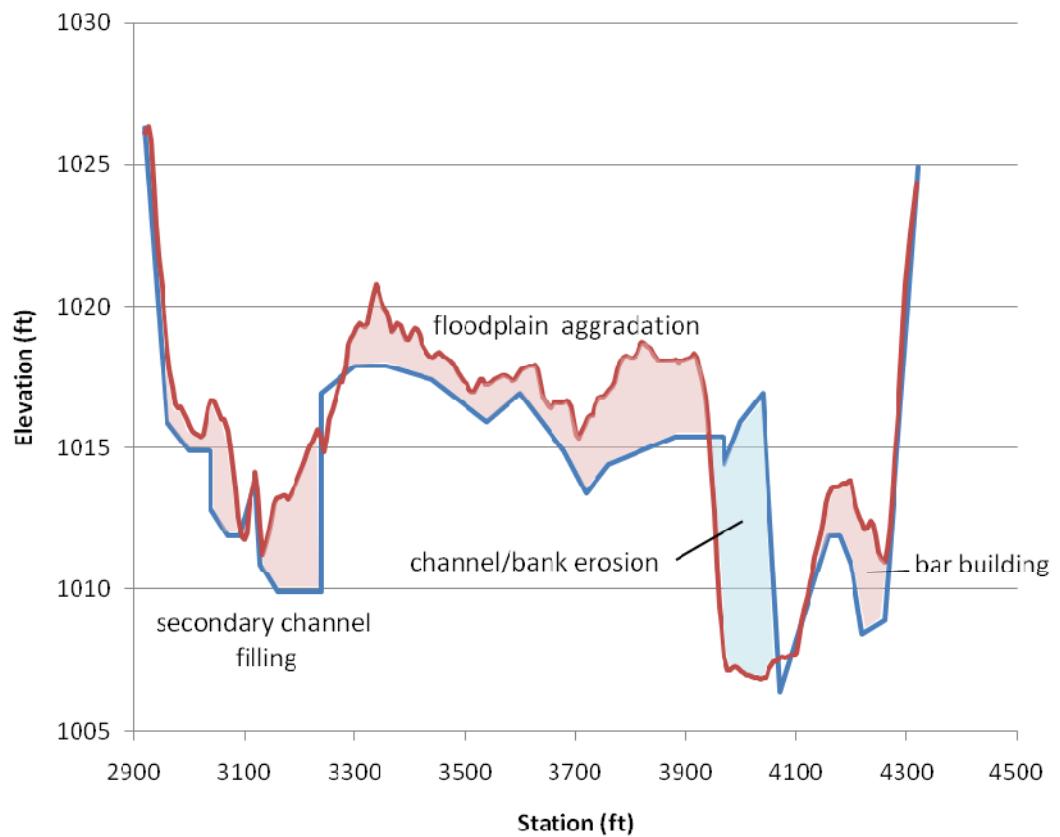
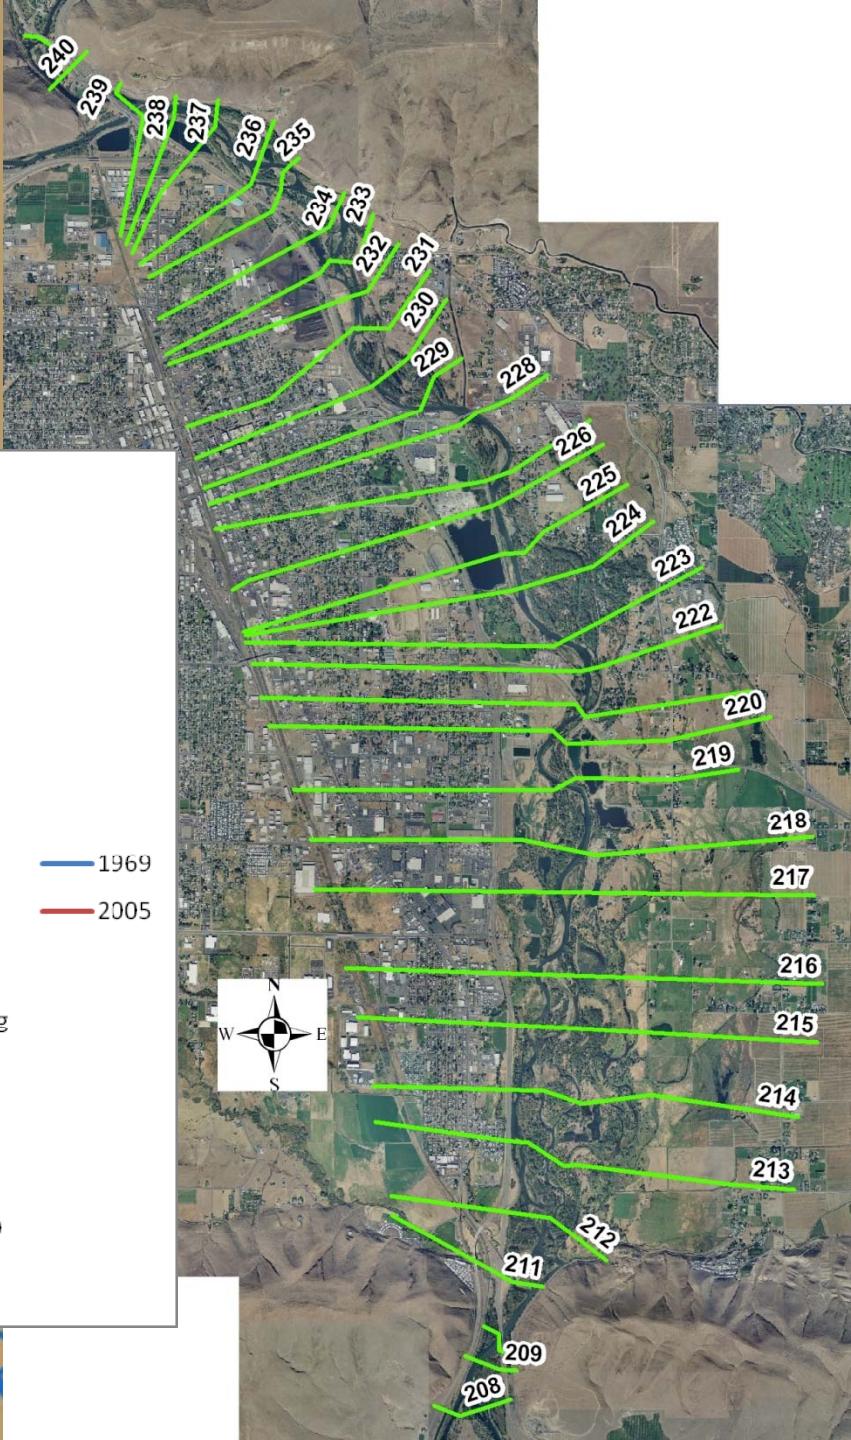
Cross section 225

Areas of aggradation and degradation

- **Areas of aggradation**
 - Triangular pit to Terrace Heights Bridge (Segment 2)
 - Beech Street pit to Old SR24 (part of segment 3a)
 - Edler Ponds to Union Gap (segment 5a)
- **Areas of degradation**
 - Naches River mouth to triangular gravel pit (segment 1)
 - Terrace Heights Bridge to Beech Street pit (part of segment 3a)
 - Old SR24 to Edler Ponds (segment 3b; segment 4)
 - Union Gap vicinity to I-82 Bridge (segment 5b)

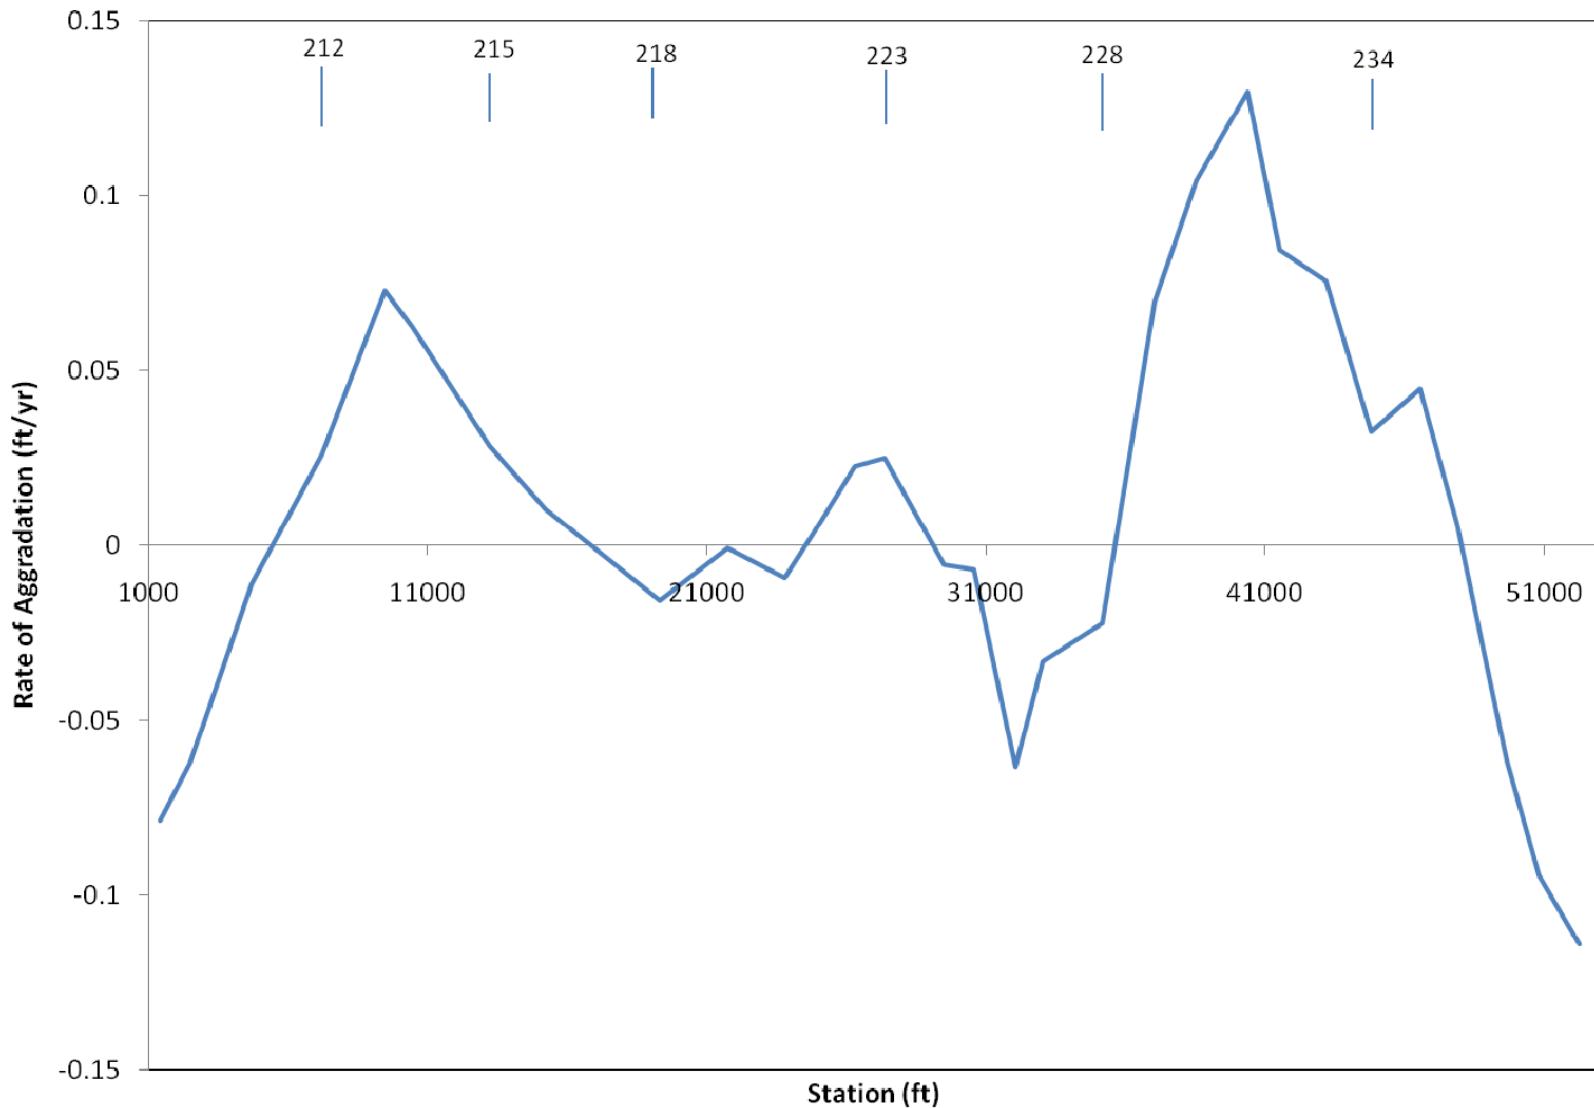
Historical aggradation rates

Average Aggradation Rate of Channel and Floodplain, 1969 to 2005

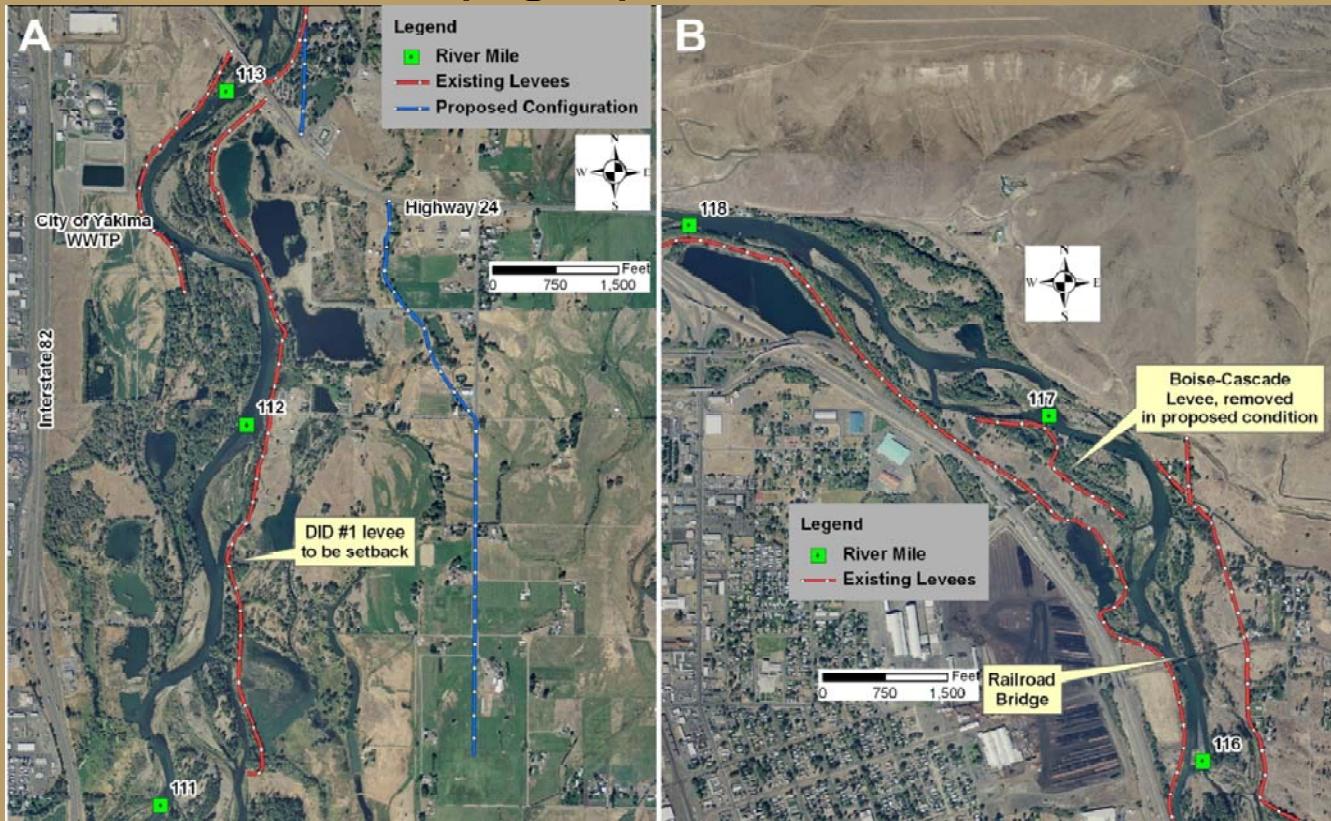
- Proposed geometry includes
 - Setting back KOA levee (Fig. A)
 - Setting back DID #1 levee (Fig. A)
 - Remove Boise Cascade levee (Fig. B)

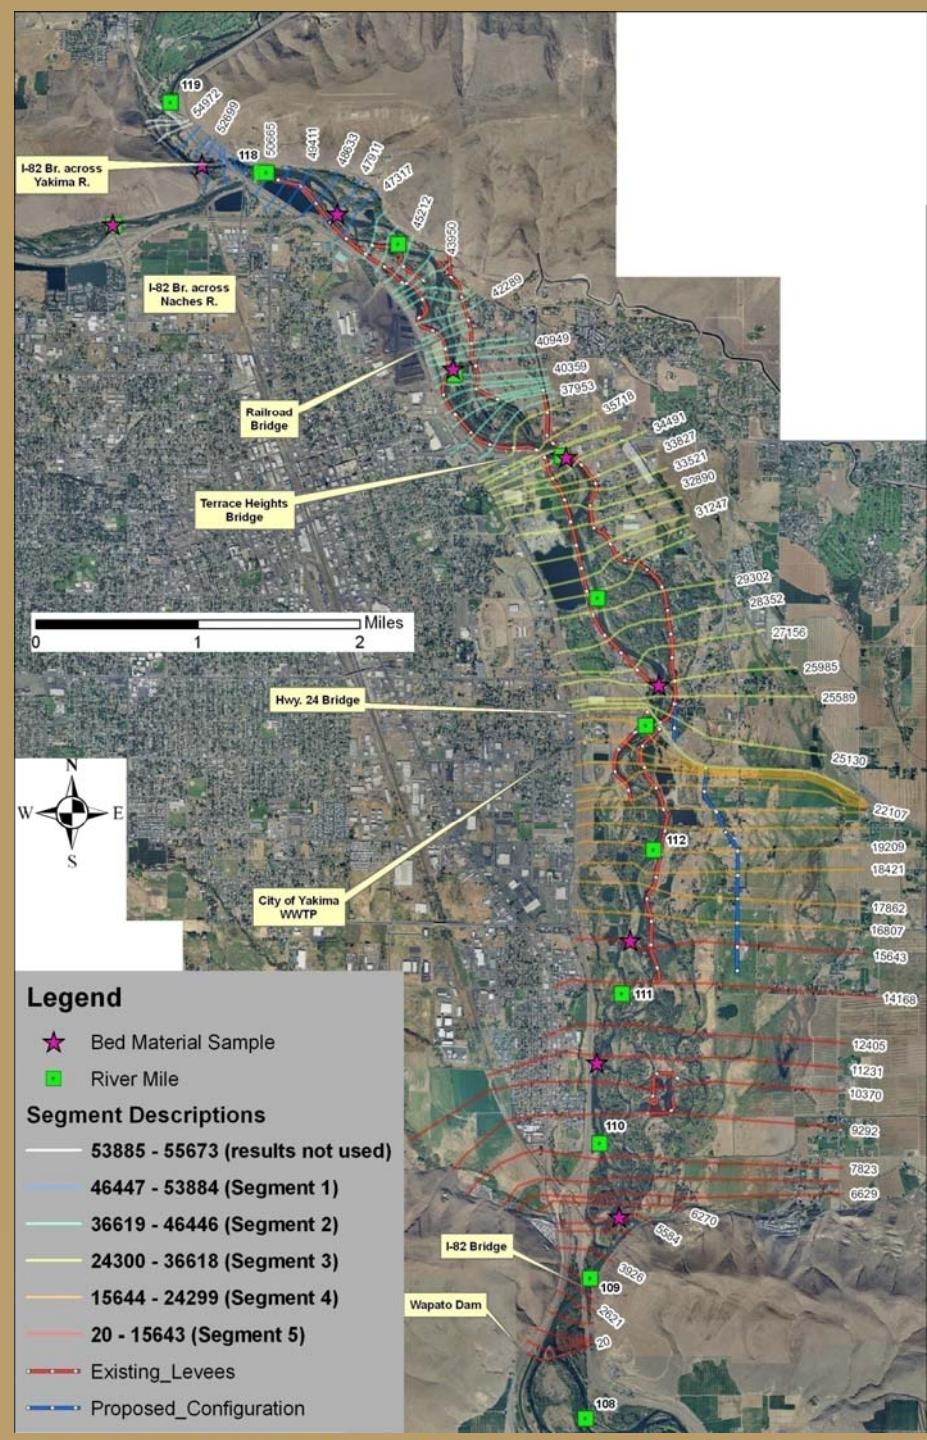
- Cross section layout

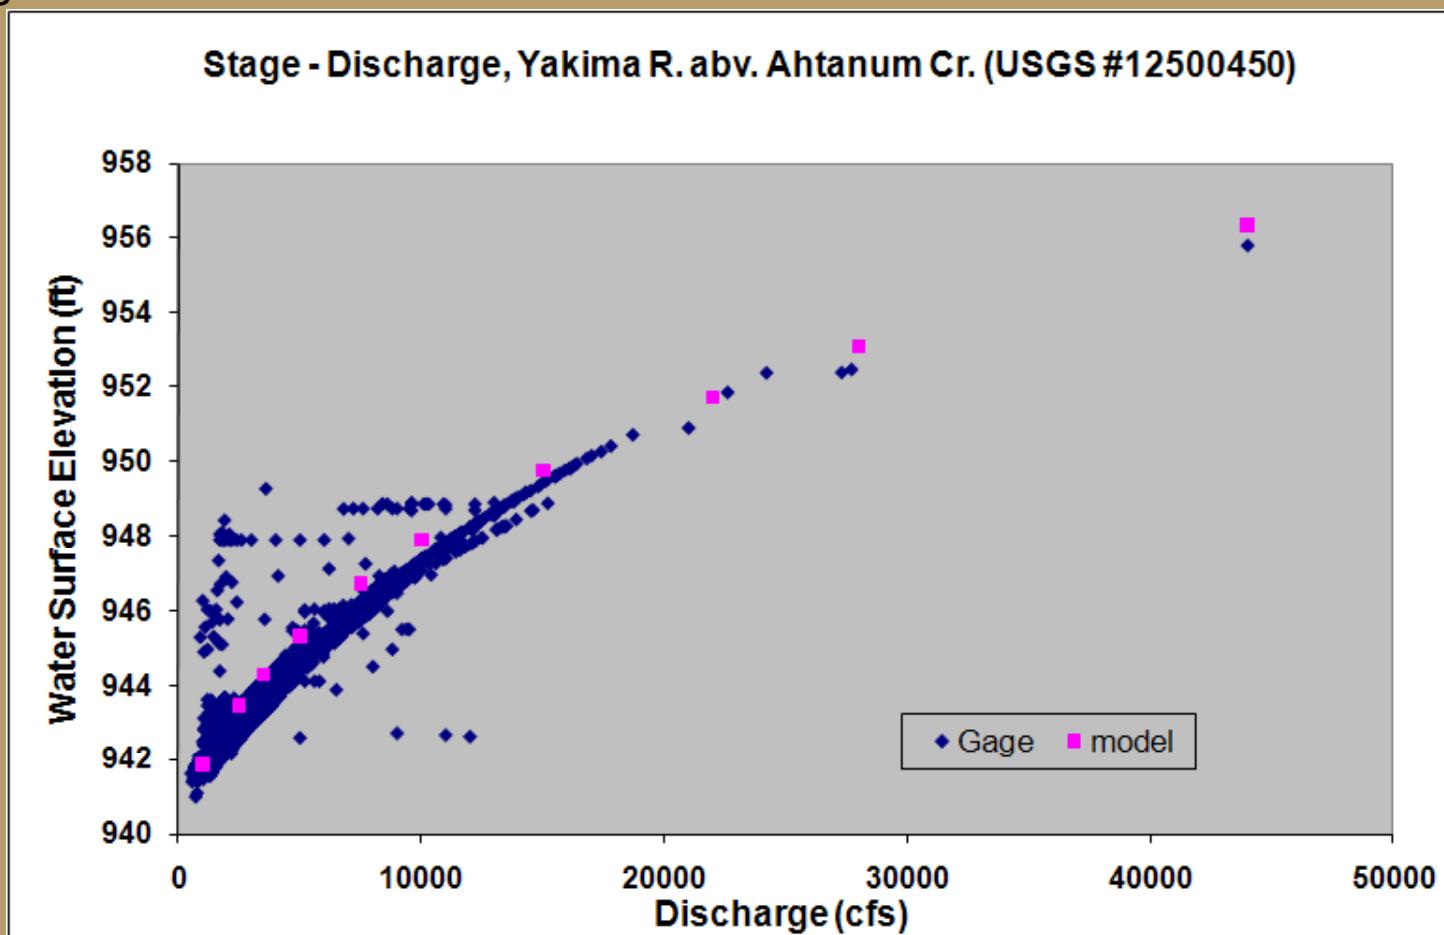
Verification of
floodplain roughness
using gage data

Stage data adjusted
to elevations by
matching the stage
discharge curve to
water surface
elevations taken
during the
bathymetric survey
