Yakima River Geomorphology and Sediment Transport Study: Gap to Gap Reach, Yakima, WA

U.S. Department of the Interior
Bureau of Reclamation

- Study performed and report prepared by:
 - Robert C. Hilldale (Hydraulic Engineer)
 - Jeanne Godaire (Geomorphologist)
 - Bureau of Reclamation, Technical Service Center
 - Denver, CO

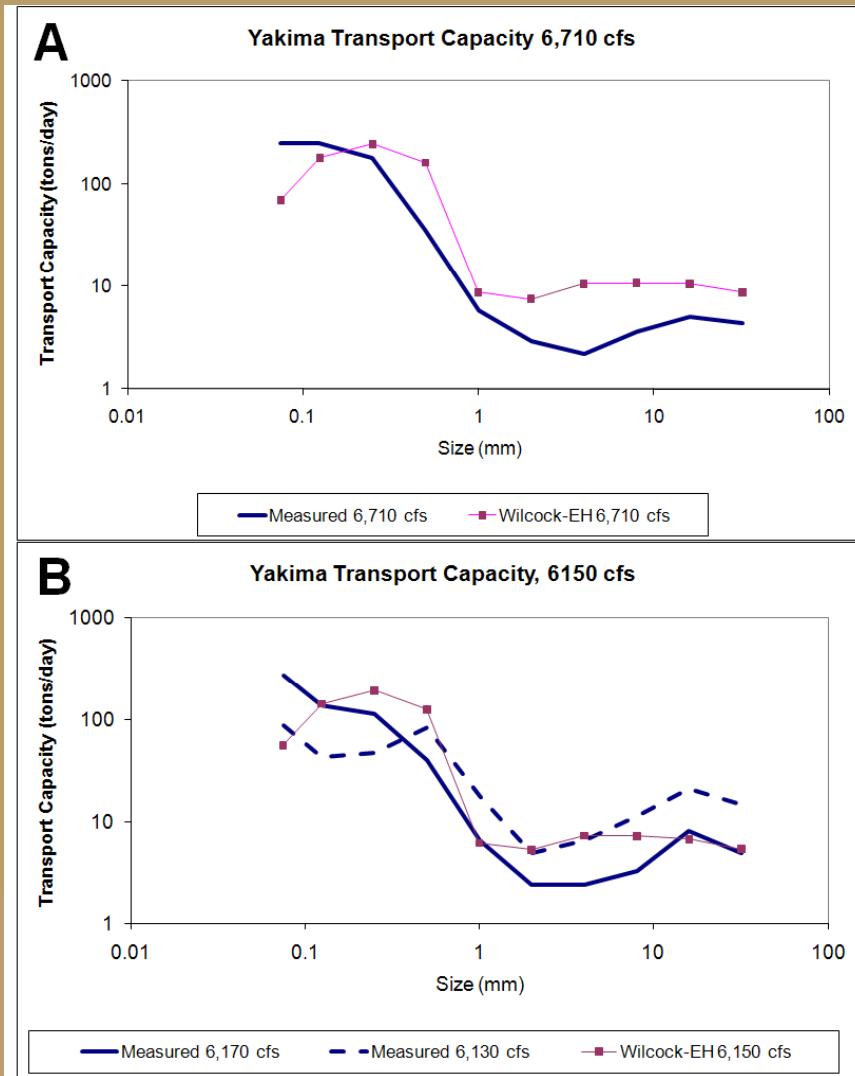
- Incoming modeled load vs. measured load

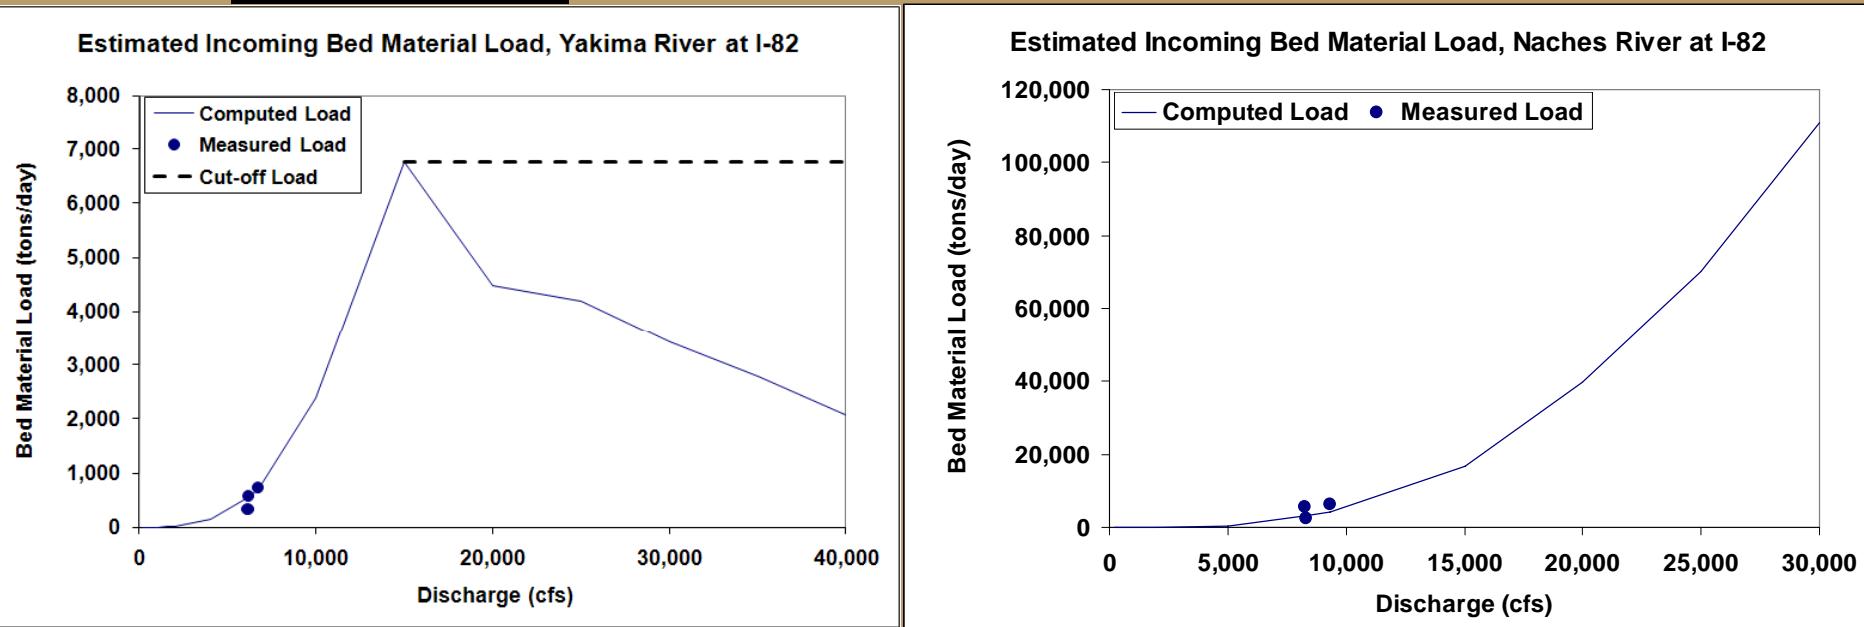
- Incoming sediment loads
 - Yakima River (Constriction at measurement point causing computed load to decrease at $Q > 15,000 \text{ ft}^3/\text{s}$)
 - Naches River

- Wilcock-Crowe (2003) combined with Engelund-Hansen (1966) used to evaluate sediment transport through the Gap to Gap reach

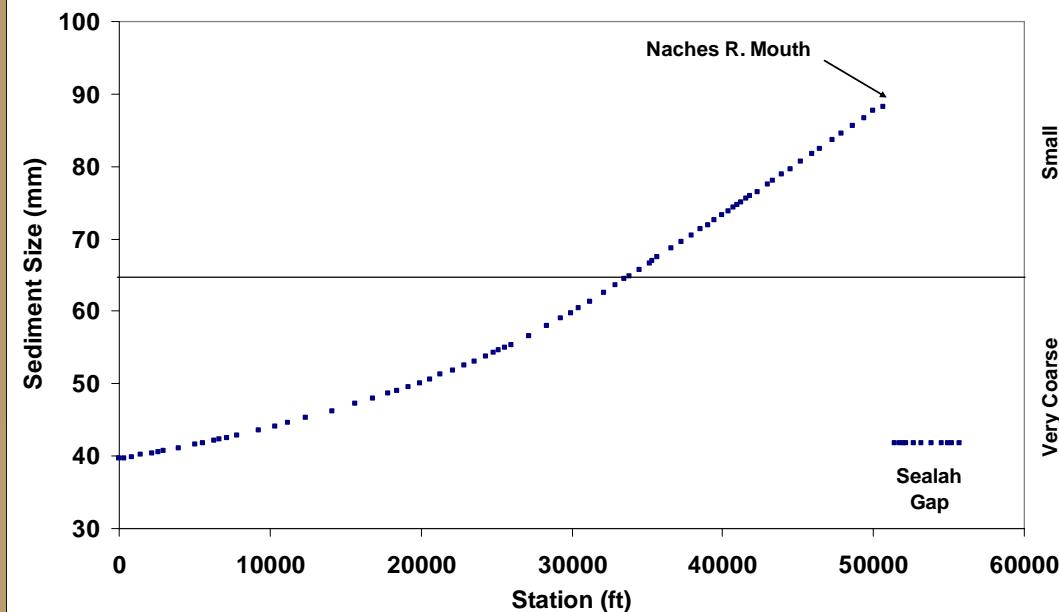
- Bed Material Distributions

Input Sediment d_{50} Throughout Gap to Gap Reach

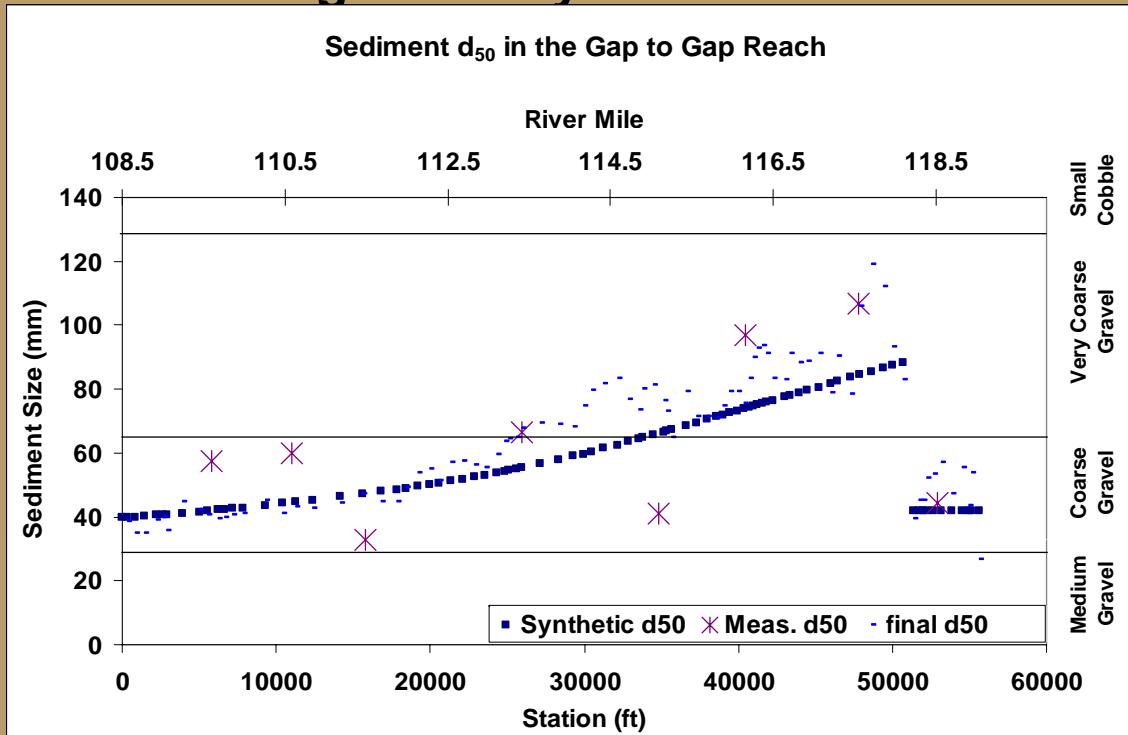
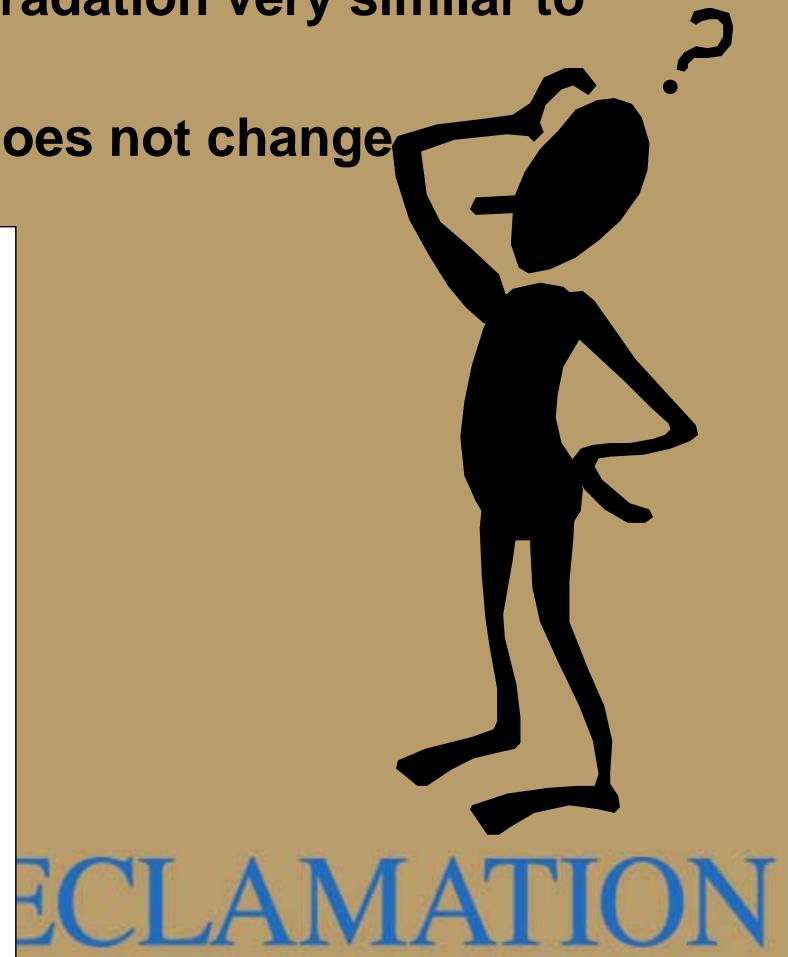
- Very little data with which to verify the model
 - Locations of aggradation and degradation very similar to period between 1969 and 2005
 - Assuming that bed composition does not change significantly...

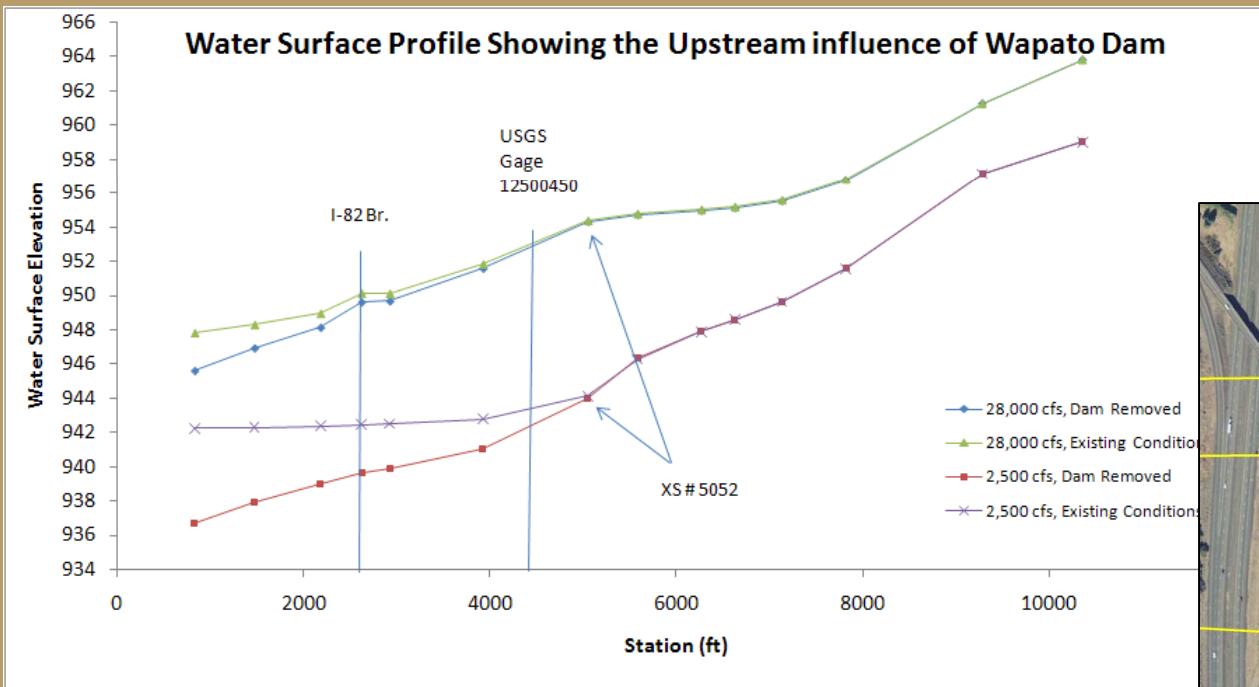
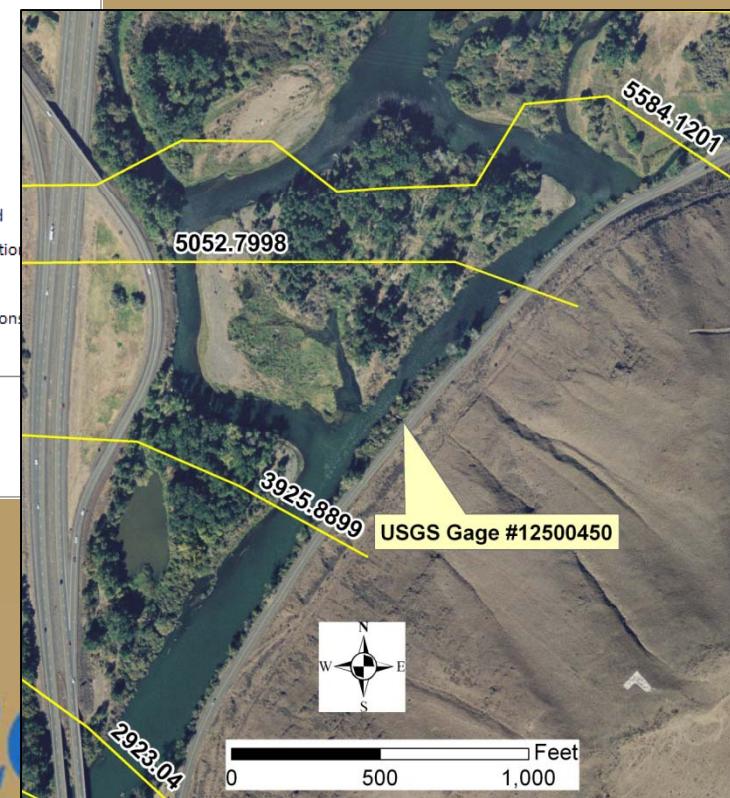
- Examining the upstream effect of Wapato Dam

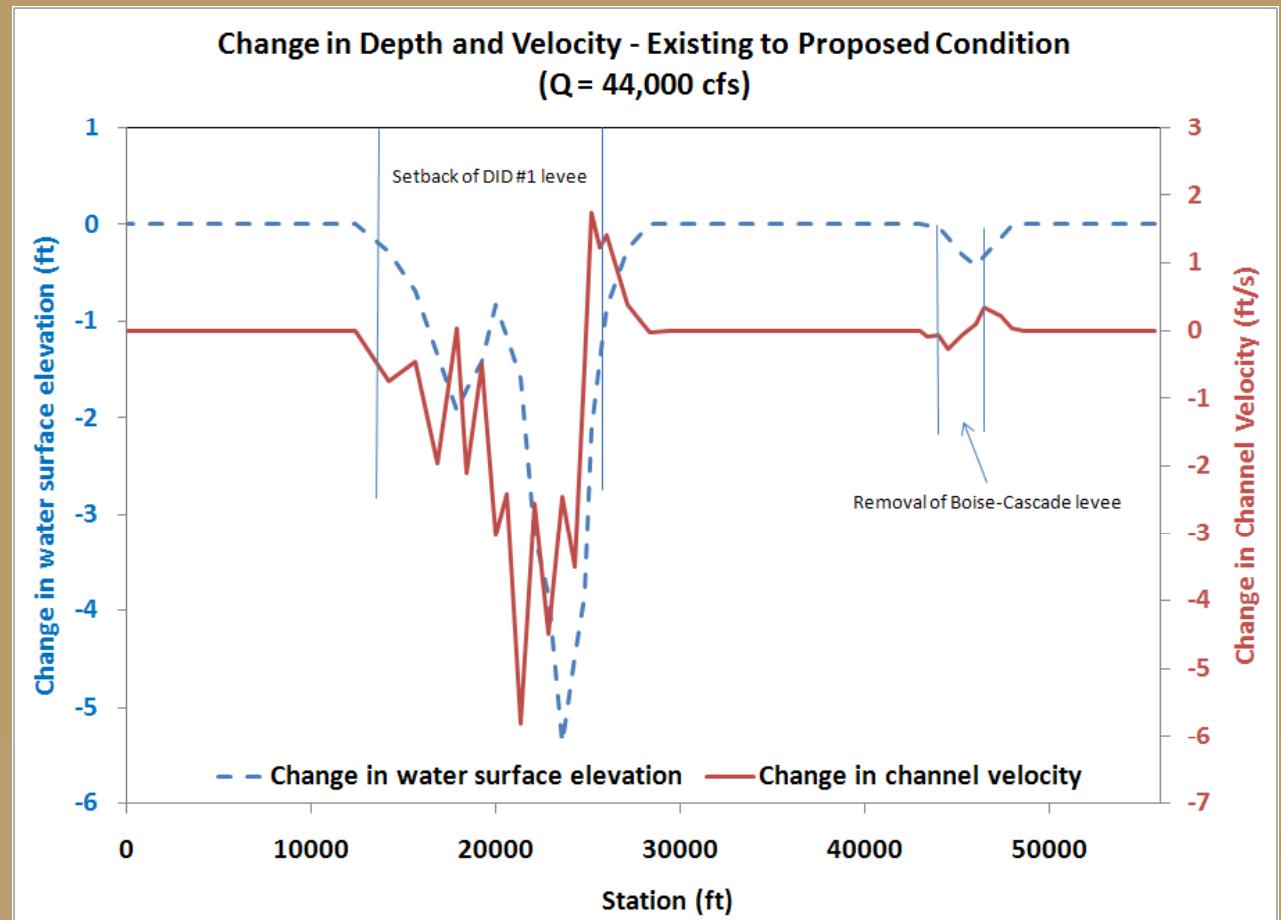
- Change in depth and velocity comparing existing and initial proposed conditions

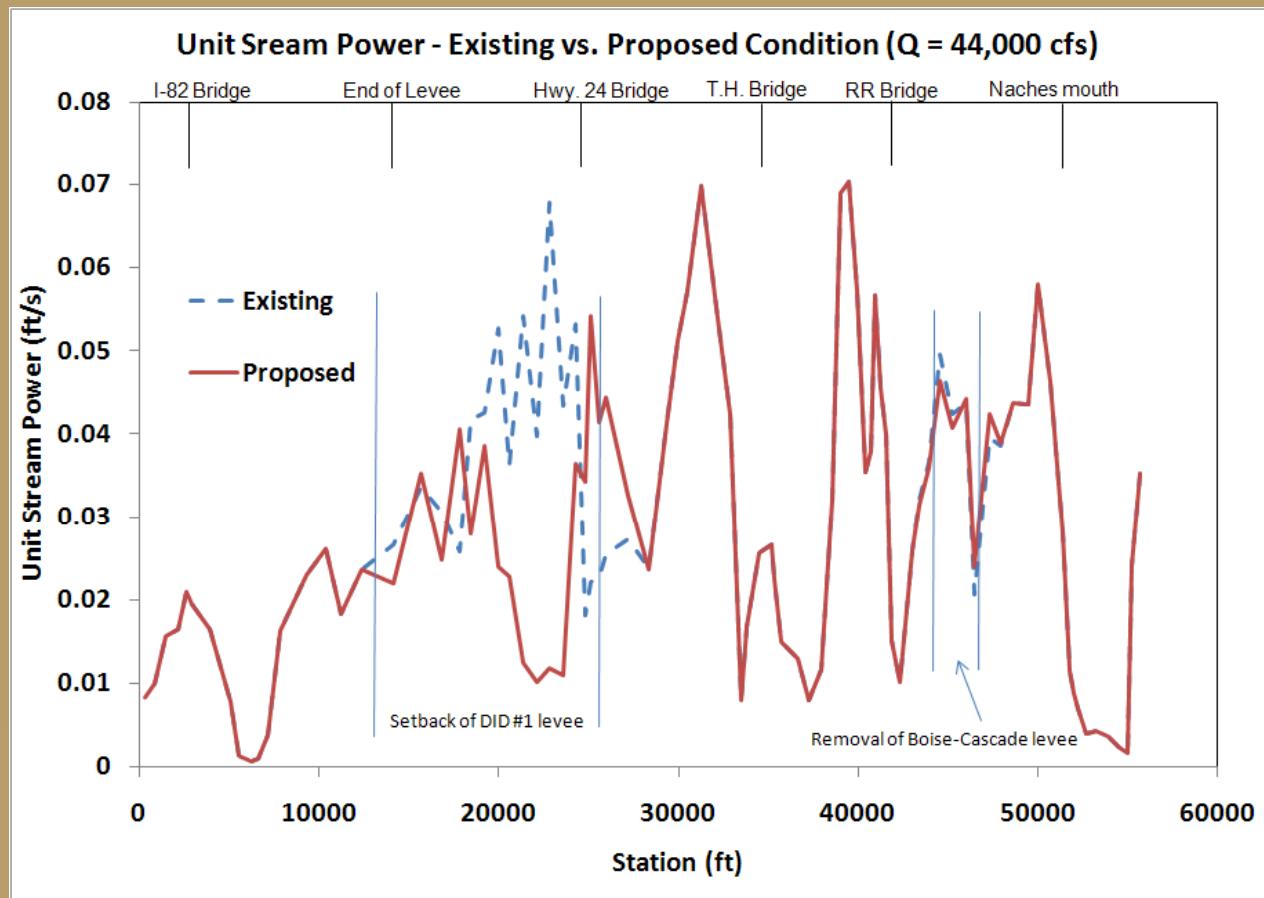
- Change in unit stream power (VS product) comparing existing and initial proposed conditions

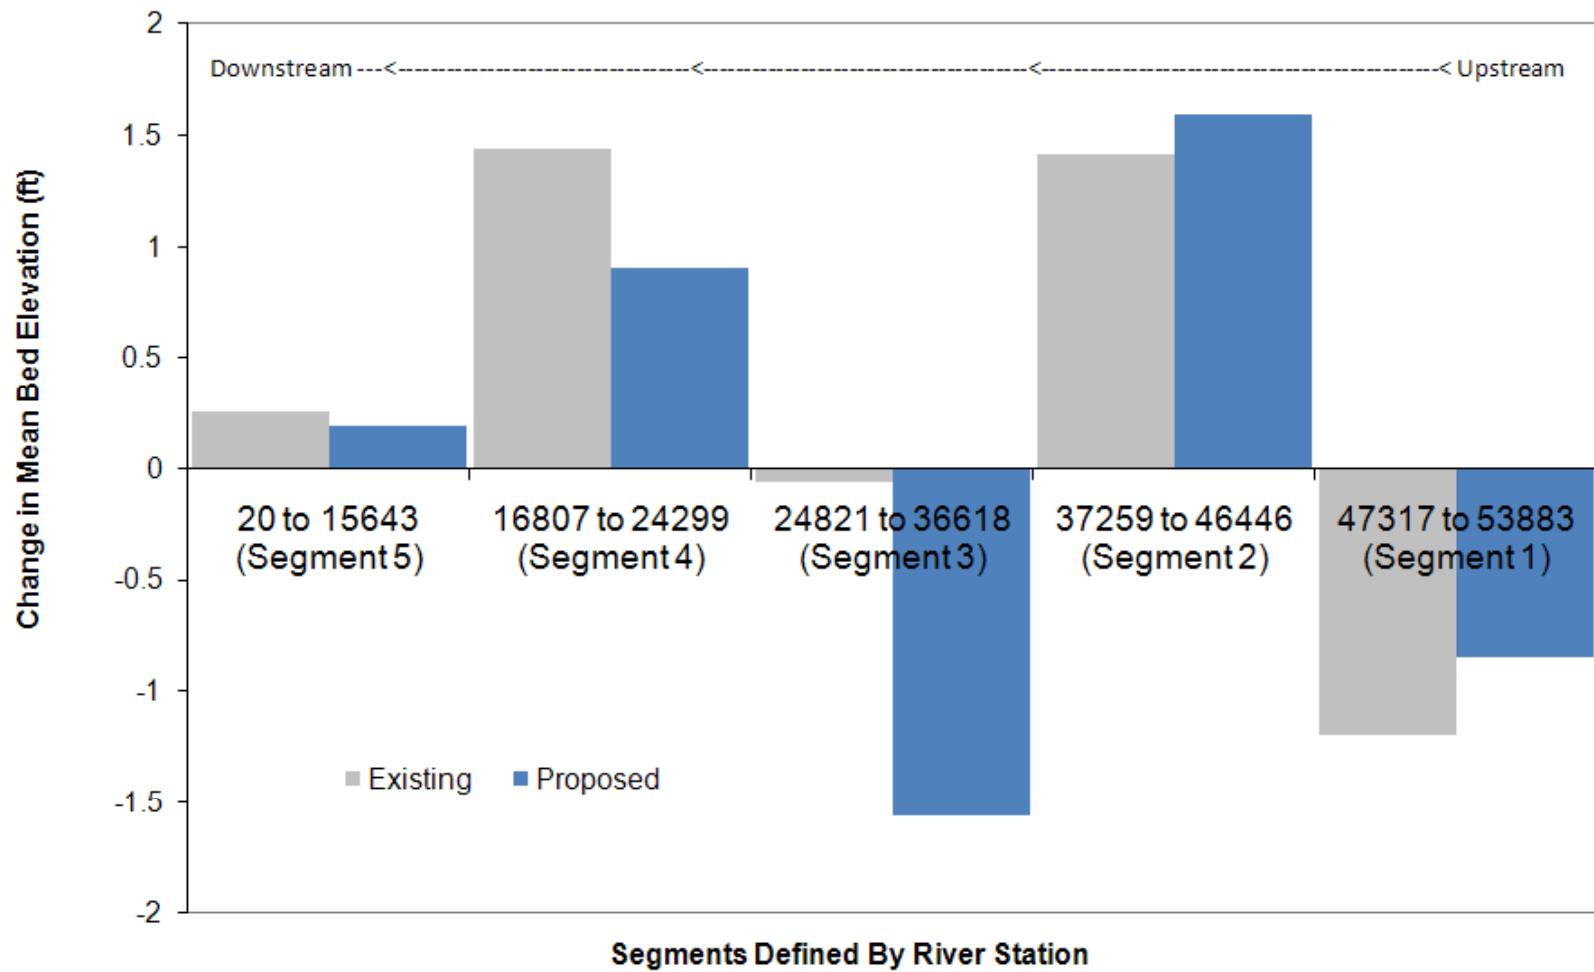
Average Change in Mean Bed Elevation by Segment

Segment #	Change in mean bed elevation (ft)					
	Existing Conditions			Proposed Conditions		
	dry	average	wet	dry	average	Wet
1	-1.0	-1.2	-3.5	-0.7	-0.9	-3.5
2	1.4	1.4	0.1	1.4	1.6	-0.1
3	0.0	-0.1	0.7	-1.1	-1.6	-1.3
4	1.4	1.4	3.5	0.4	0.9	4.4
5	0.3	0.3	0.6	0.3	0.2	0.5

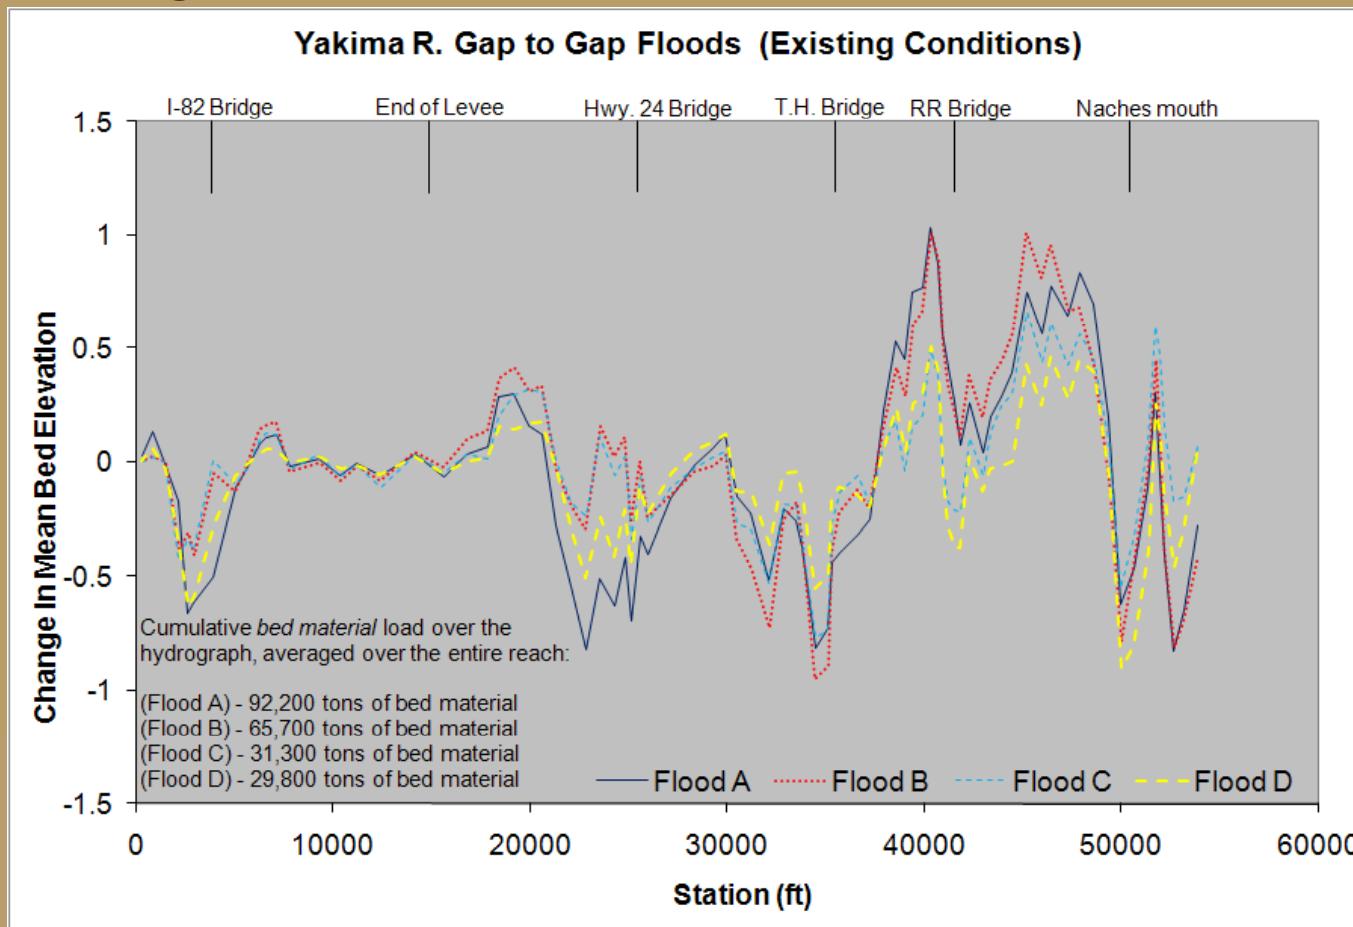
- Event Based Sediment Transport
 - Existing conditions

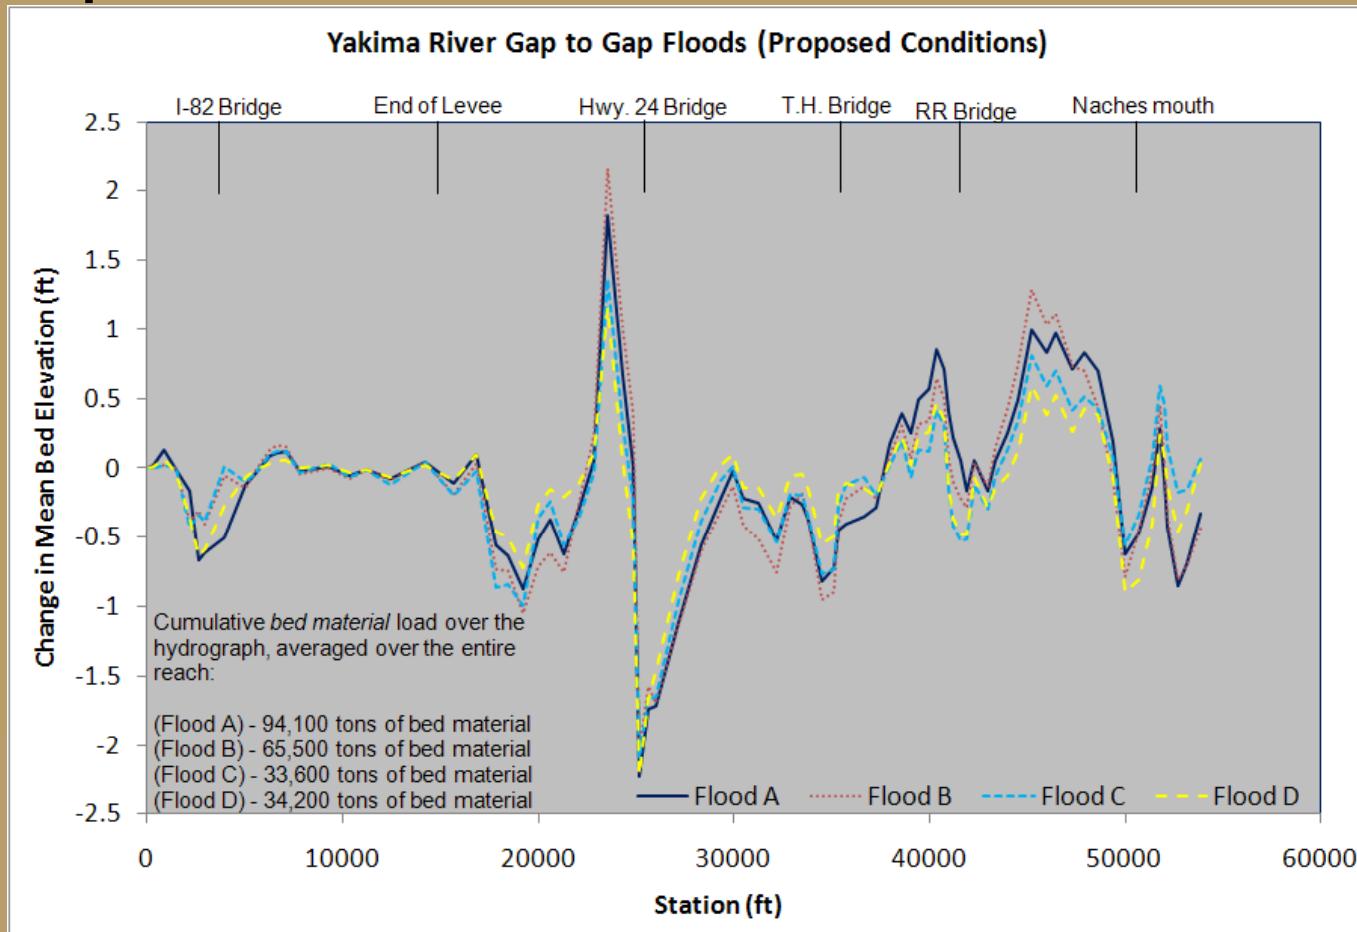
- Event Based Sediment Transport
 - Proposed conditions

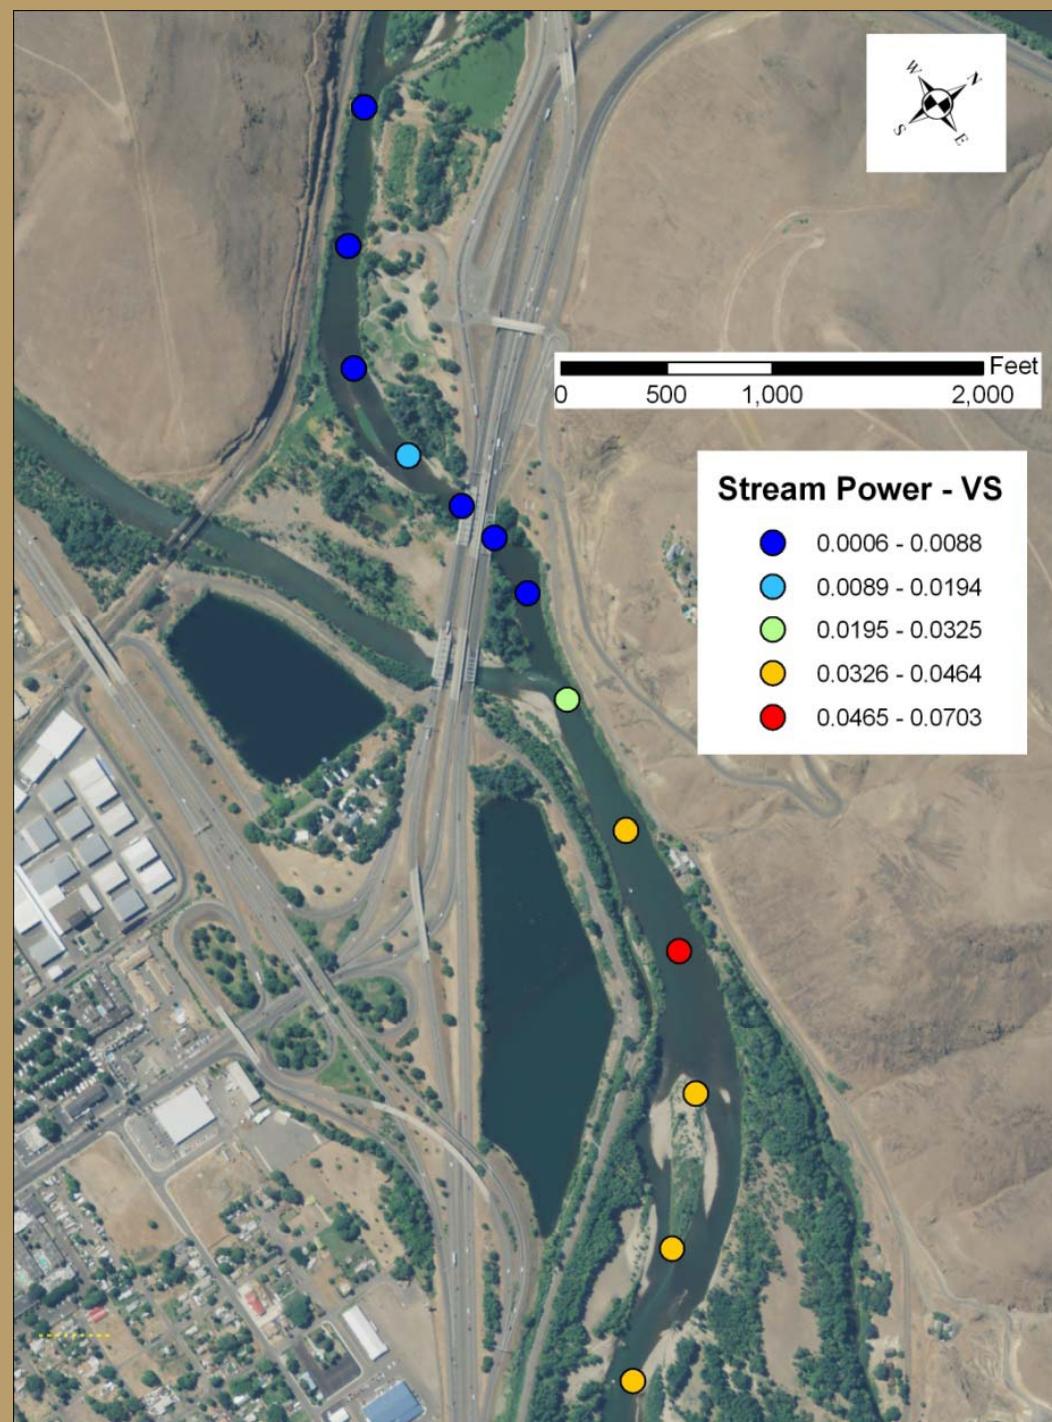
- **SEGMENT 1**

- No change in levee configuration
- No change in stream power
- No locations of active or predicted lateral channel change
- No active bank erosion
- Degradation predicted; -0.9 ft. proposed, -1.2 ft. existing
- Channel convexity expected to remain

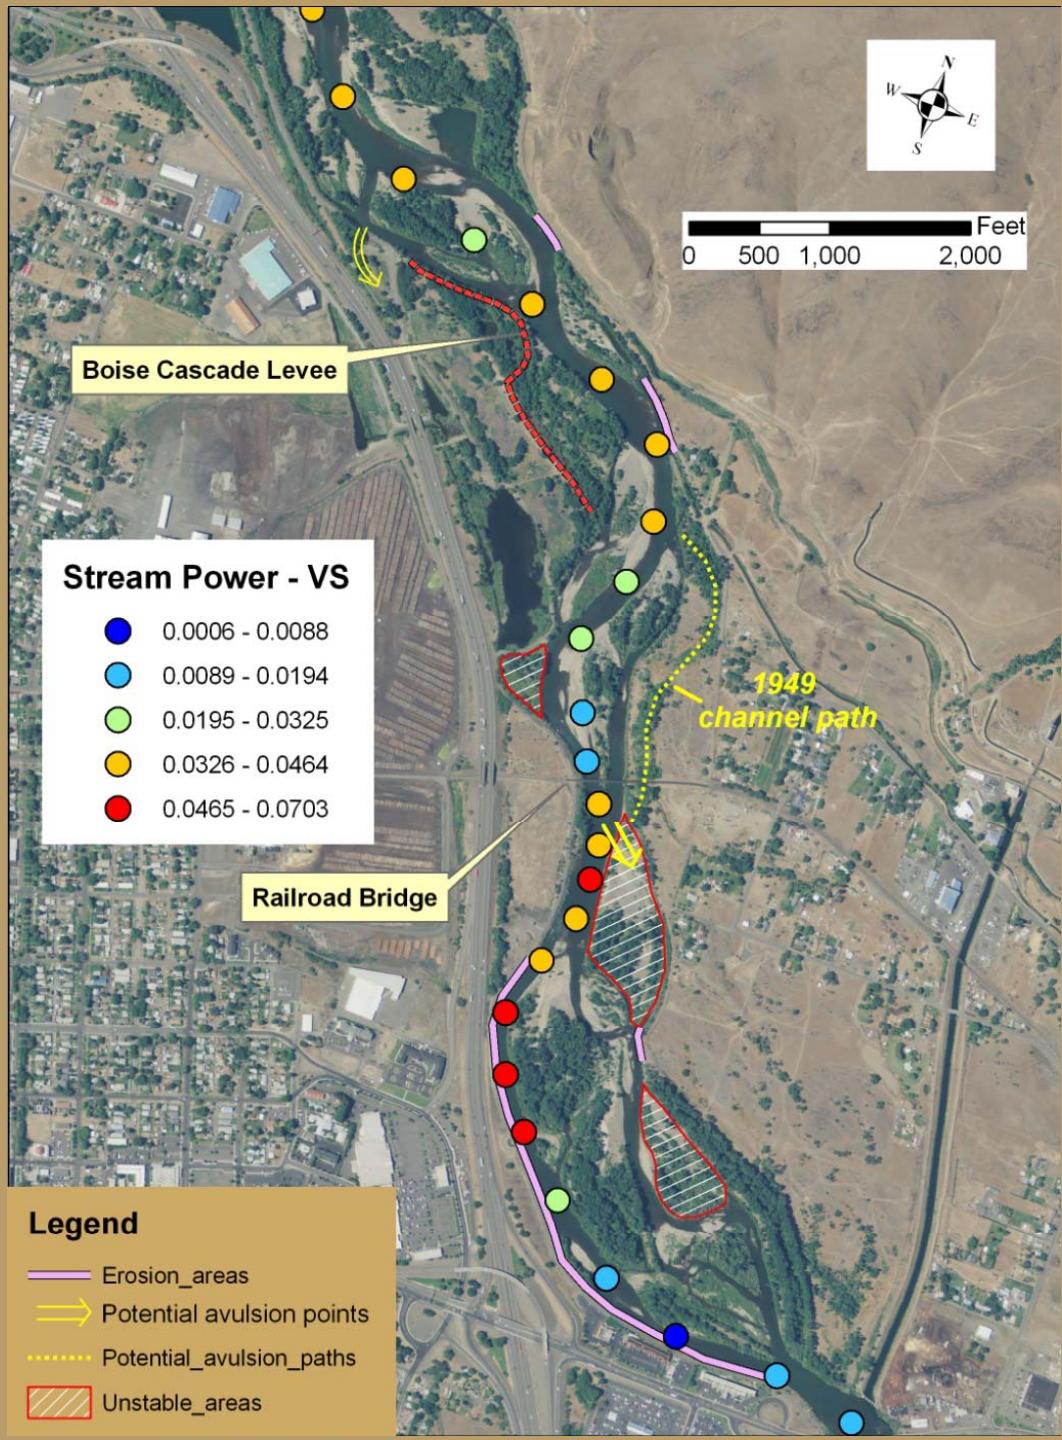
- **SEGMENT 2**
 - Includes proposed removal of Boise Cascade levee
 - Stream power:
 - Decreases slightly in vicinity of levee
 - Increased slightly upstream of levee
 - Avulsion points identified
 - Eroding banks identified
 - Unstable areas identified
 - Aggradation; 1.4 ft. existing, 1.6 ft. proposed

- Removal of Boise Cascade levee has a limited impact to future aggradation/degradation
 - Area more likely to become laterally active
 - Ripe for change under existing conditions
 - About 1.5 feet of aggradation anticipated under both existing and proposed conditions through most of segment 2
- Setback of KOA levee reduces constriction
 - Causes segment 3 to degrade under proposed conditions
 - Segment 3a remains aggradation/degradation neutral under existing conditions
 - Segment 3b remains somewhat aggradational under existing conditions

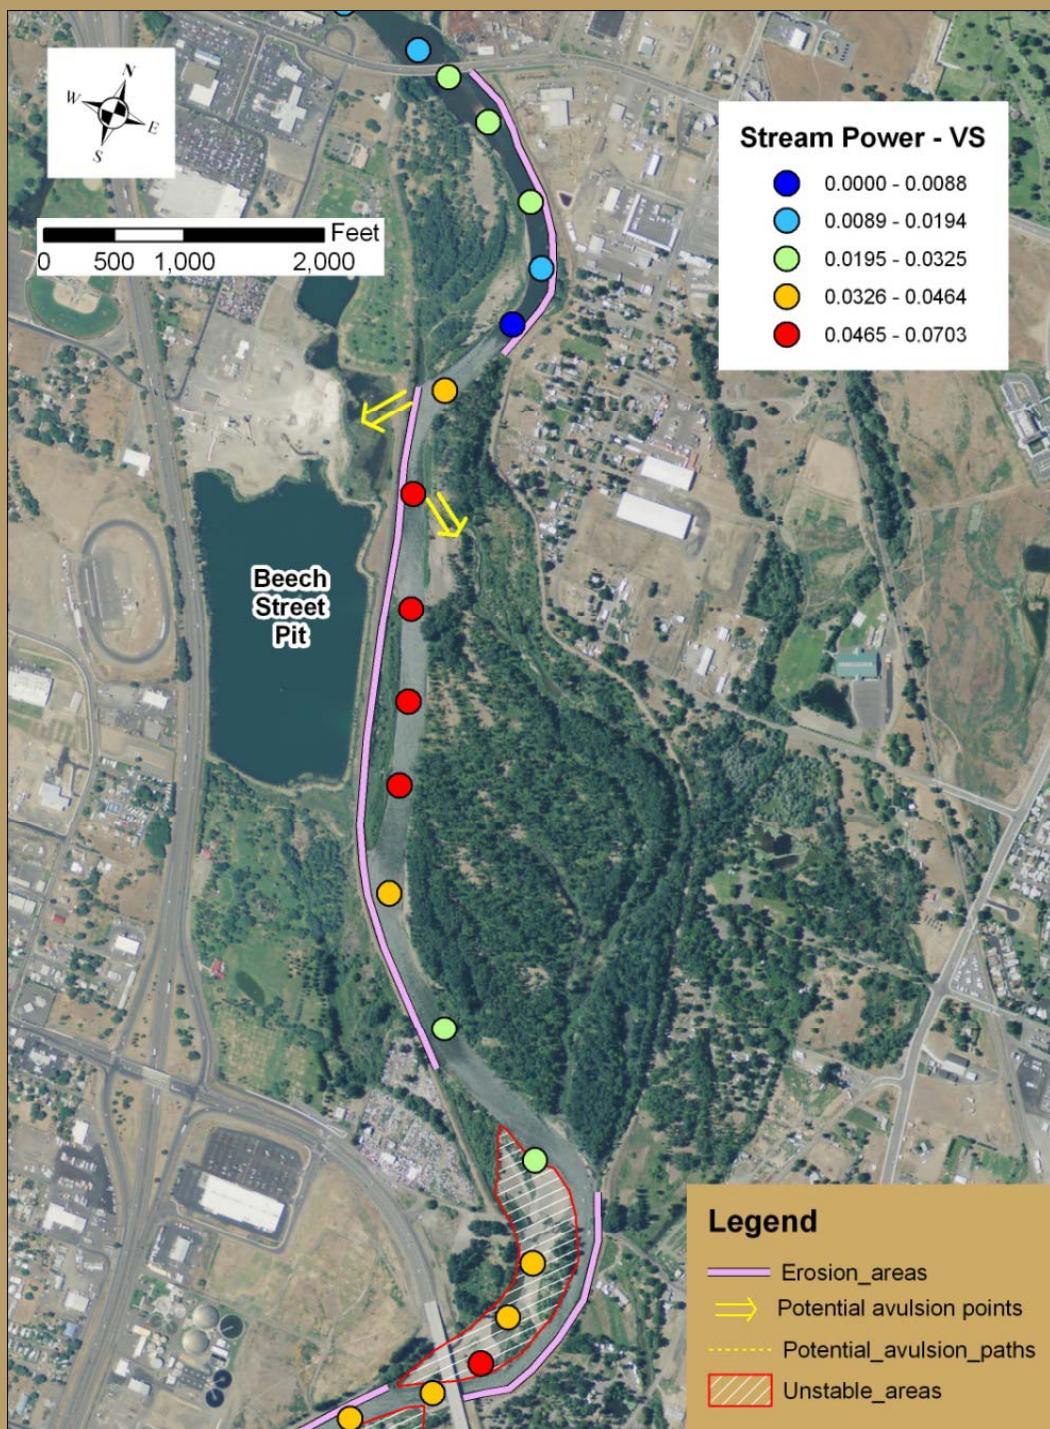
- **SEGMENT 3**
 - Setback of KOA levee on left bank
 - Stream power unchanged
 - Avulsion points identified
 - Eroding banks along levees observed
 - Unstable area upstream of SR 24
 - ~2 feet of degradation anticipated under proposed conditions

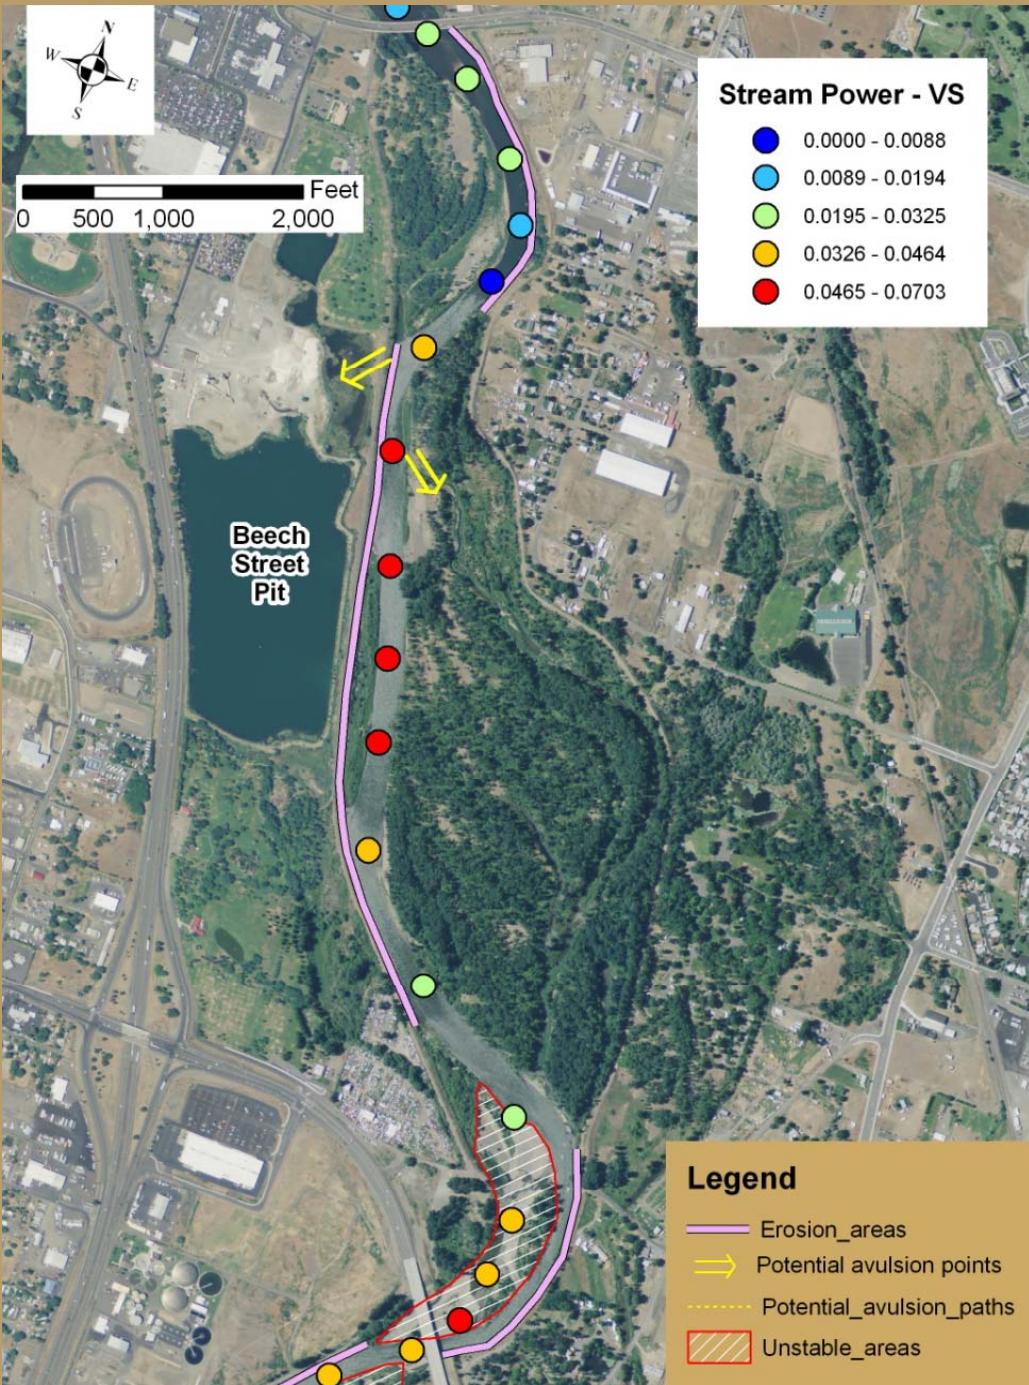
- Beech Street Pit
 - Actively eroding levees have been observed
 - High stream power throughout length of the pit
 - Anticipated degradation under proposed conditions will increase risk of erosion along levee toe

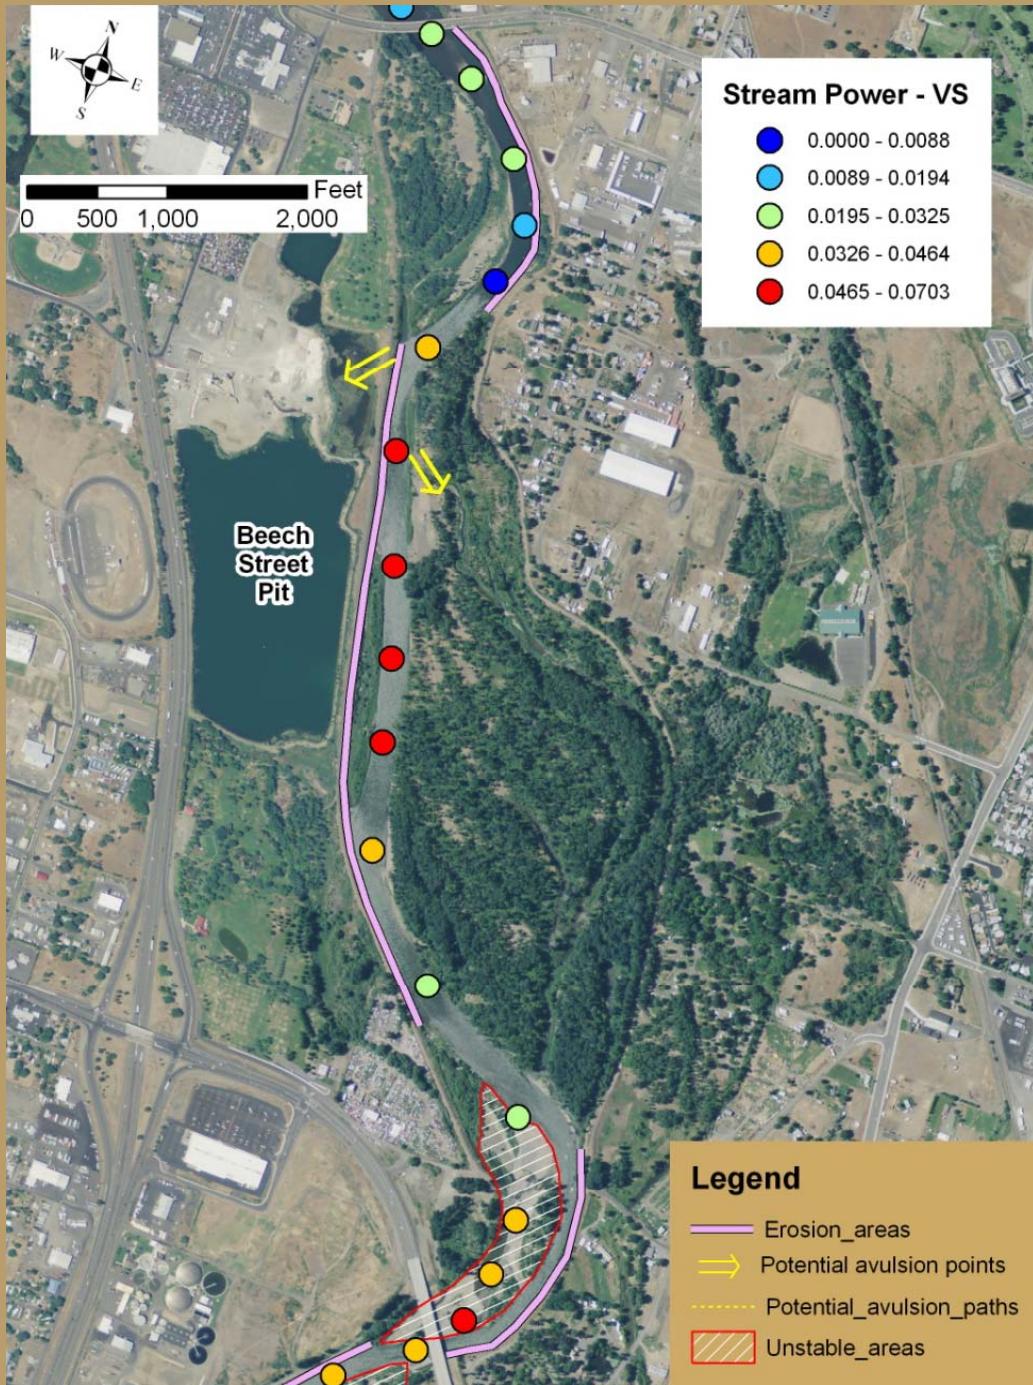
- SR 24 Bridge and KOA Levee
 - Setback of KOA levee reduces (not eliminates) the constriction in this area
 - Levee at auto salvage yard ~ 650 ft. width here vs. bridge span of ~1300 ft.
 - Channel here has been laterally active historically.
 - Most recently avulsed in January 2009

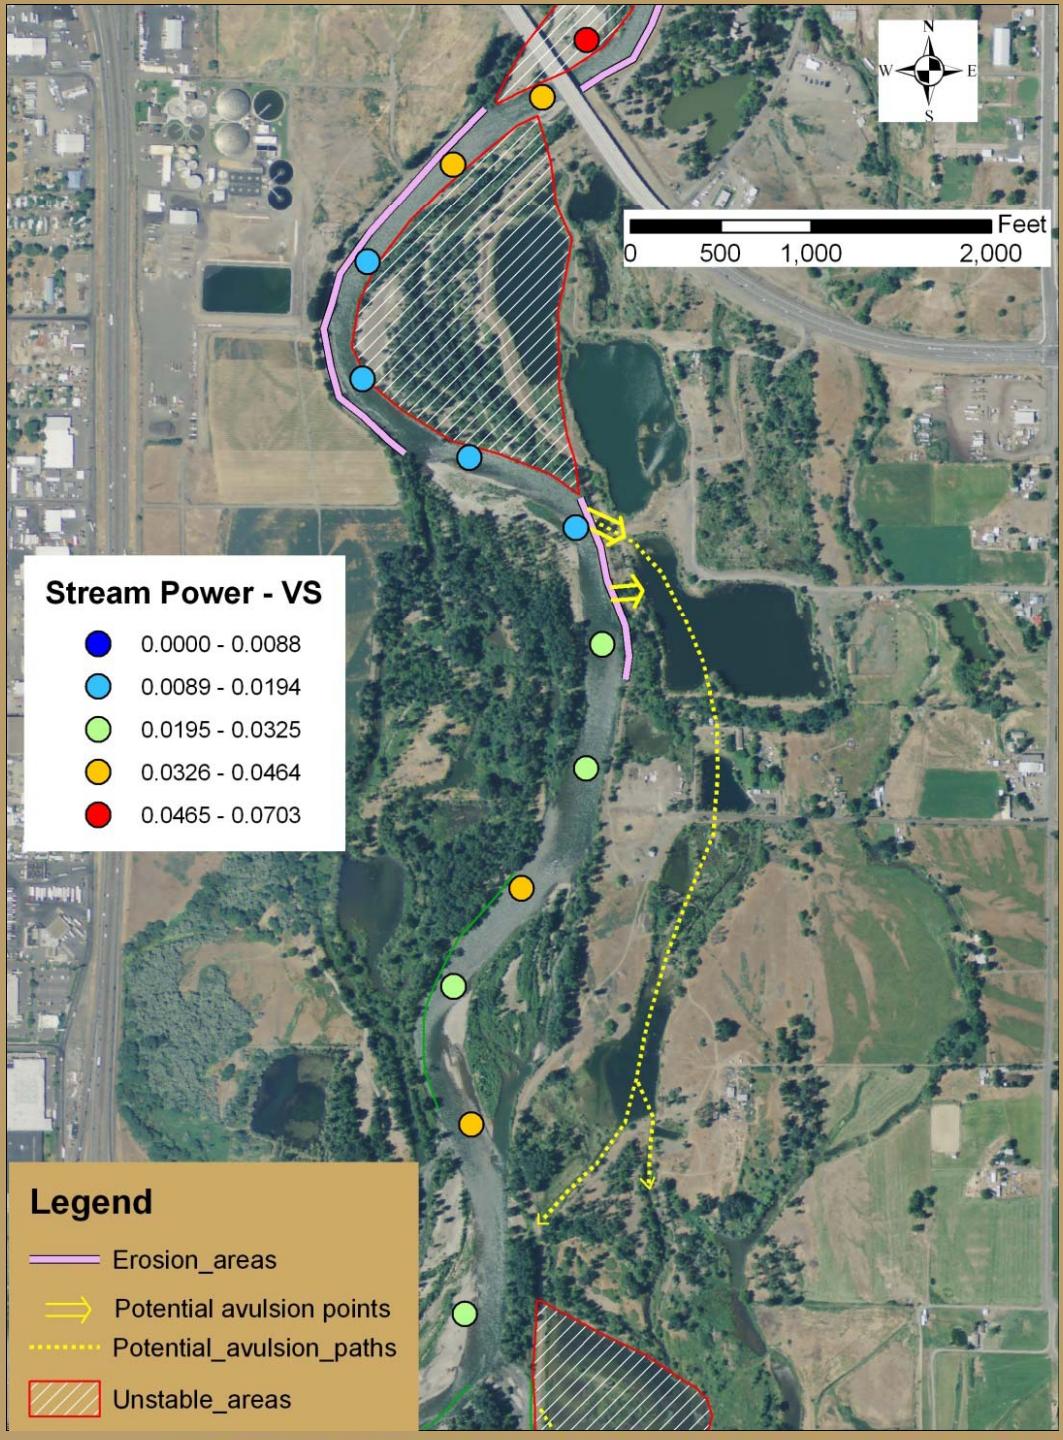
- **SEGMENT 4**
 - DID #1 levee setback on left bank
 - Stream power decreases significantly under proposed conditions
 - Avulsion points identified
 - Unstable areas identified
 - Eroding banks identified
 - ~ 2 feet of aggradation anticipated
 - Greatest uncertainty in model results

- **Setback of DID #1 levee also greatly reduces the existing constriction**
 - Reduces water surface elevations locally
 - Places many gravel pits within the floodplain
 - Potential for pit capture
 - Creates an aggradational condition in vicinity of wastewater treatment plant and Newland pits, ~2+ feet
 - With an overall reduction in water surface elevation of ~2 ft.
 - Does not appear to affect sedimentation in segment 5
 - Contributes to degradation in segment 3
