Yakima River Geomorphology and Sediment Transport Study: Gap to Gap Reach, Yakima, WA

U.S. Department of the Interior
Bureau of Reclamation

- Study performed and report prepared by:
 - Robert C. Hilldale (Hydraulic Engineer)
 - Jeanne Godaire (Geomorphologist)
 - Bureau of Reclamation, Technical Service Center
 - Denver, CO

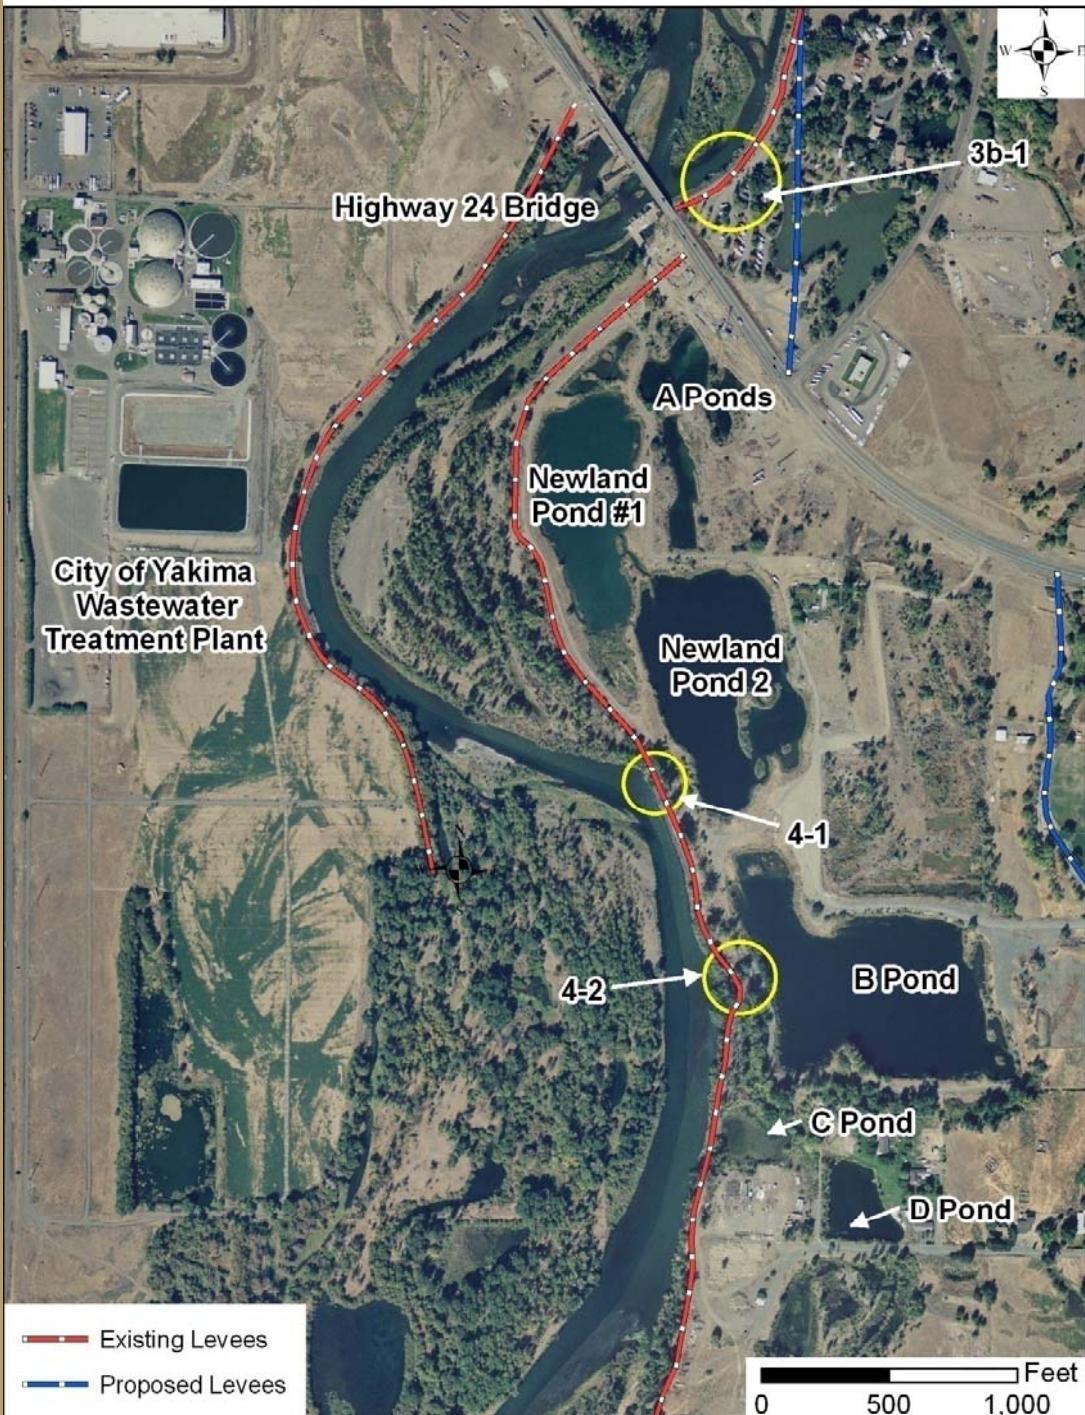
- **Newland Ponds**
 - Avulsion into one or more of these pits could put infrastructure at risk through headcutting and nickpoint erosion
 - Interrupt sediment flow for decades
 - Ecological consequences

- **Develop an engineered plan for Newland pits**
 - Survey their bathymetry
 - Explore possibilities of infilling with existing floodplain sediment
 - Determine elevation and width for upstream entrance and downstream exit to the pit(s)
 - Planned breach to slowly fill pit with river sediment
- **Monitor encroachment on levee freeboard due to anticipated aggradation upstream and downstream of the RR bridge**
- **Investigate the adequacy of the levee system that protects Yakima and Union Gap**

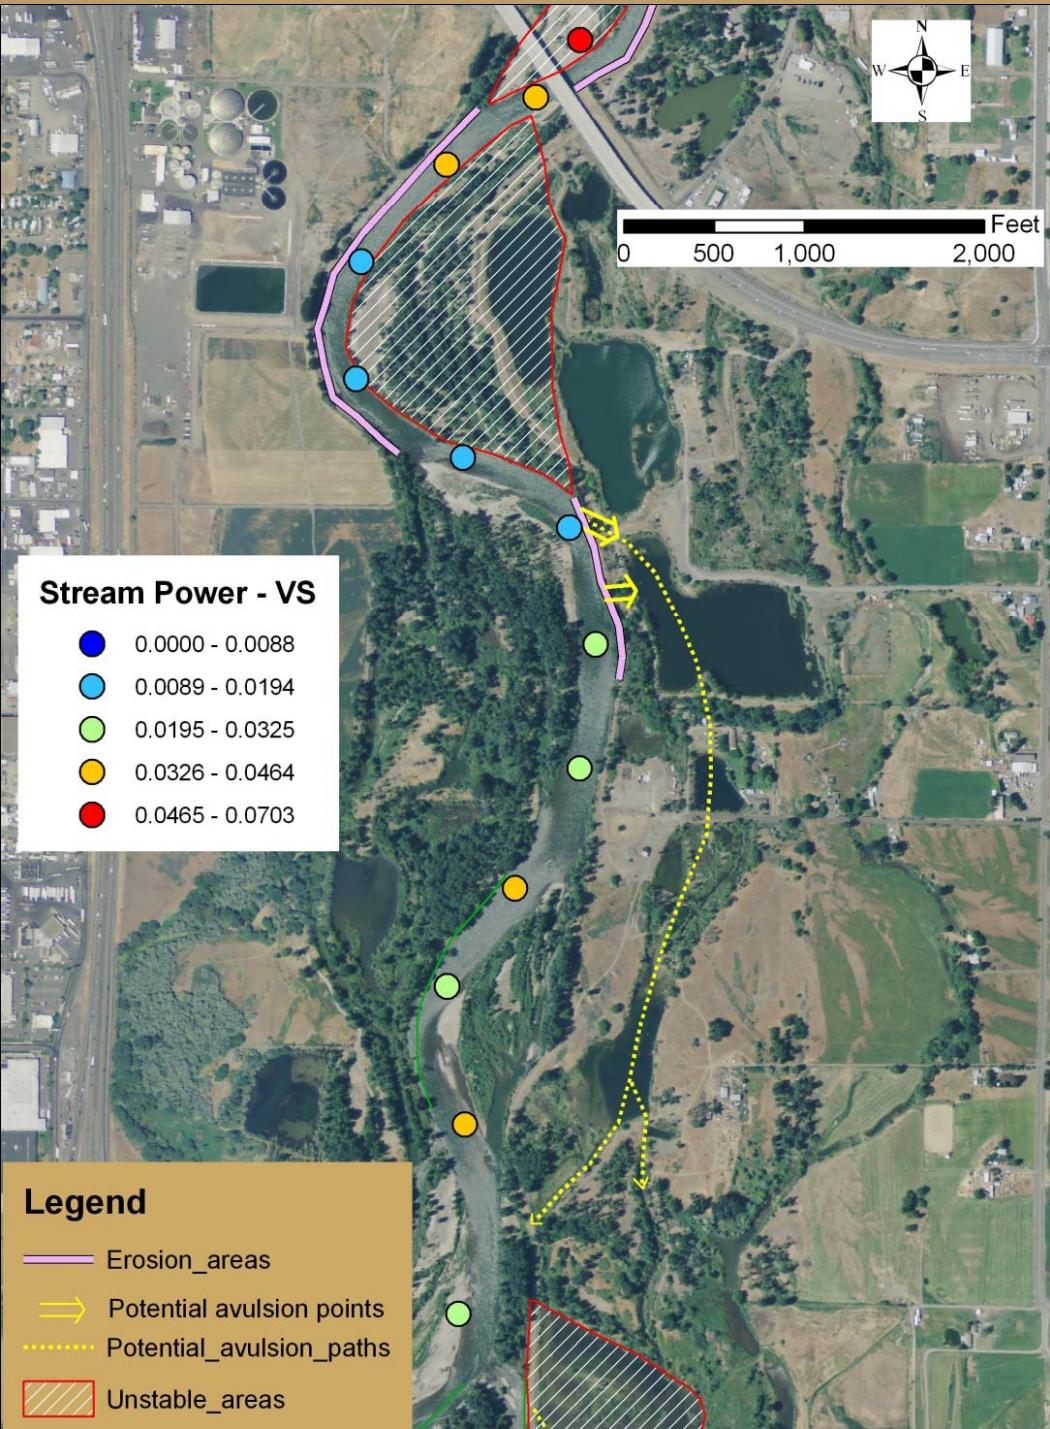
- **Wastewater Treatment Plant**
 - Actively eroding bank
 - Decrease in water surface elevation along the length of the right bank levee following levee setback
 - Predicted to aggrade ~2+ ft.
 - 5' at $t = 0$, ~ 2 ft. at $t = 25$ yr
 - Split channel likely in this location

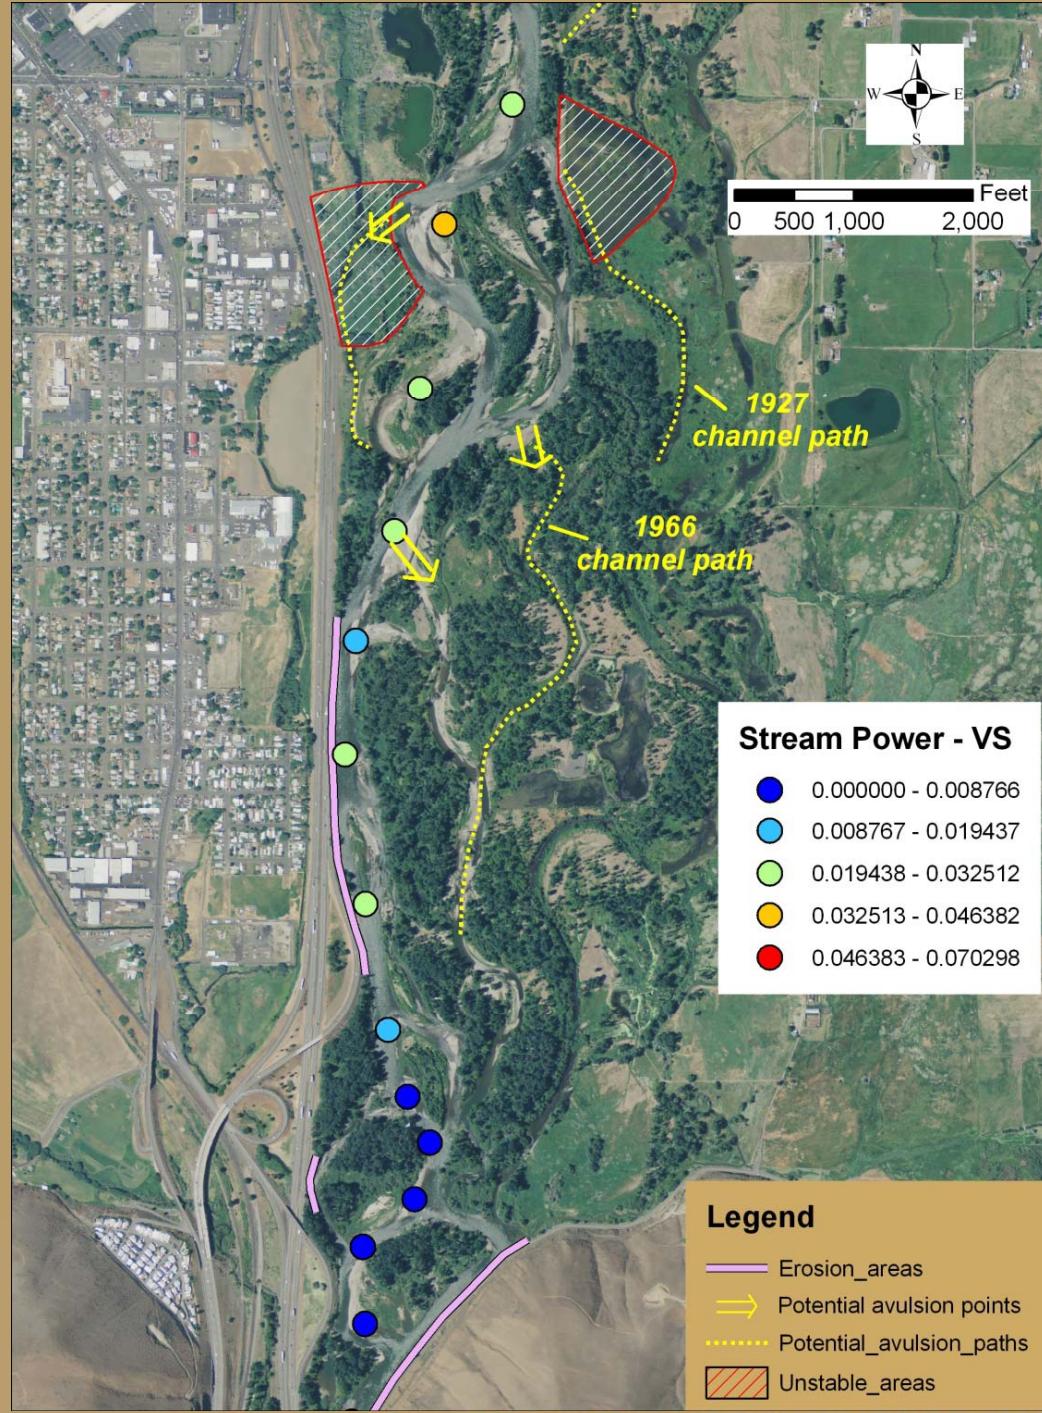
- **SEGMENT 5**
 - No changes to levee configuration
 - No changes in stream power, existing to proposed
 - No changes in aggradation/degradation existing to proposed
 - Multiple avulsion points identified
 - Actively eroding banks where river contacts I-82
 - Unstable areas identified at the upstream of the segment
