CHAPTER 4.

YAKIMA RIVER FLOODING CHARACTERISTICS

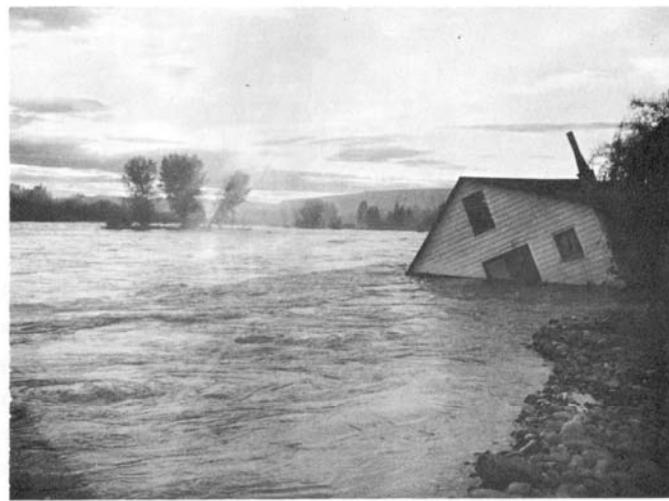
Figure 4-3a. Keyes Road, May 1948.

Figure 15.--MAY 1948 FLOOD DAMAGE TO
RESIDENCE ON KEYES ROAD

Residence of Mr. Tymboeck downstream of
Terrace Heights Bridge on Keyes Road.
Many residences suffered damage in this
district. (Photo courtesy of Bureau of
Reclamation.)

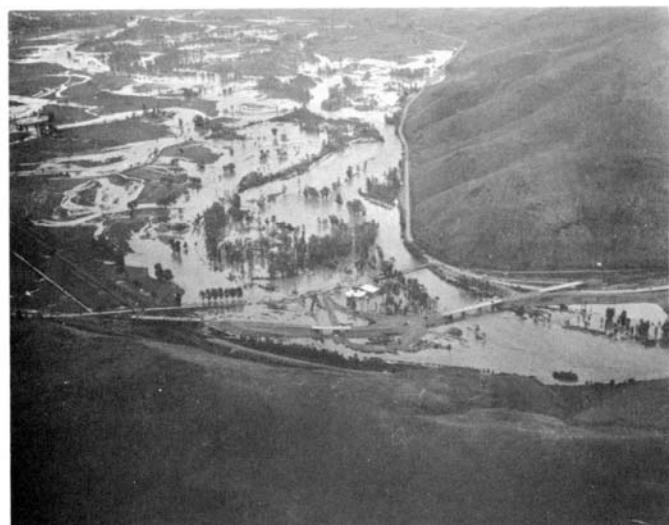
Figure 4-3b. Selah Gap, Looking Upstream.

Figure 5.--AERIAL VIEW OF MAY 1948
FLOOD AT SELAH GAP

Aerial view looking upstream from twin U.S.
Highway 99 bridges north of Yakima.
