## HYDRAULIC EVALUATION AND CONCEPTUAL DESIGN OF MITIGATION MEASURES FOR YAKIMA RIVER GRAVEL PIT CAPTURE

### FINAL REPORT

Prepared by:  
Northwest Hydraulic Consultants Inc.  
16300 Christensen Road, Suite 350  
Seattle, WA  
98188-3422

September 2015

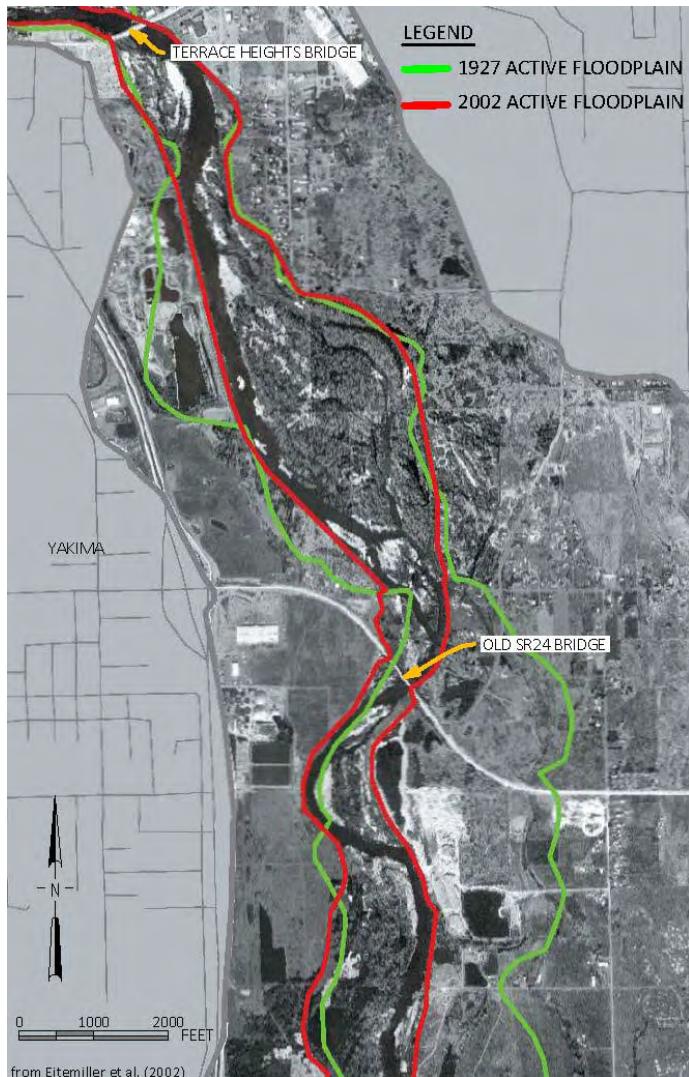
**Figure 8: Change in hydrologically active floodplain area from 1927 to 2002**

Furthermore, the hydrologically active portion of the floodplain, defined as areas recently exposed to flow (as interpreted from aerial photos) was reduced from 808 hectares in 1927 to 584 hectares in 2002, a loss of approximately 28% (Figure 8).

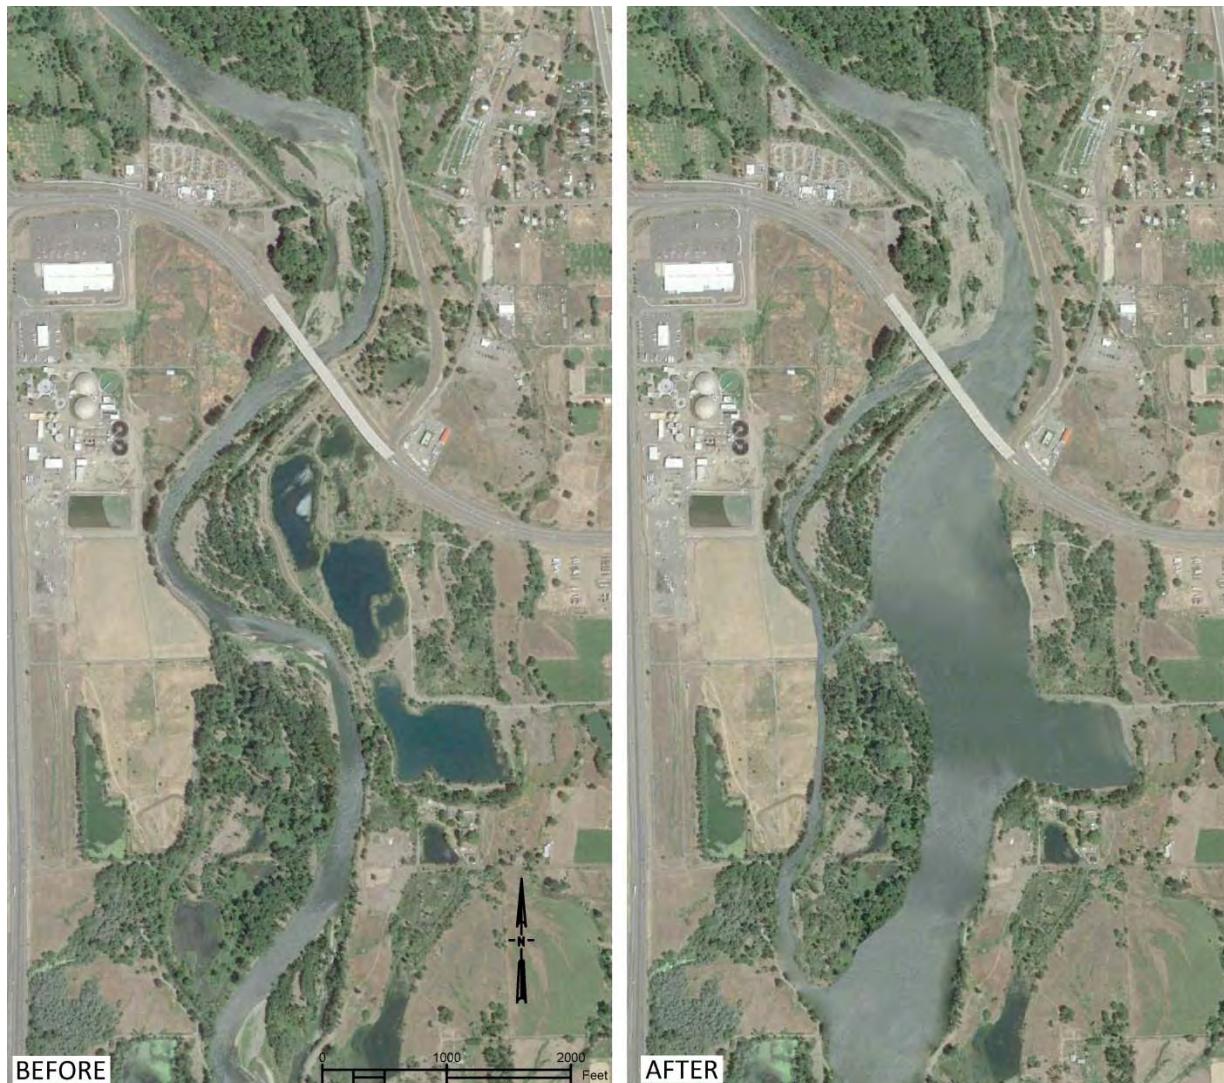
**Figure 35: Future eastward shift in river alignment if no mitigation is carried out**

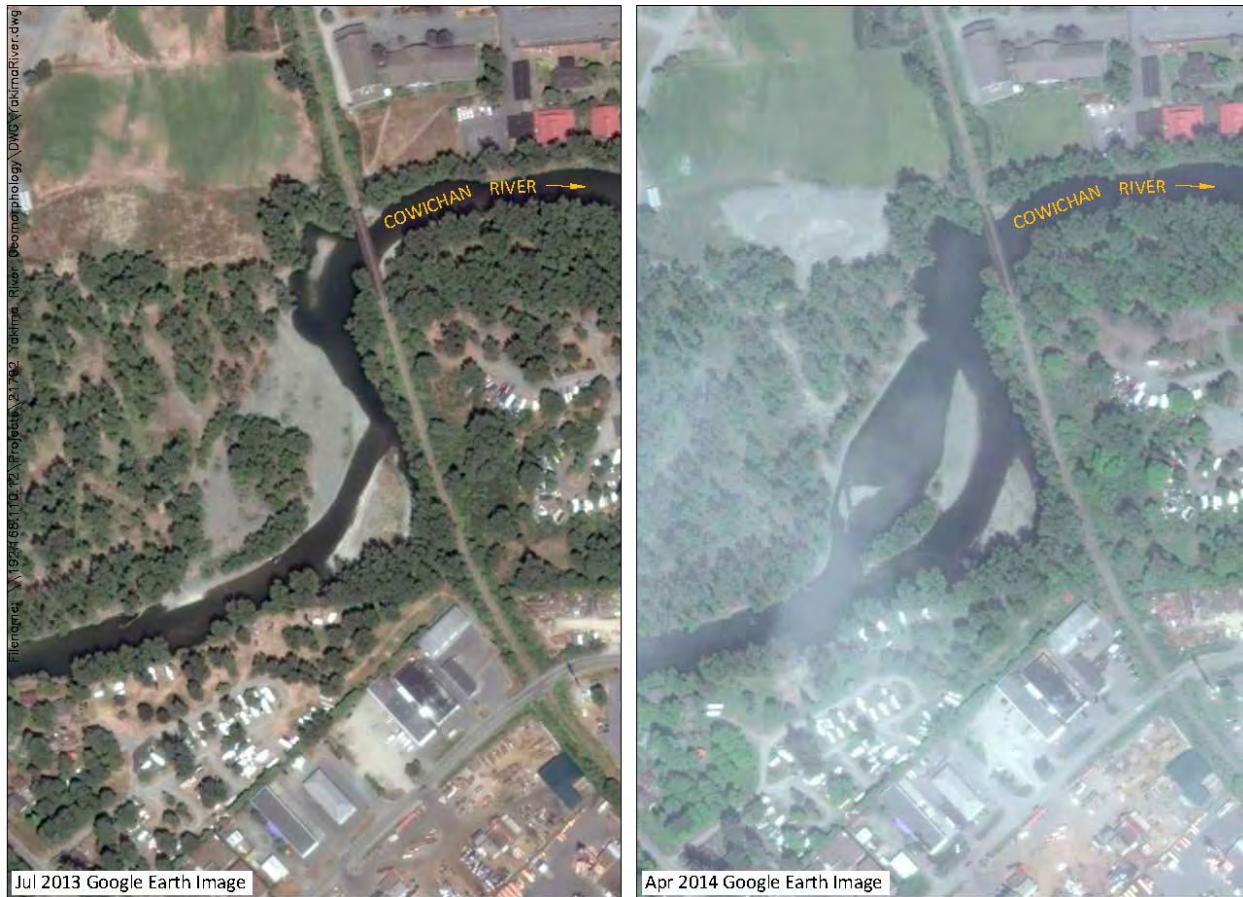
**Figure 38: Example of a chute cutoff side channel development at a bend**

The channel would transport gravel and sand bed load from upstream and would shift laterally across the floodplain, re-working the floodplain sediments which would maximize re-connection of the floodplain into the active channel zone. The existing channel on the west side of the river, downstream of the SR24 Bridge will become shallower in response to the decreased velocity and flows. This is likely to initiate a more complex pattern of bars through this branch.

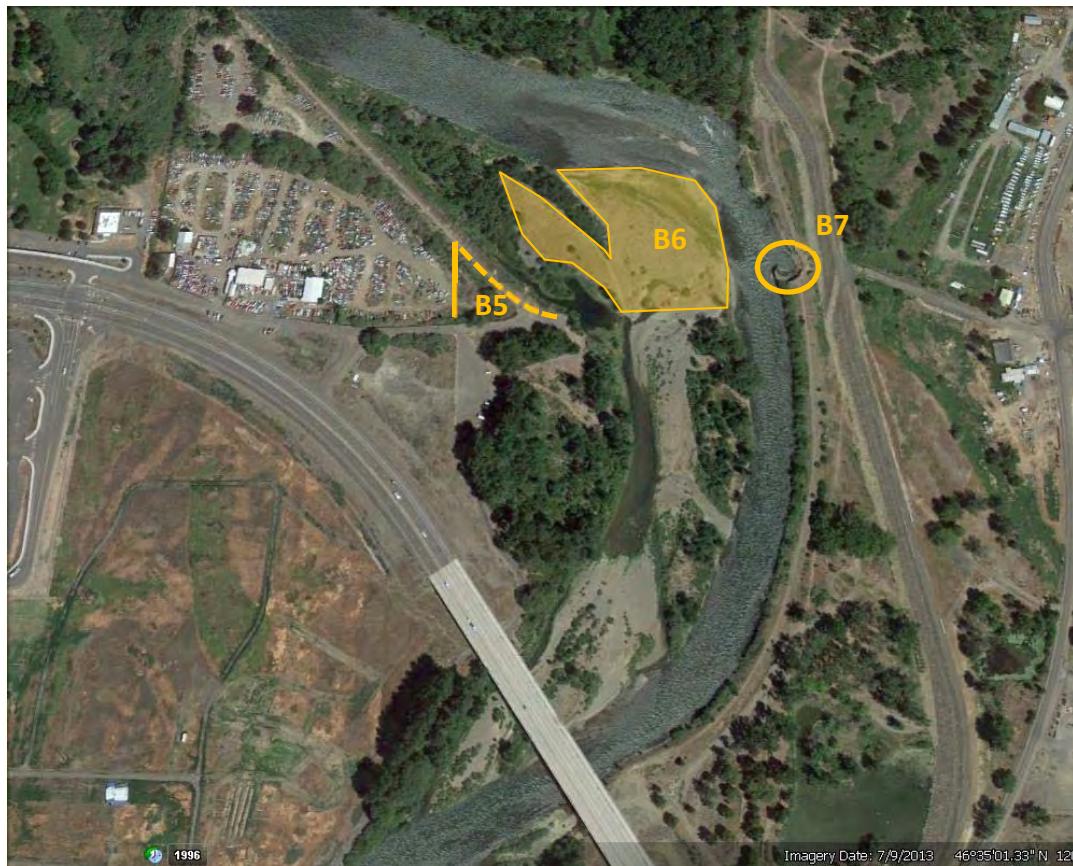
**Figure 44: Alternatives (B5) Removal of Nob Hill levee segment, (B6) gravel bar excavation on west bank point bar, and (B7) removal of old SR24 abutment.**
