# Current Status of Cottonwood Recruitment on the Naches and Yakima Rivers

With Special Emphasis on the Gap to Gap Reach and the 1135  
Ecosystem Restoration Project

May 2021

Yakima County Public Services

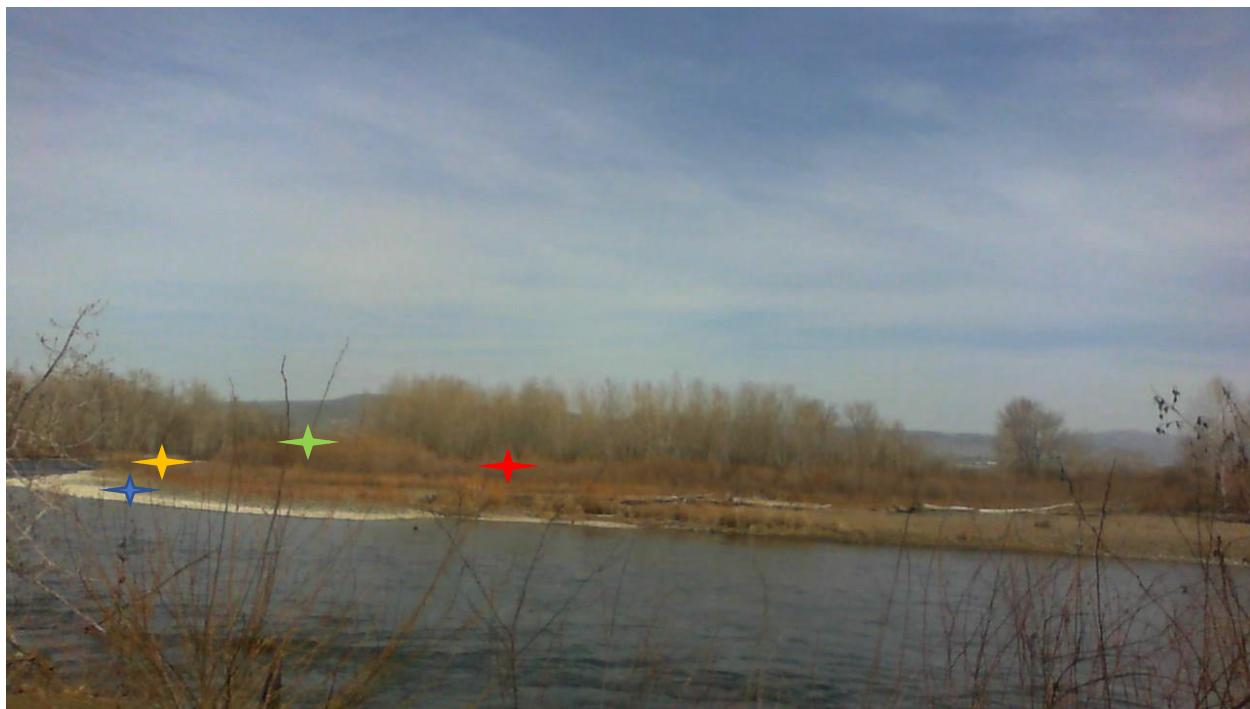
Yakima River near Valley Mall Boulevard – This photo is the clearest example of establishment of willow in meander bands.

- ❖ 2017 meander scroll (no cottonwood starts visible)
- ❖ 2015 meander scroll (small, sparse starts)

★ 2013 meander scroll (some 3-4 foot tall Cottonwood with 5-20 foot spacing)

◆ 2011 meander scroll (Cottonwood beginning to overtop)

- 1) willows establish in a meander line in either a narrow or broad meander line.
- 2) Subsequent flood deposit finer sediments along that line or plot of willow.
- 3) Cottonwoods establish in that line, growing slowly (allowing their roots to develop)
- 4) Eventually Cottonwoods overtop the willow and dominate the site.

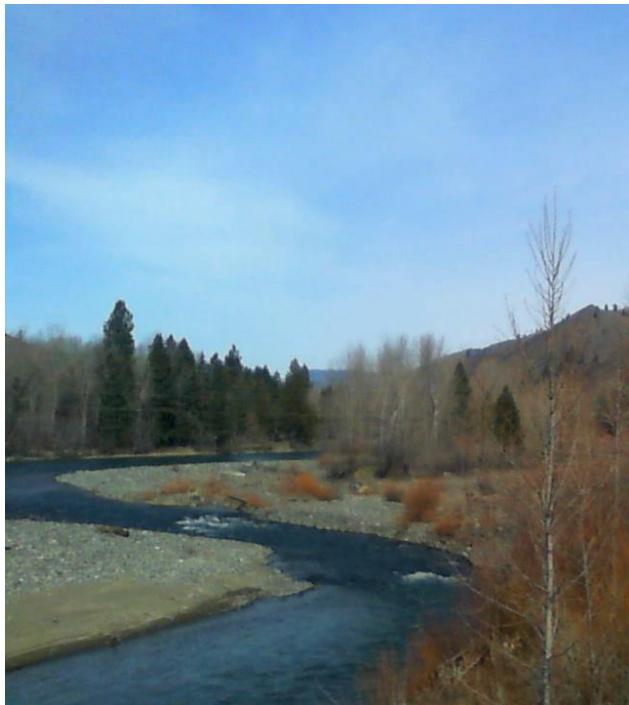
Nile Landslide – This area of the Naches River channel had several “pilot channels” constructed across the various bars to try and allow the river to regrade in response to the new channel alignment upstream and removal of a severe constriction at the lower Nile Bridge (just downstream of the photo) those channels became active and all of what you see here was bare gravel after the 2011 flood. Establishment of Cottonwoods at this site was expected as this part of the upper Naches has one of the most “normative” hydrographs in the basin, with less than 8% of the natural runoff stored in Bumping Lake and released during the irrigation season.

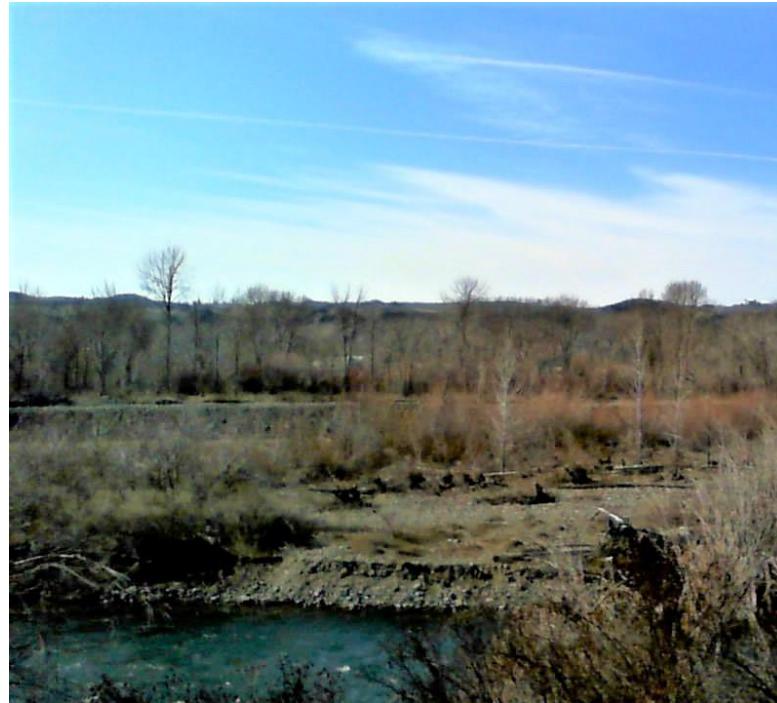
Upstream of City of Yakima Water Treatment Plant Diversion on Naches River – bar in foreground was also a completely bare bar after the 2011 flood as a headcut worked through this reach from May-July. Re-establishment of native riparian vegetation here was not expected due to the highly modified hydrograph in this reach. Similar to the Wapato Reach, flows in this reach are severely reduced after the spring freshet, unlike the Wapato Reach, flows dramatically increase in August and September under the “flip flop” operation, which would be expected to drown newly established cottonwood seedlings. Older Cottonwoods in photo center, younger Cottonwoods establishing on downstream portion of bar on left of photo.

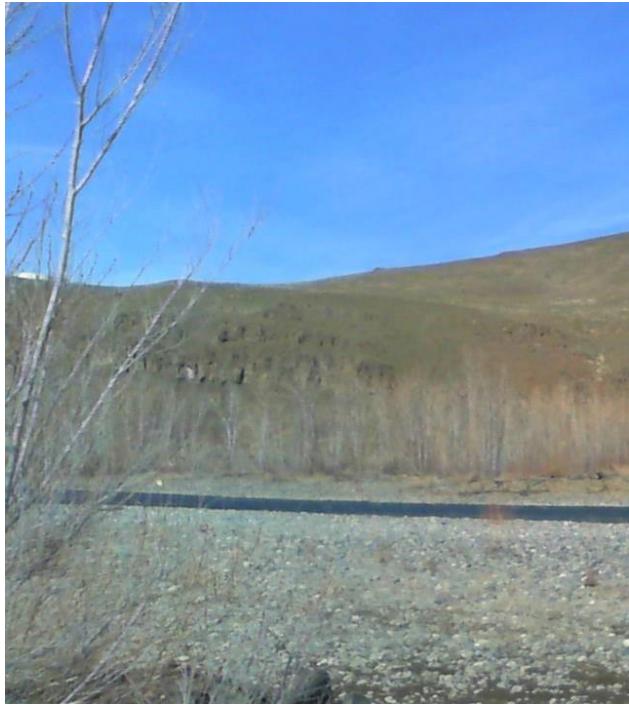
Naches River just upstream of 16<sup>th</sup> Avenue Exit - This is a very densely established stand on a site also bare after the 2011 flood. WSDOT had implemented a bank project here in 2007. The area shown was excavated to allow the river to establish a new channel, but the river never did occupy it. During this 2011 flood, this area was inundated during the first and second flood pulse, but during the second flood pulse the river did create a new channel downstream and avulse through it. This resulted in a fresh floodplain surface being exposed here during the seed release of 2011, and the high flows of that year allowed this example of excellent establishment on the floodplain during that same flood year.

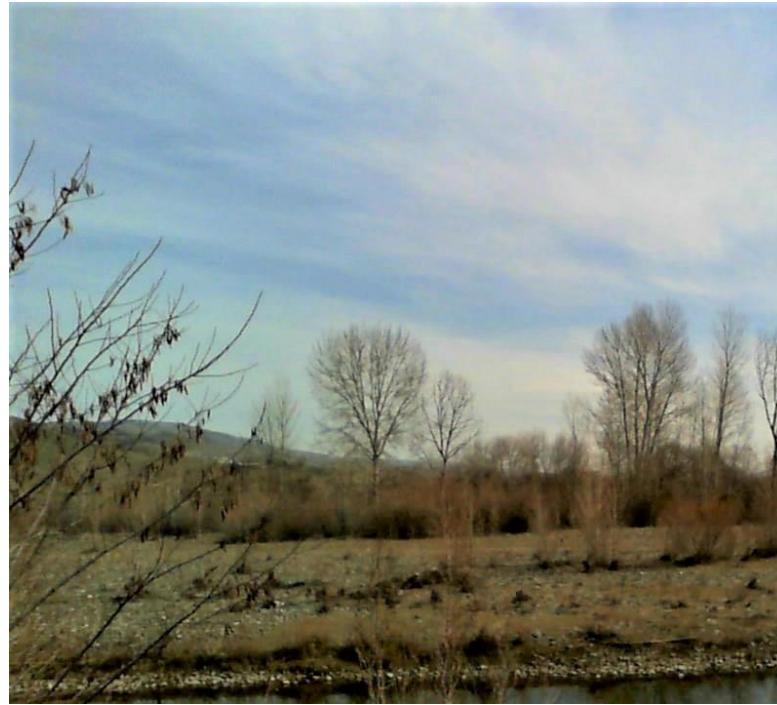
Gap to Gap Reach, just upstream of RR bridge crossing - FCZD removed sections of levee upstream that had been a very severe flow restriction, causing large amounts of sediment to build upstream of the constriction, and gravel starvation downstream. The 2011 flood transported large amounts of the stored sediment and eroded the banks downstream to add even more sediment to the system. This bar, except for the taller Cottonwood in the background, was completely bare after the flood. This photo shows two different establishment events, the background line of Cottonwoods and willows likely from the 2012 year, and the foreground line during the 2014 year. Even though this photo was taken only several months ago, this site looks much more dominated by Cottonwoods presently, the long duration spring freshet has allowed for rapid early spring growth, with the Cottonwoods in the foreground already 3-4 feet taller.

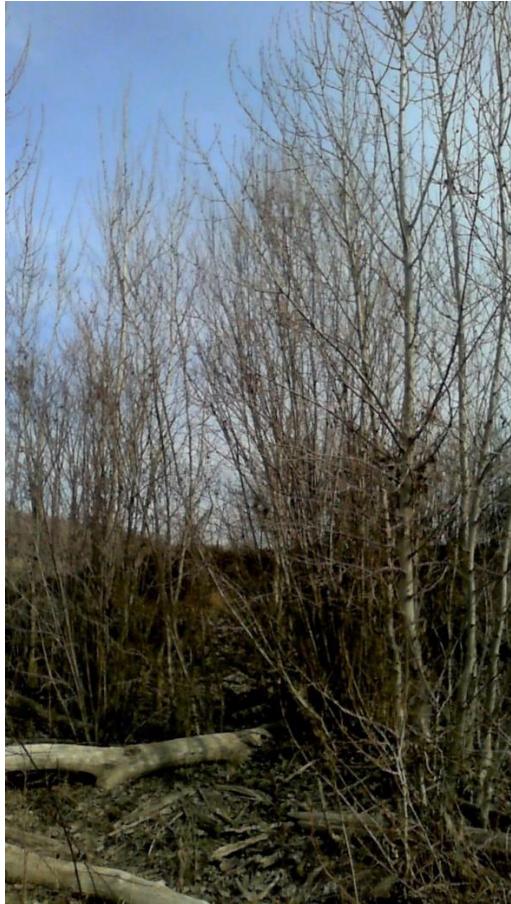
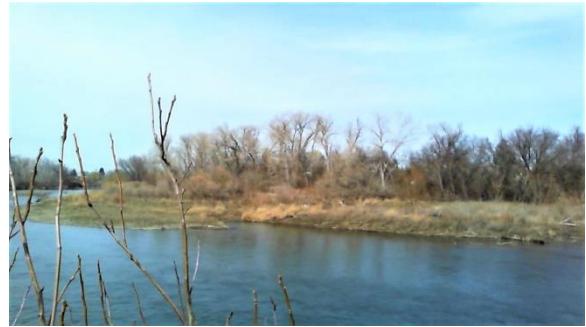
Wapato Reach, WDFW land on Mellis Road – Removal of levees here in 2009 resulted in channel avulsions and channel response in 2011 during the overbank flood. The bar above (in left of photo) was bare after flood, now occupied by Coyote Willow and Cottonwood. Portions of channel that had experienced avulsion reacted similar to the 16<sup>th</sup> Ave site, very heavy establishment of near pure cottonwood stands in former channels and in many areas in the floodplain – on open areas as well as in existing Gallery Forest stands - well away from the river in this reach.
