Yakima River at Union Gap Ecosystem Restoration

Section 1135 Project

**Hazardous, Toxic, and Radiological Waste
Final Preliminary Site Assessment**

14 February 2017

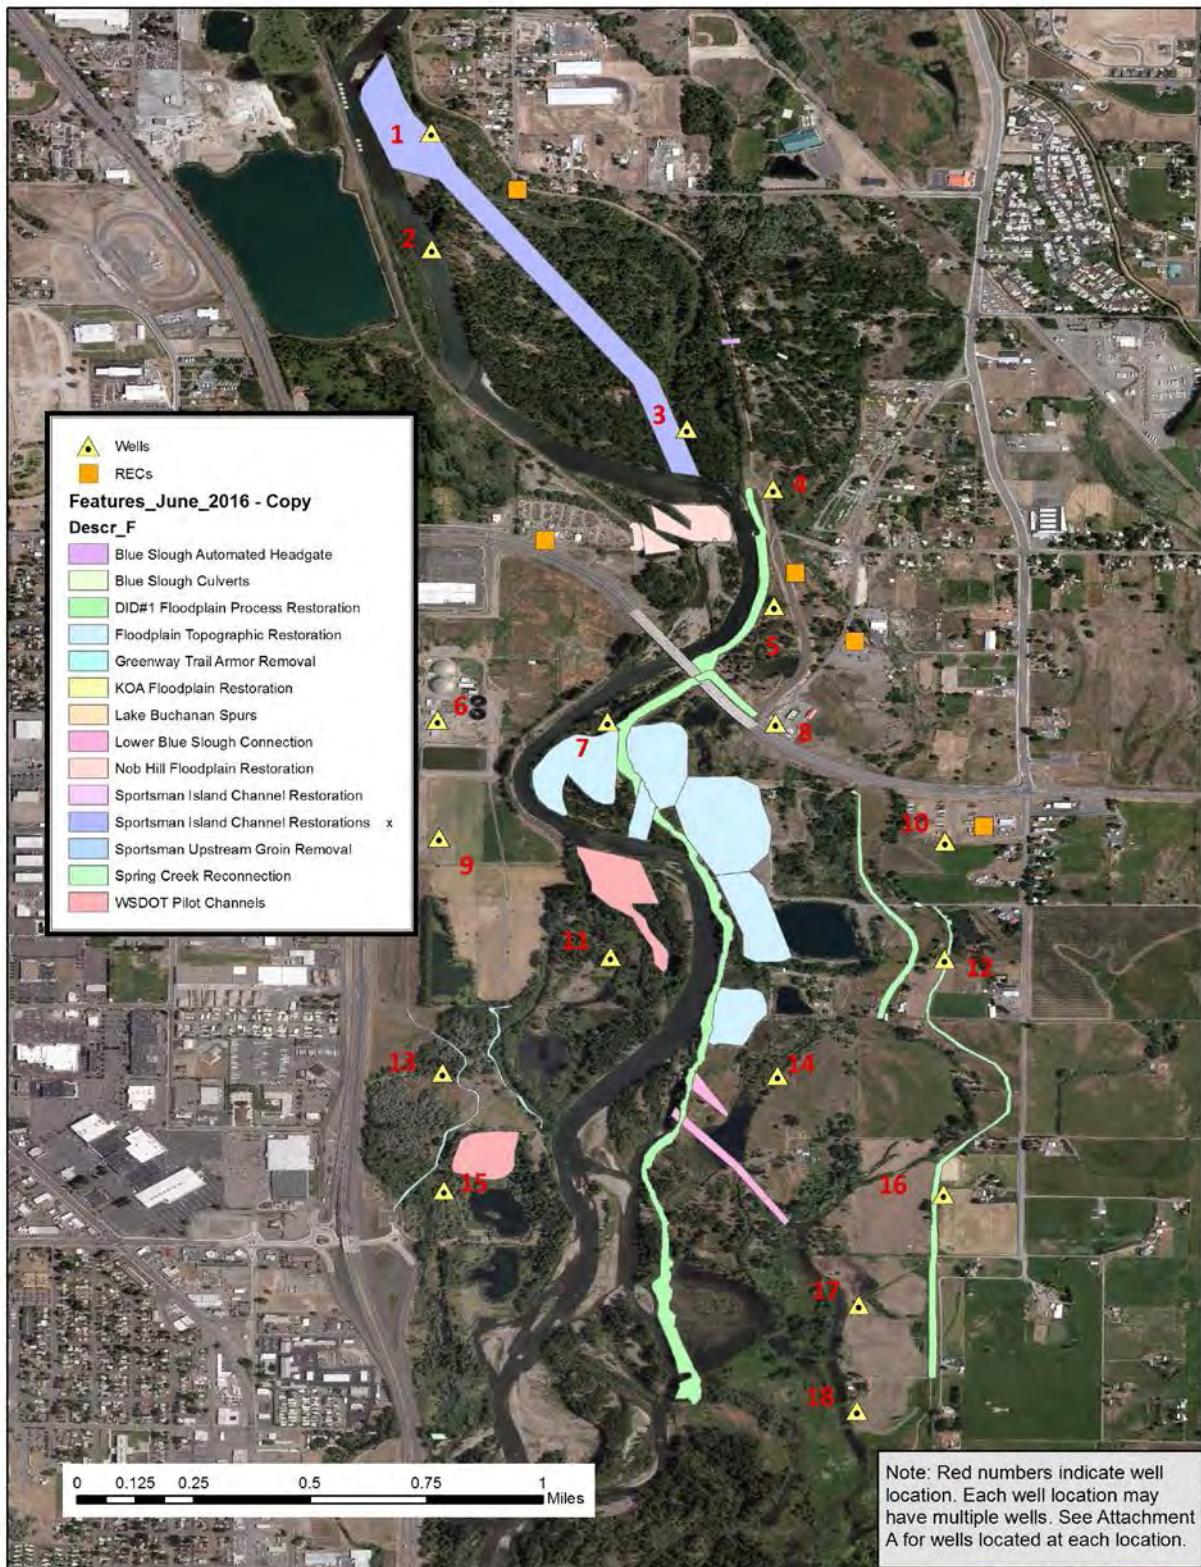
Figure 1. Recognized Environmental Conditions (RECs) and wells located near the proposed project. Map updated 2/2/2017.

Note: Please see Figure 1 for location numbers.
