YAKIMA RIVER BASIN  
ECOSYSTEM RESTORATION  
YAKIMA COUNTY, WASHINGTON

**ENGINEERING APPENDIX**

**April 2018**

**Integrated Feasibility Report and  
Environmental Assessment**

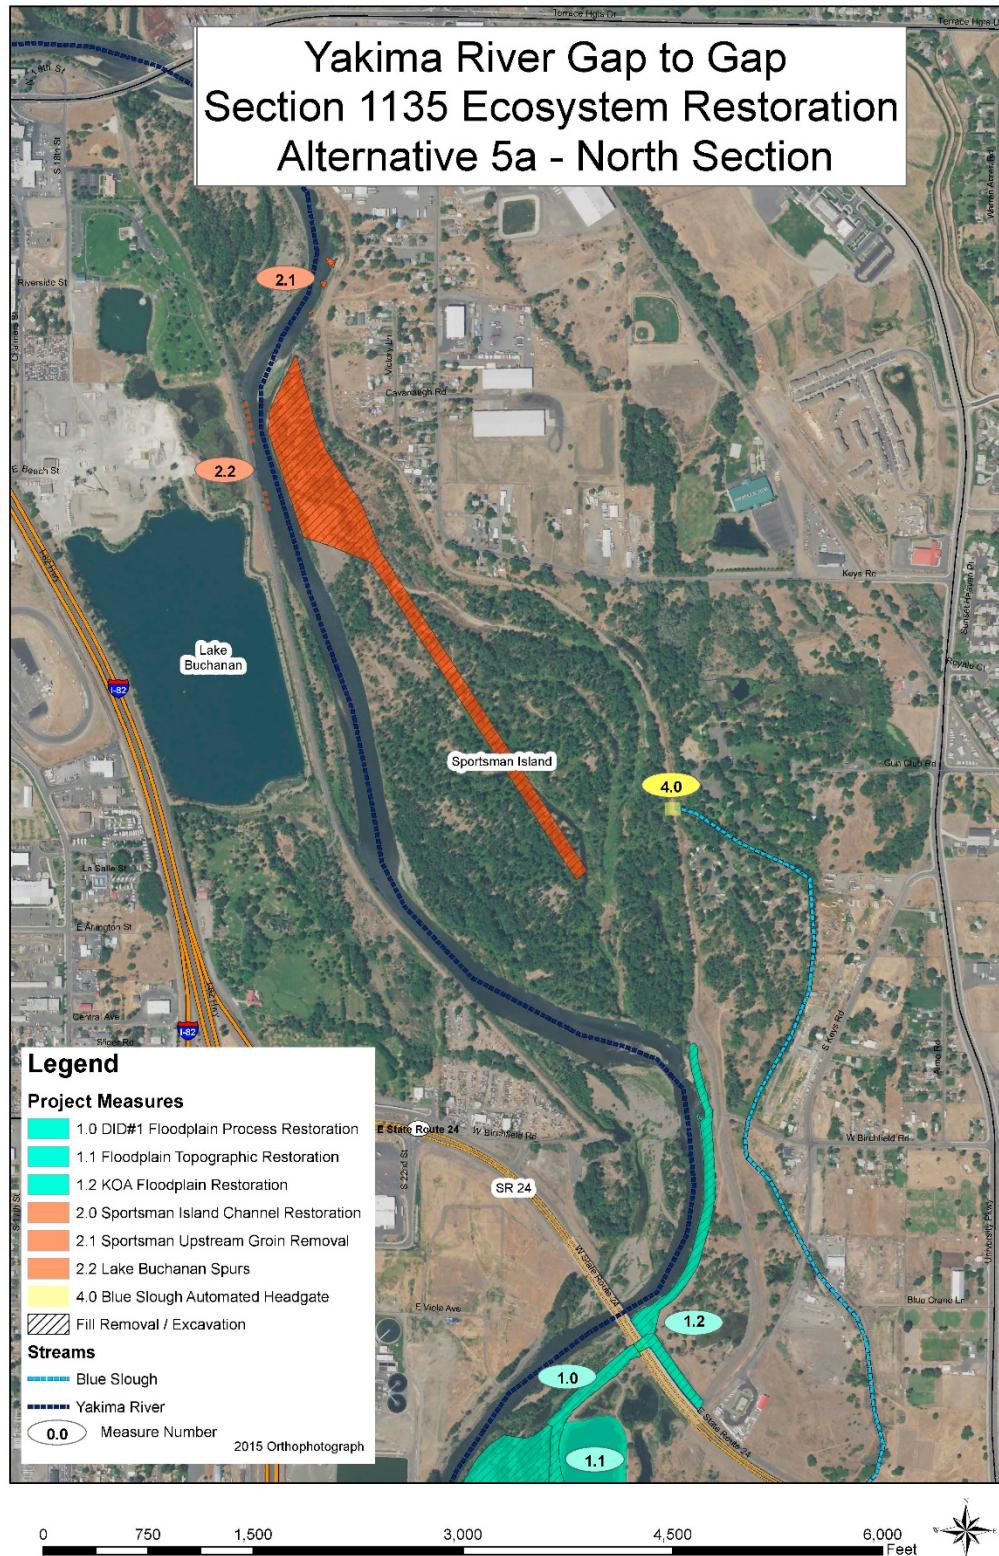
**Figure 1-1. Tentatively Selected Plan– North Section**

The tentatively selected plan includes the bolded items in the list below. Tentatively selected plan features are illustrated in Figure 1-1 and Figure 1-2 and Annex A; Sheets C-003 and C-004.

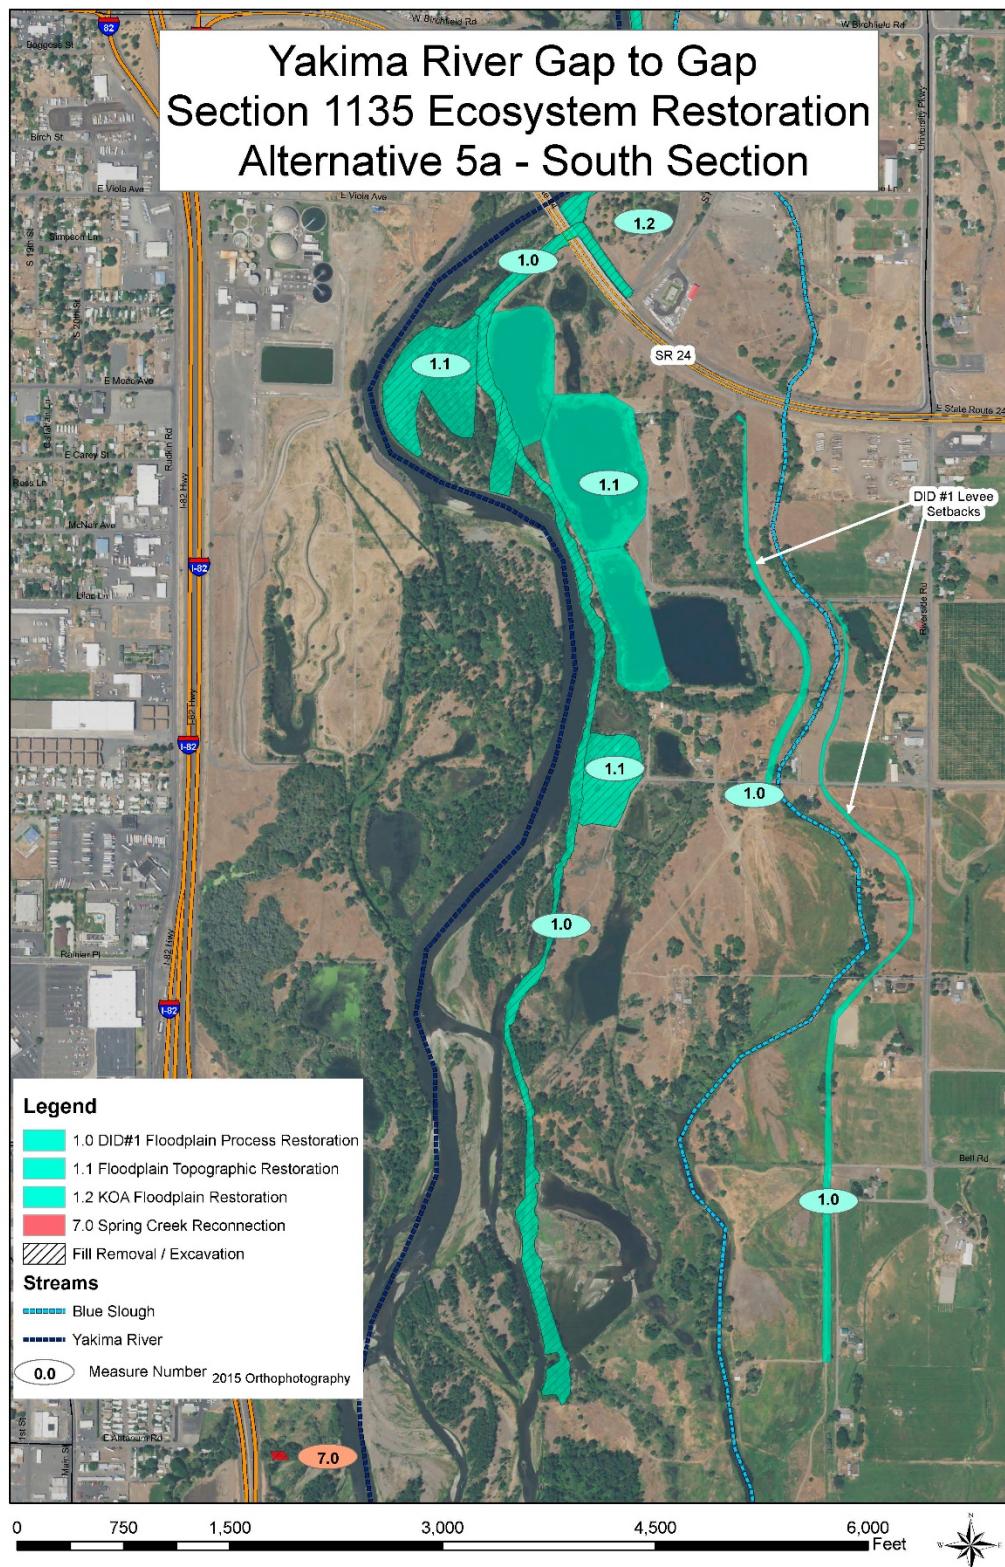
**Figure 1-2. Tentatively Selected Plan– South Section**

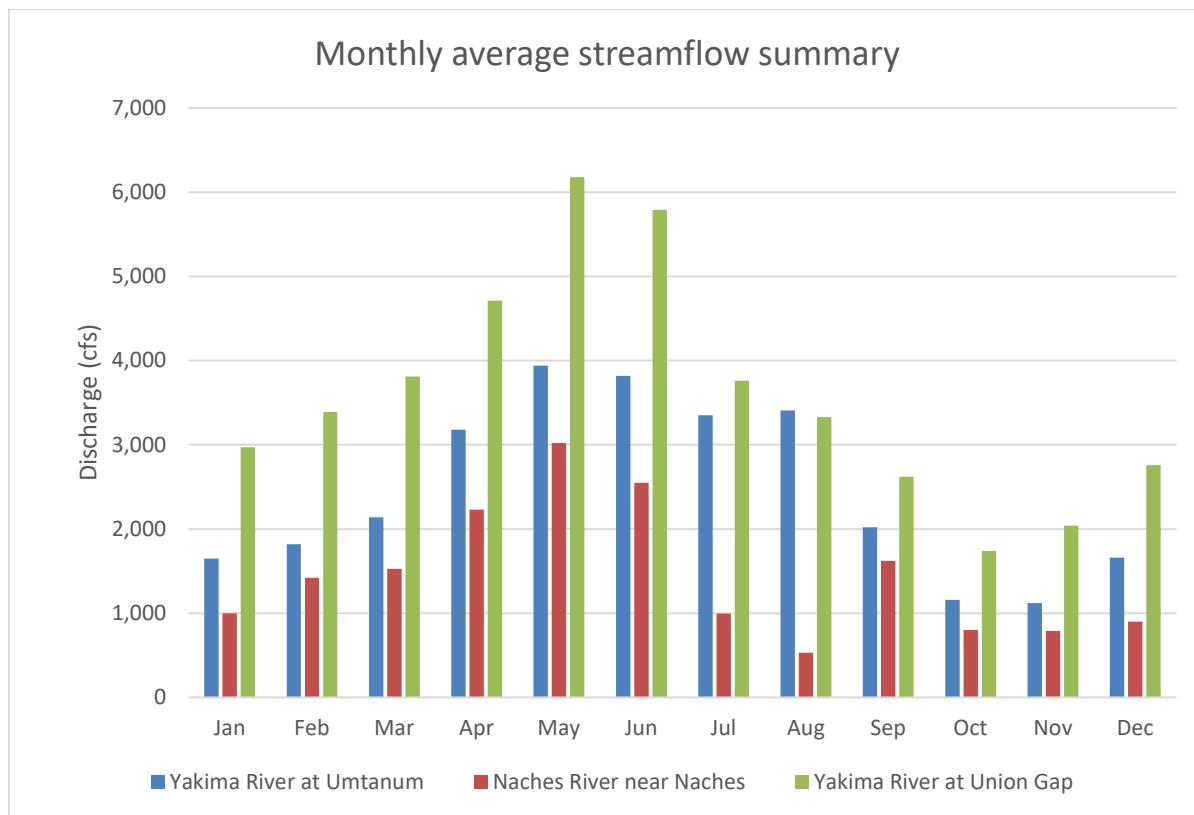
**Figure 1-3. Monthly average streamflow summary, Gap to Gap reach**

Flows through the project area tend to be on the order of 1,500 cfs during the lowest summer to fall periods (October) and roughly 15,000 cfs during a “bankfull” (2-year) recurrence event. Average annual flows are roughly 3,500 cfs at Union Gap, which is less than the combined average annual flow at the upstream gages due to agricultural diversions (Roza canal, etc). Yakima River flows primarily originate from snowmelt and rainfall on the eastern slope of the Cascade Mountains in the fall and winter, and are augmented by reservoir releases in dry months. Average flows are highest during the months of April, May, and June as a result of spring snowmelt runoff (Figure 1-3), however, peak flood

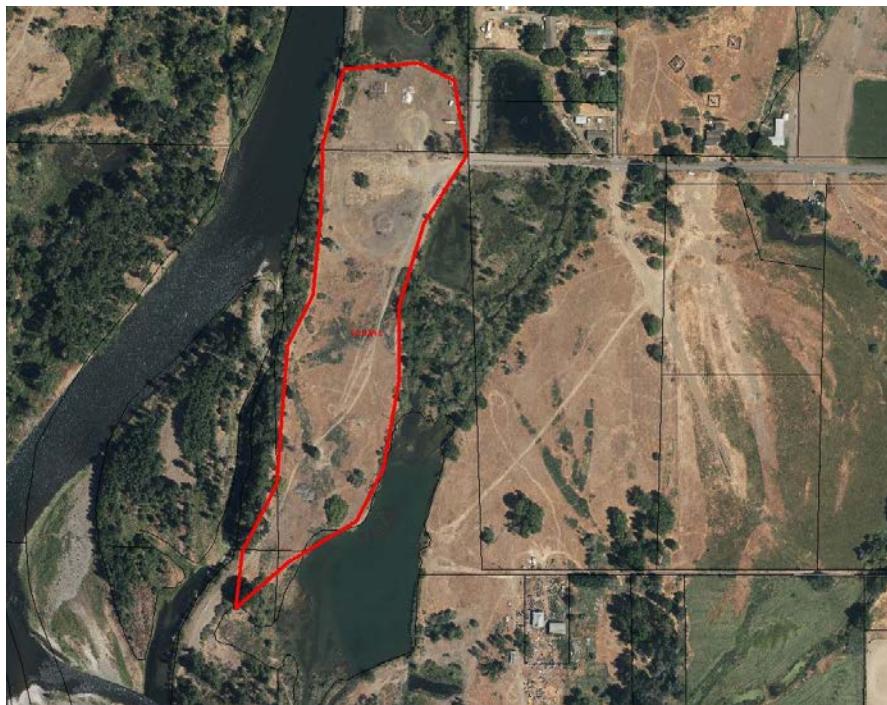
Figure 2-1. Area to be Re-vegetated as Part of DID#1 Levee Removal

For levee removal (existing DID#1 levee, KOA levee, and cross dike), revegetation of the excavated area should consist of hydroseed with native grass mix for erosion-control, with the intent to minimize invasive species. Some damage to existing trees during levee removal is expected, but most of the roots will remain. Damage to the trees may actually increase the likelihood of re-sprouting from the roots for cottonwood, coyote willow, and other species. The large area (approx. 14 acres) shown below in Figure 2-1 consists primarily of invasive weeds and will be further disturbed by levee removal. This area should be hydroseeded and, if the project is done over the winter or late spring, live parts of trees salvaged from other actions could be “planted” here. If work is not done during winter when plants are dormant, salvaged parts of trees could be buried here, with the remaining area replanted with cottonwood. Some areas may require localized application of spray for at least a year after project completion to regulate invasive species.

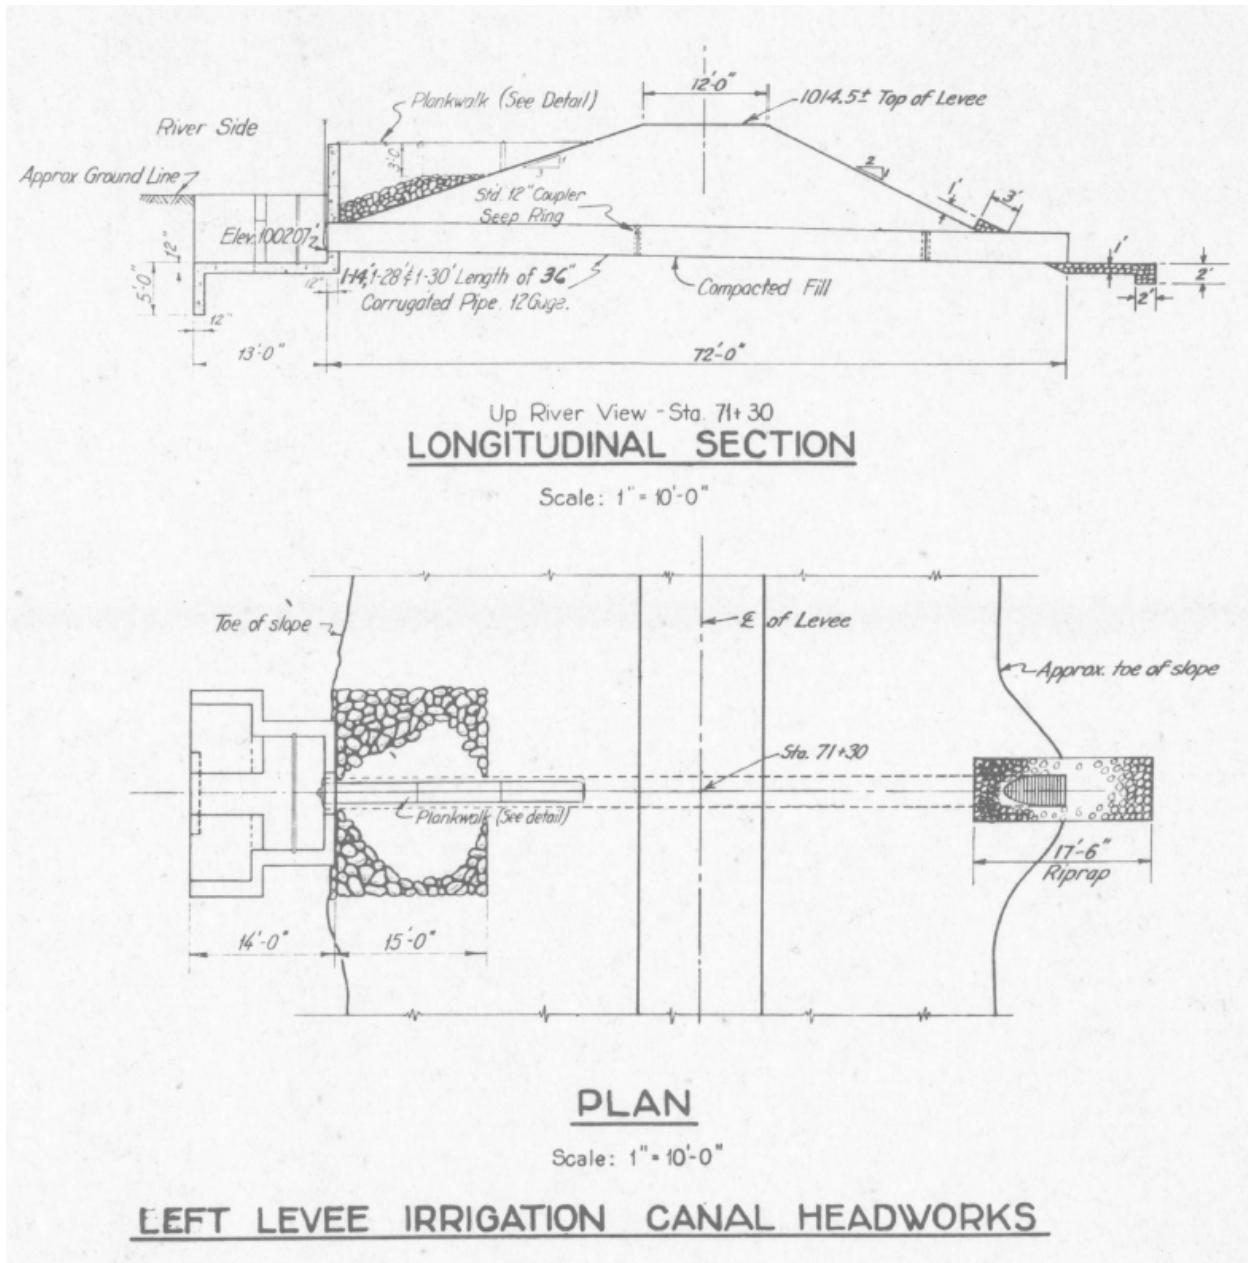
Figure 8-1. Existing Blue Slough Headworks and Culvert – Plan and Longitudinal Section

Replacement of the Blue Slough inlet works and culvert will require excavation into the existing Yakima Authorized Project, Left Bank Levee. It is recommended that the existing pipe be completely removed and replaced. This will require excavation and reconstruction of the existing levee embankment in the vicinity of the culvert. Figure 8-1 and Figure 8-2 illustrate the as-built conditions of the headgate as it pertains to the levee.

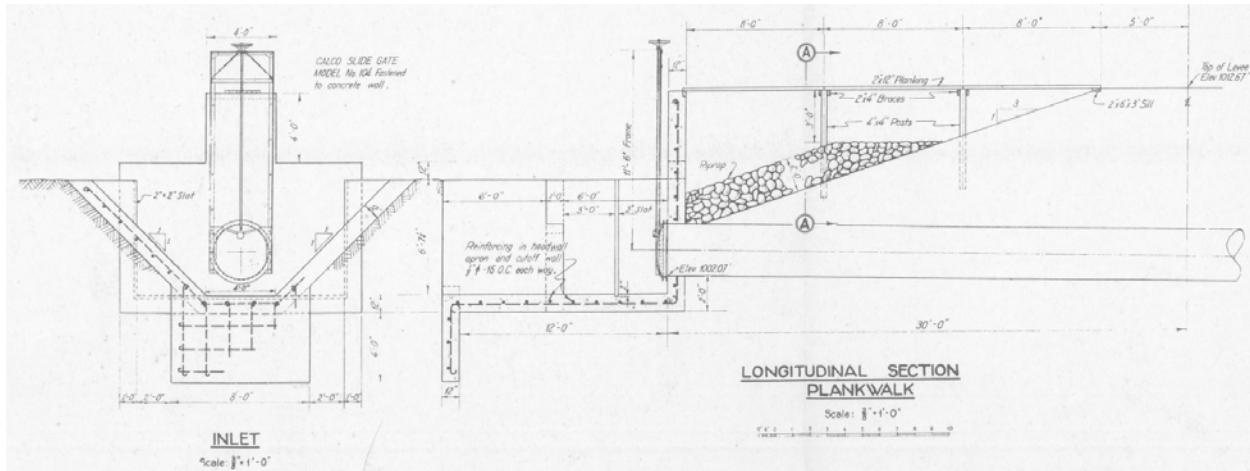
**Figure 8-2. Existing Blue Slough Headworks Inlet – Longitudinal Section**
