# Lower Naches River Geomorphic Atlas

Prepared for  
**Yakima County Water Resources Management Division**

Prepared by  
**Northwest Hydraulic Consultants**  
Seattle, WA

September, 2015

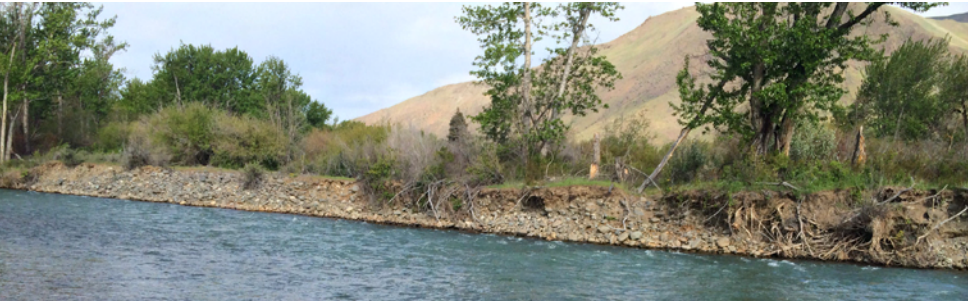
Left Bank Erosion at RM 16.5. Note coarse texture of floodplain material being mobilized.

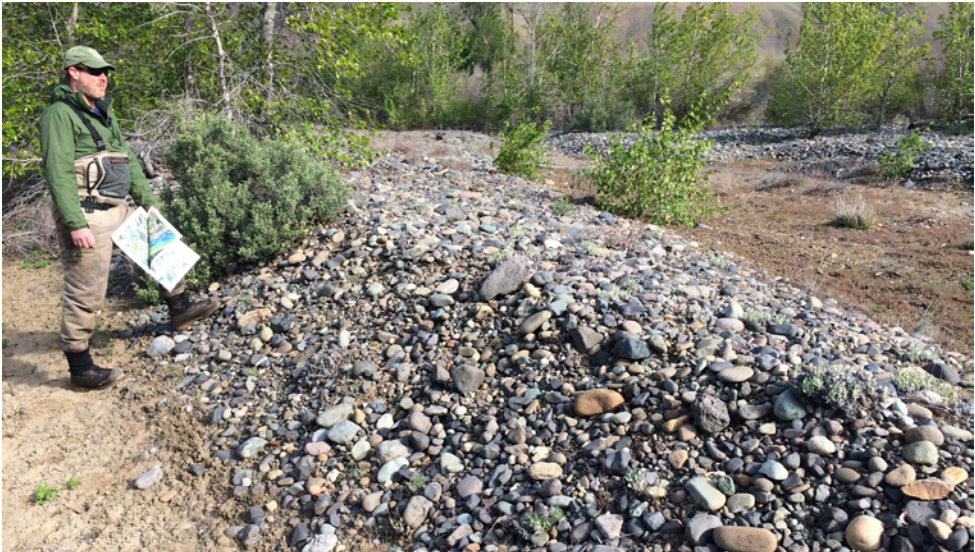
Gravel splay deposit in cross-bar channel at RM 16.3.

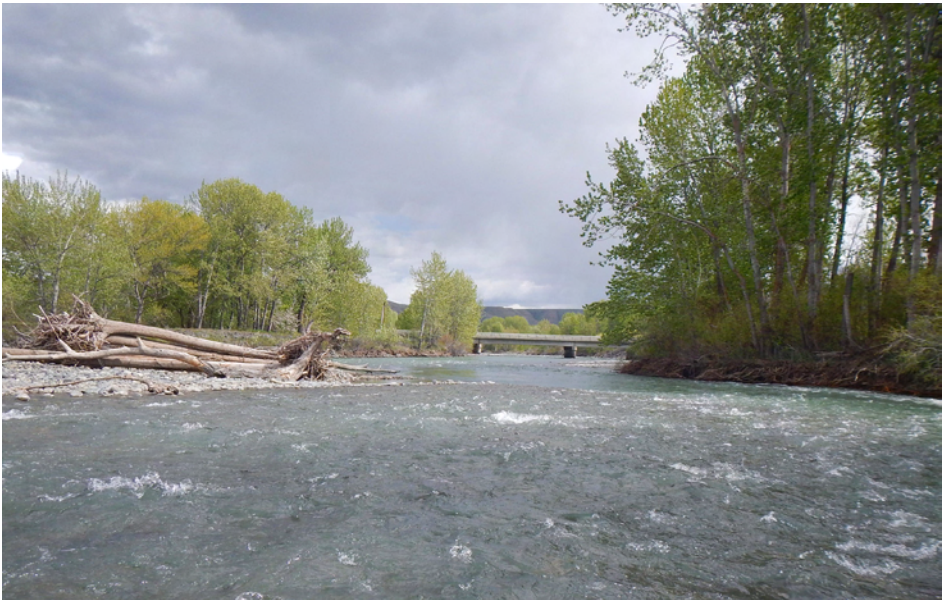
Front of bar complex upstream of S. Naches Road Bridge and eroding right bank.

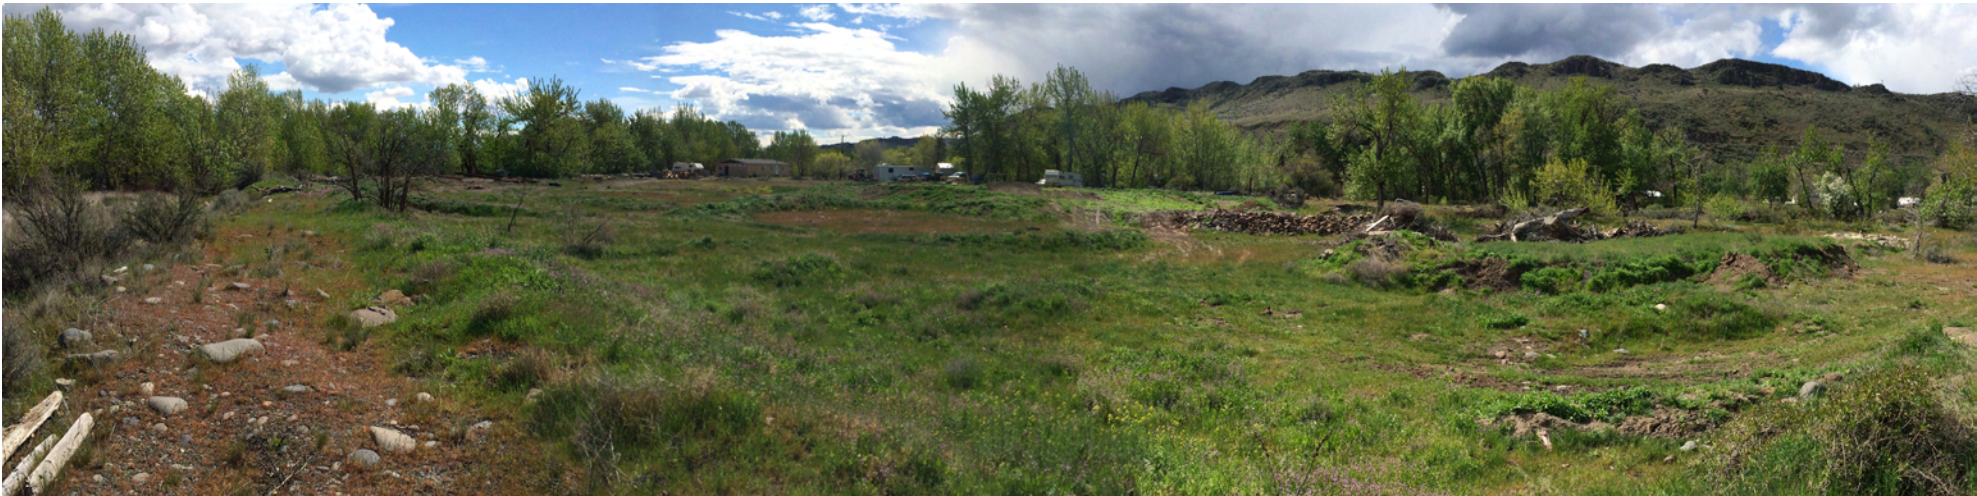
Low floodplain area blocked by downstream portion of N9 levee and private berm (left of side of photo), which are planned to be removed in 2016.

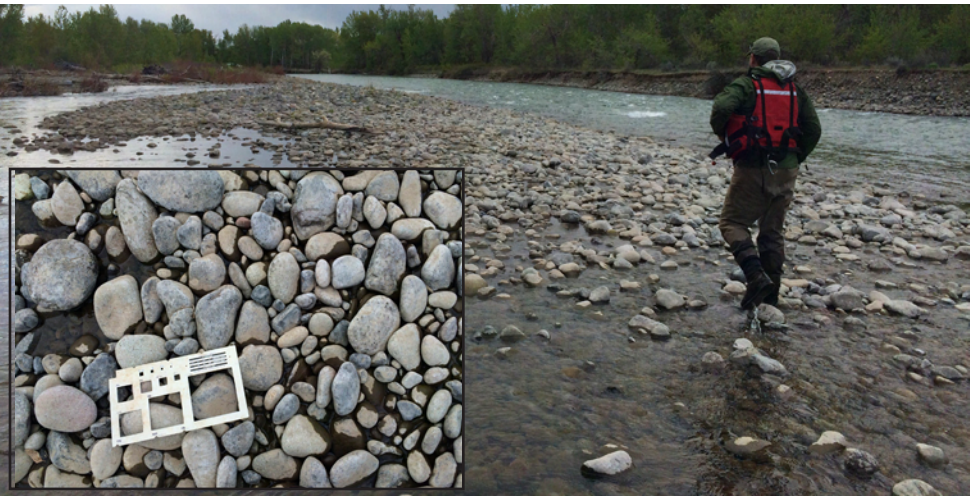
Overview of pebble count location and detail of sampled deposit.

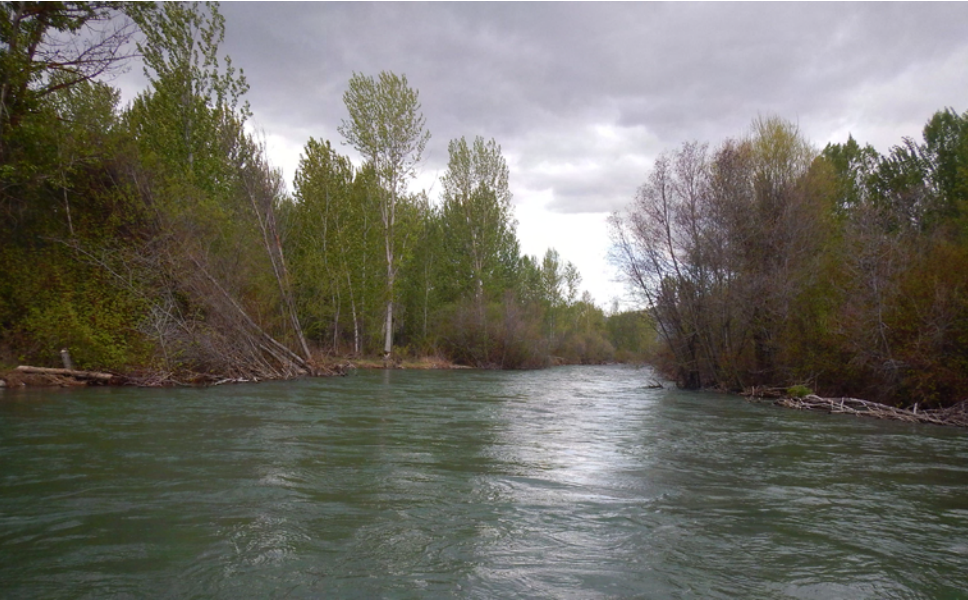
Enlarging avulsion channel between RM 10.9 and 11.15.

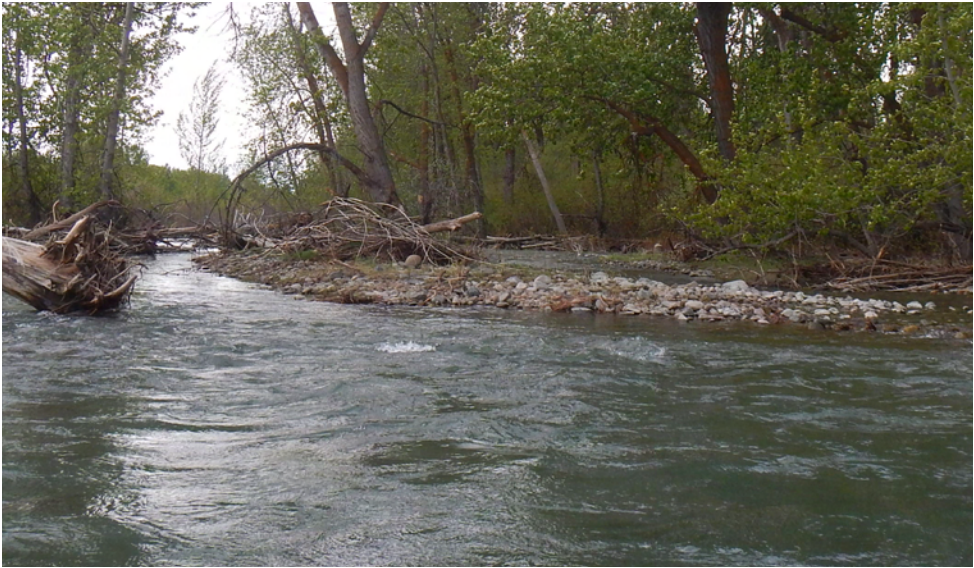
Secondary avulsion channel forming near RM 10.95

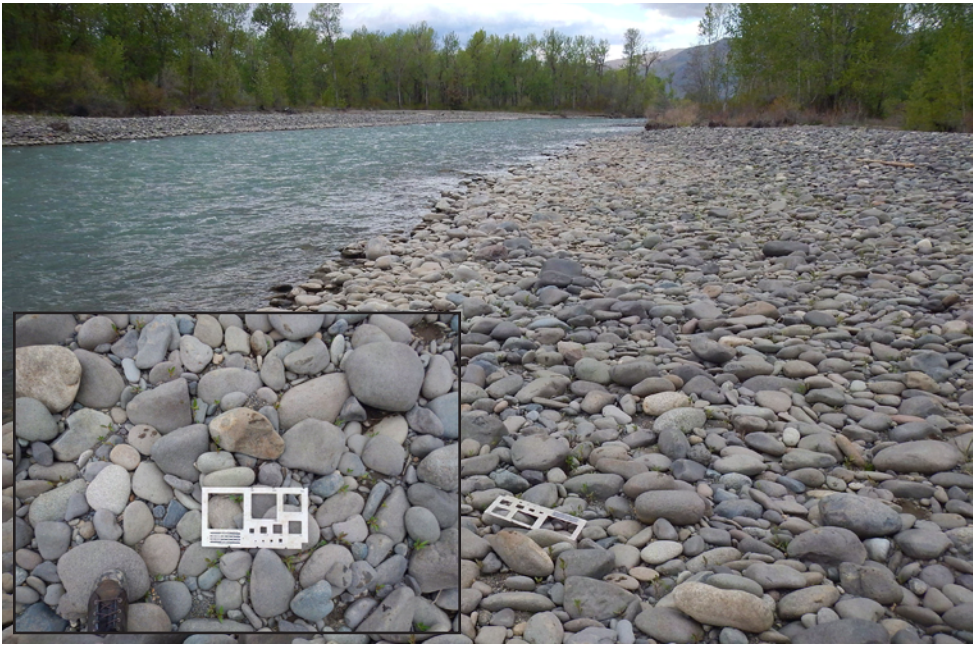
Overview of pebble count location and detail of sampled deposit.

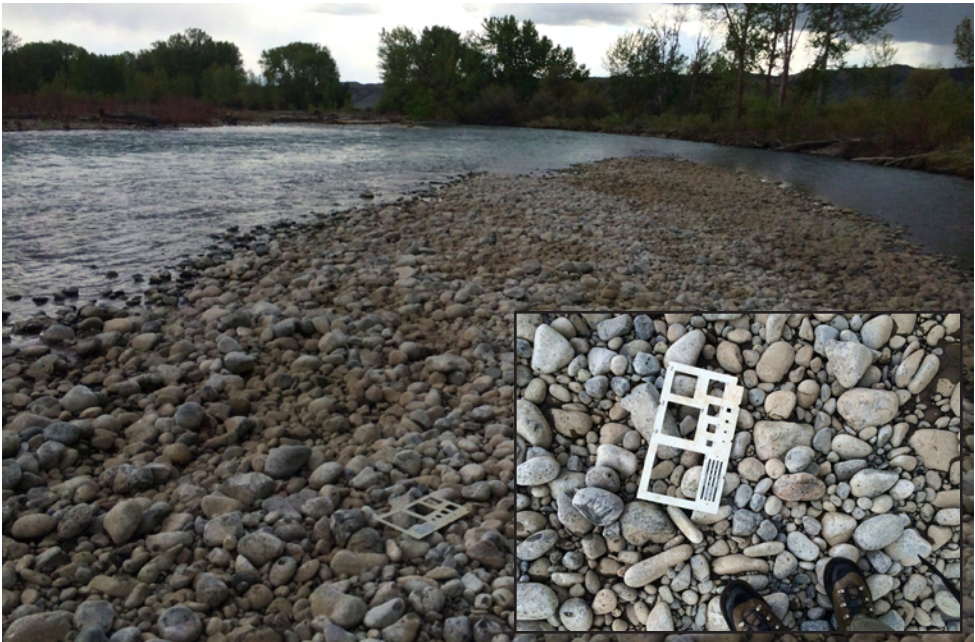
Overview of unsampled right bank bar at RM 10.6 and detail of bar surface material.

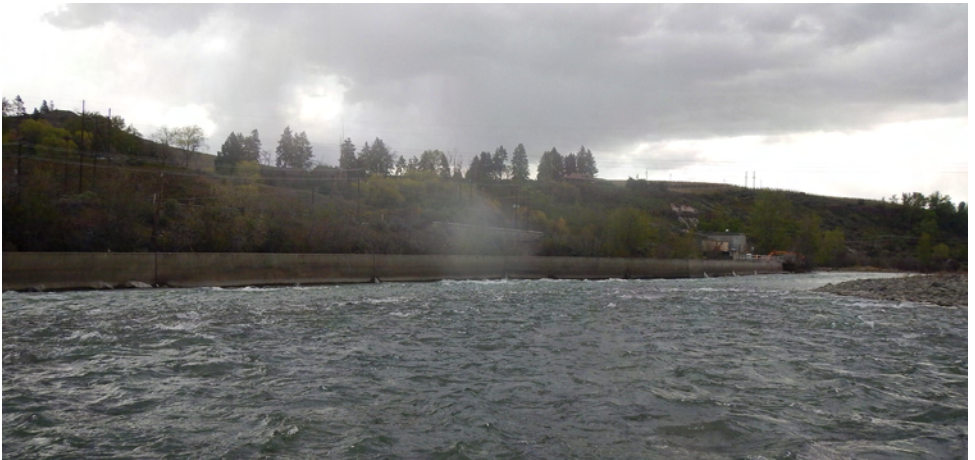
- Channel constriction and grade control at the City of Yakima Water Diversion have created a zone of instability and sedimentation upstream.
- This instability and management response to it has destroyed (or caused removal of) most of the length of levees upstream of the diversion, and is now positioned to allow flanking erosion to damage the Gleed Diversion levee.

City of Yakima water diversion structure.

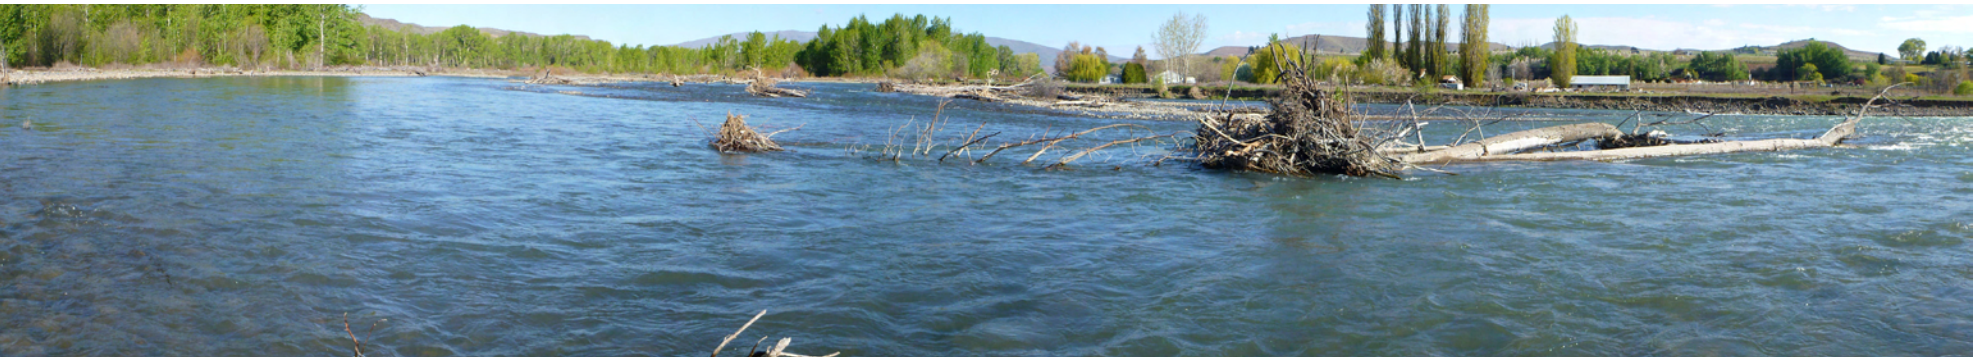
Over-wide aggrading channel between RM 8.5 and RM 8.4.

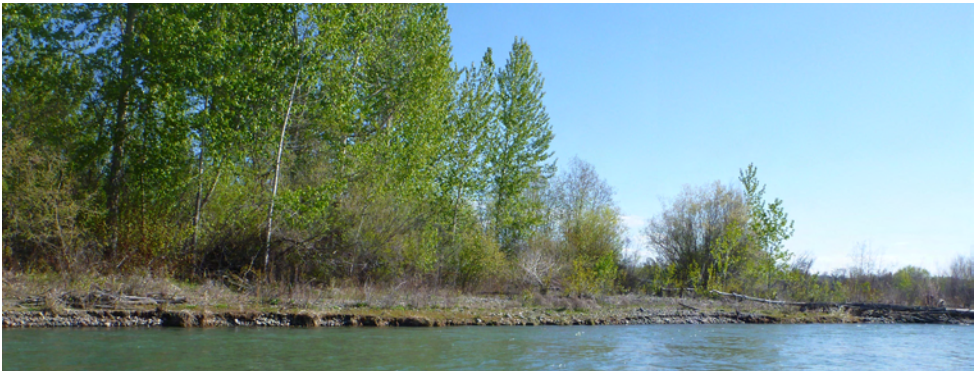
Low floodplain and potential avulsion path (left bank, RM 7.2).

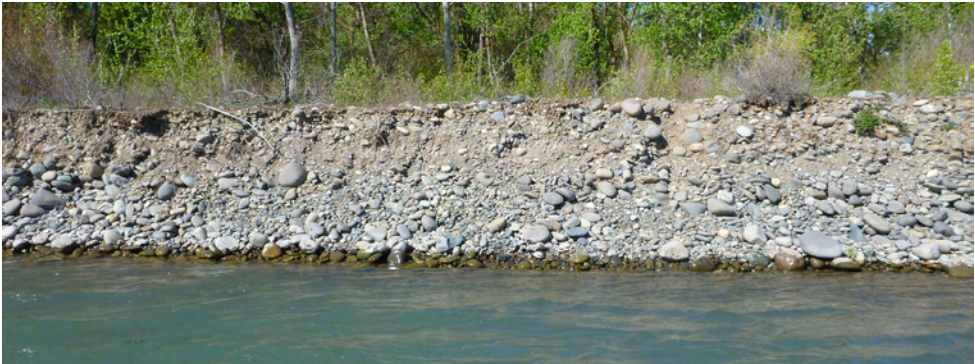
Eroding right bank at RM 6.6. Note absence of fine over bank deposits.

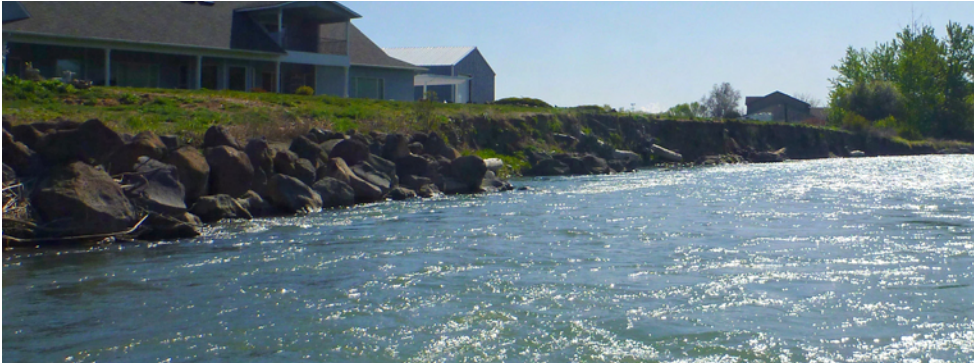
Left bank Erosion at RM 7.85 threatens homes. Erosion is into 1st terrace above geomorphic floodplain and mobilizing relatively abundant fines.

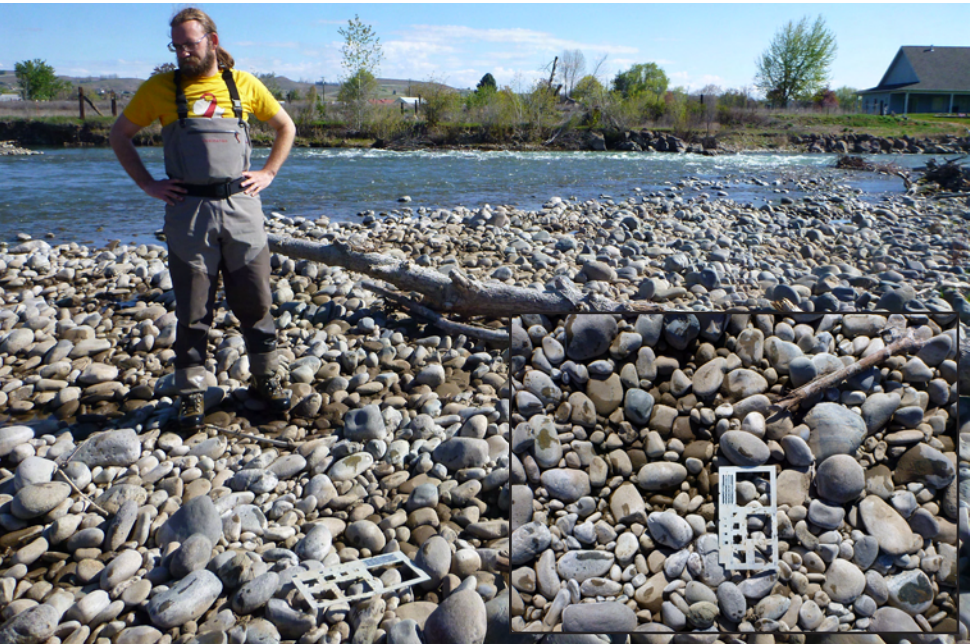
Overview of pebble count location at RM 7.85 and detail of sampled deposit.

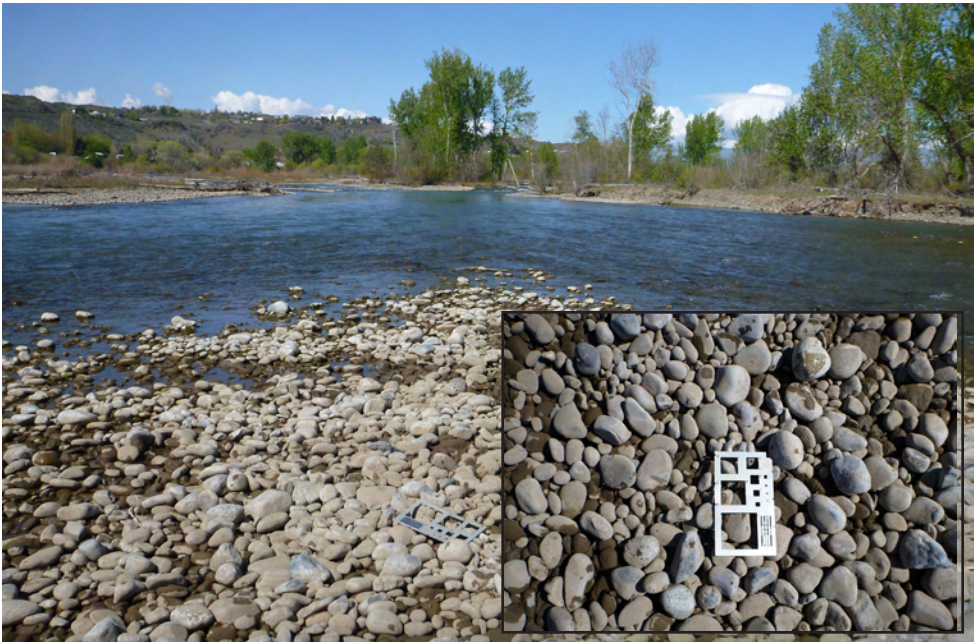
Overview of pebble count location at RM 5.05 and detail of sampled deposit.

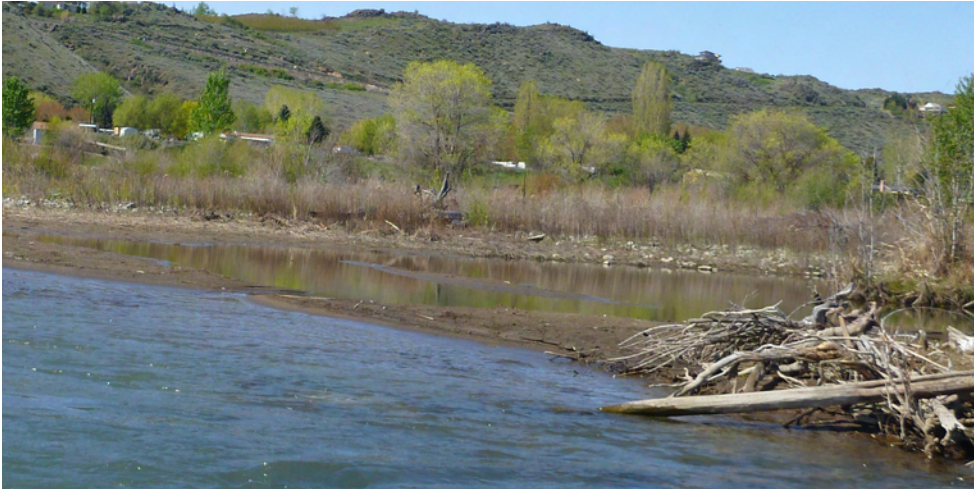
Sand deposition in right bank backwater channel at RM 5.25

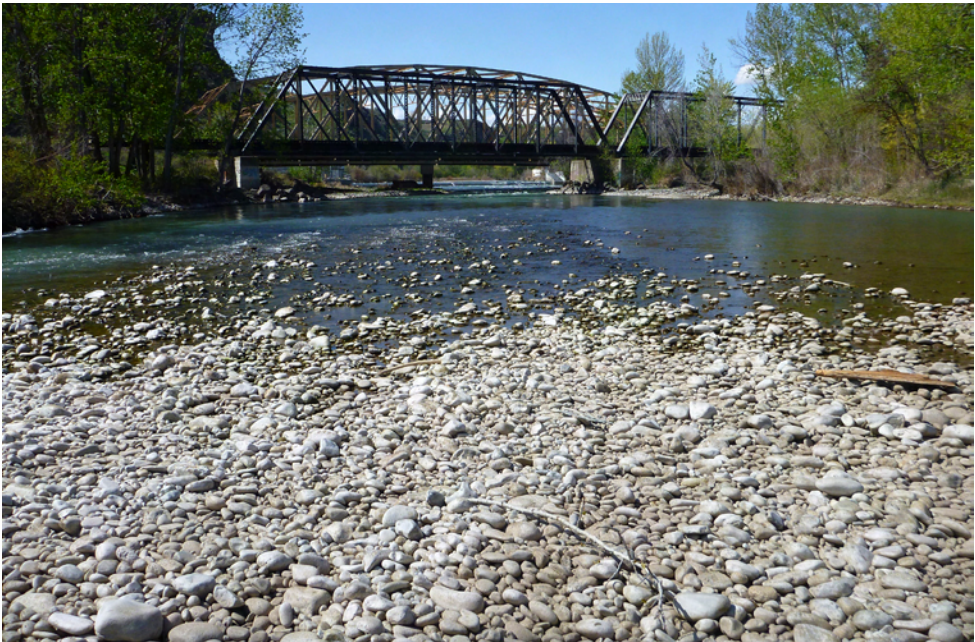
Overview of pebble count location at RM 3.6.

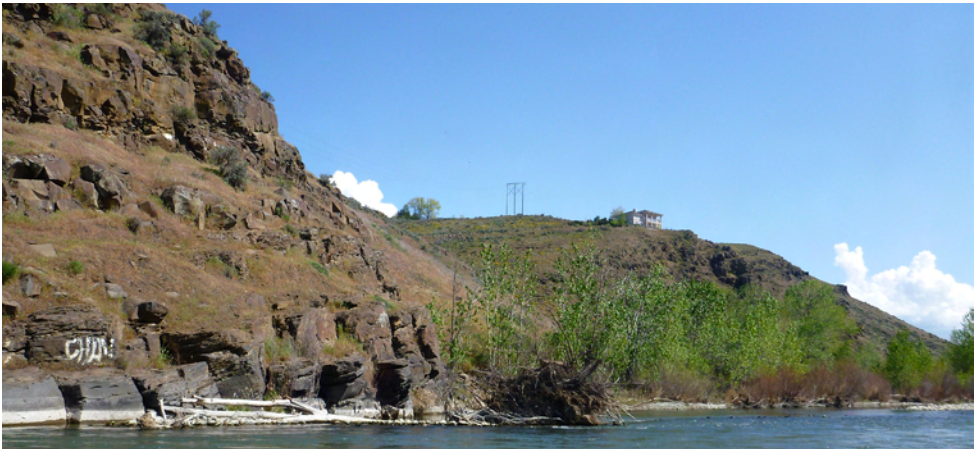
Left bank bedrock outcrop at RM 3.35.

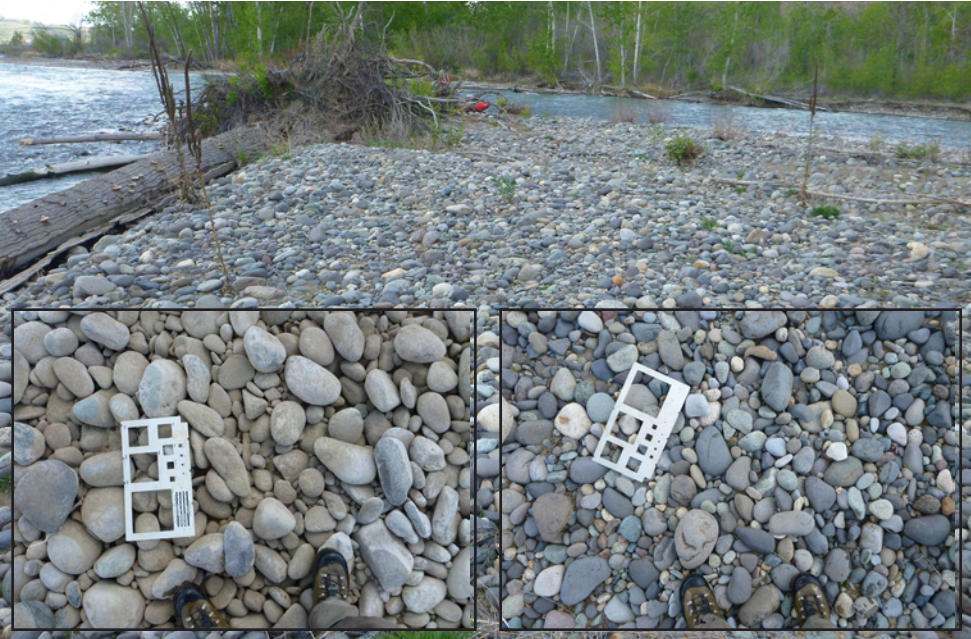
Overview of pebble count location at RM 3.0 and detail of sampled deposits. The right detail image is the unwinnowed gravel deposit, while the left detail image is from the bar apex and shows the texture of the material after armor development.

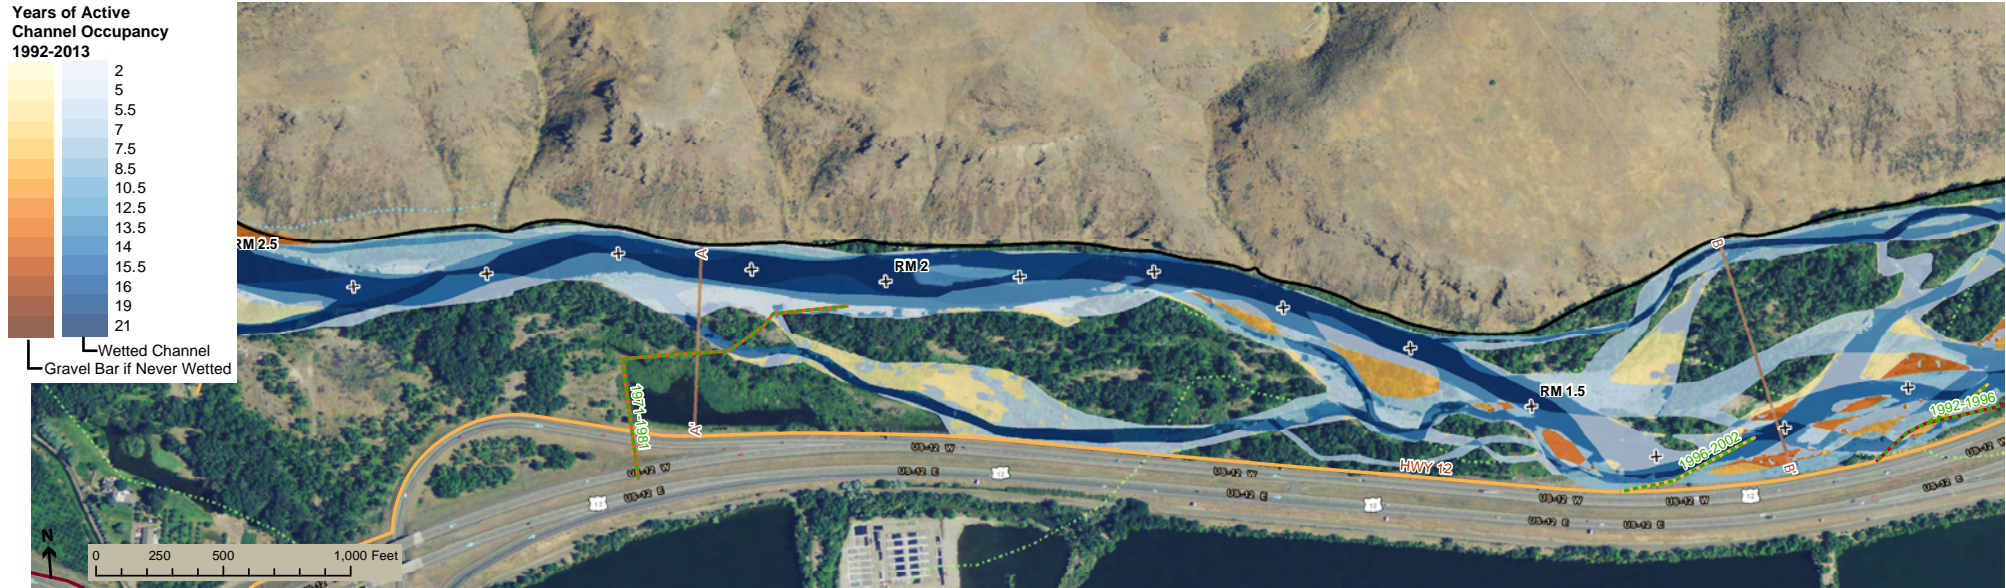
- A pronounced constriction at RM 0.9 creates a zone of persistent sedimentation through this reach upstream.
- This constriction was a nodal point in the active channel in the early 20th century, but was built to a high elevation that blocked floodplain flow conveyance during construction of Highway 12 between 1968 and 1971.
- Presently, a set of rock barbs protect Highway 12 between RM 1.5 and RM 1.0. These have induced local deposition of sandy gravel.

Sequence of mid-century historical aerial photos showing persistent node at RM 0.9 and several aggregate pits excavations.

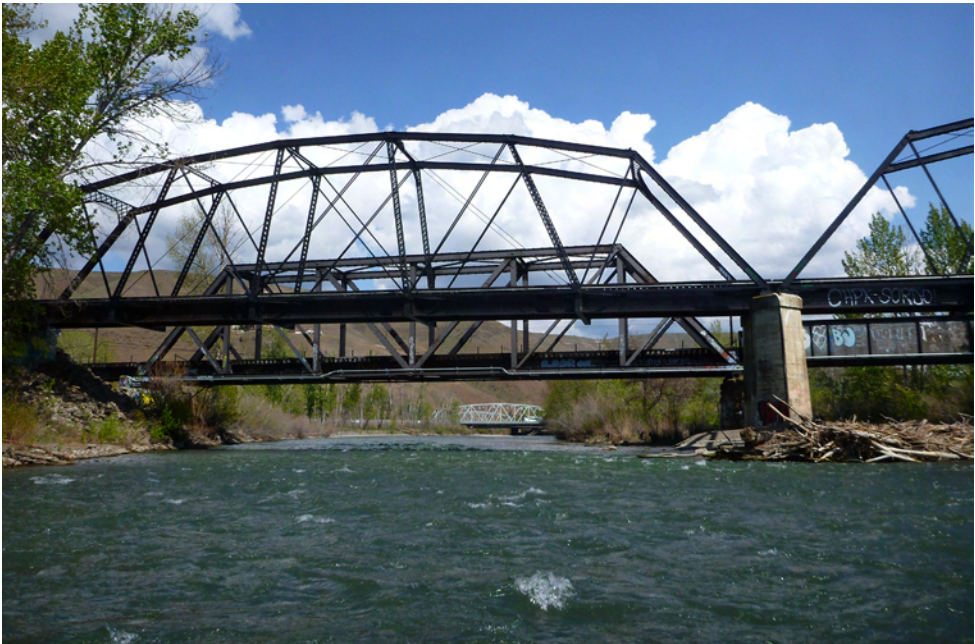
Bridge-confined corridor of the lower portion of this reach.

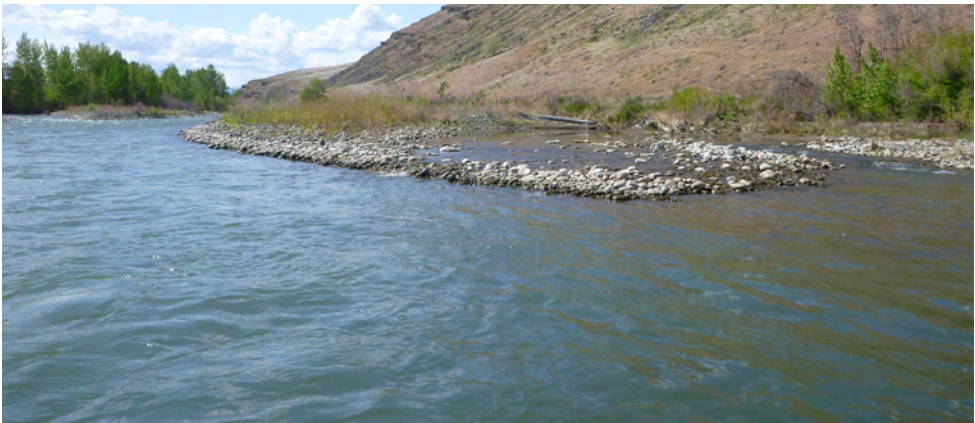
Mouth-bar at RM 0.7 indicative of sediment deposition into a backwatered environment.

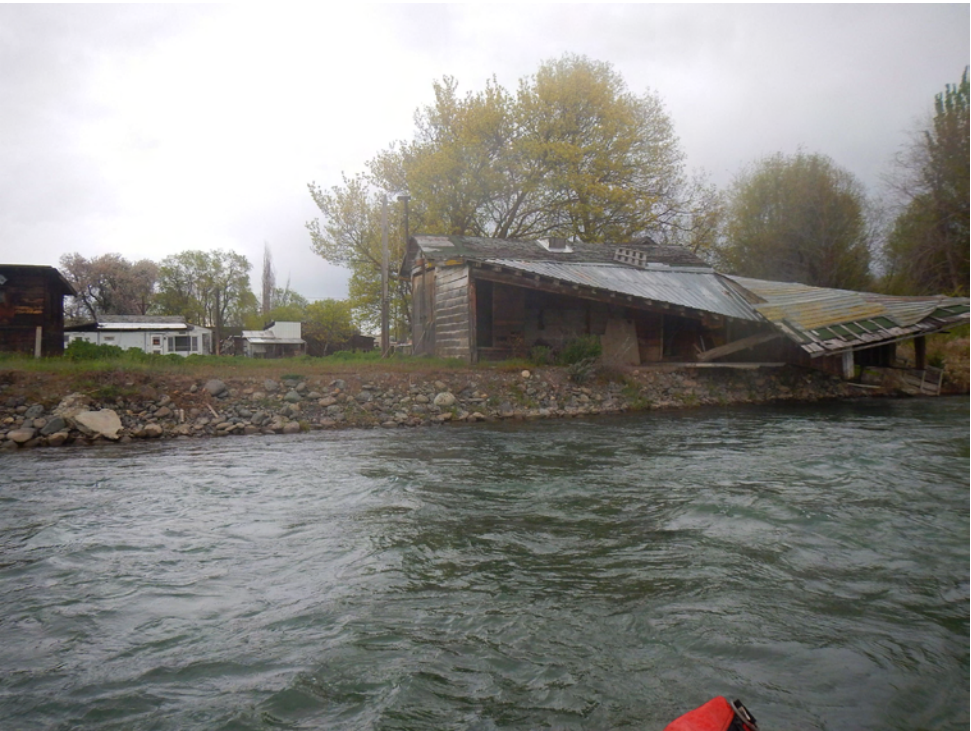
Lateral meander migration destroying an abandoned structure at RM 8.3.

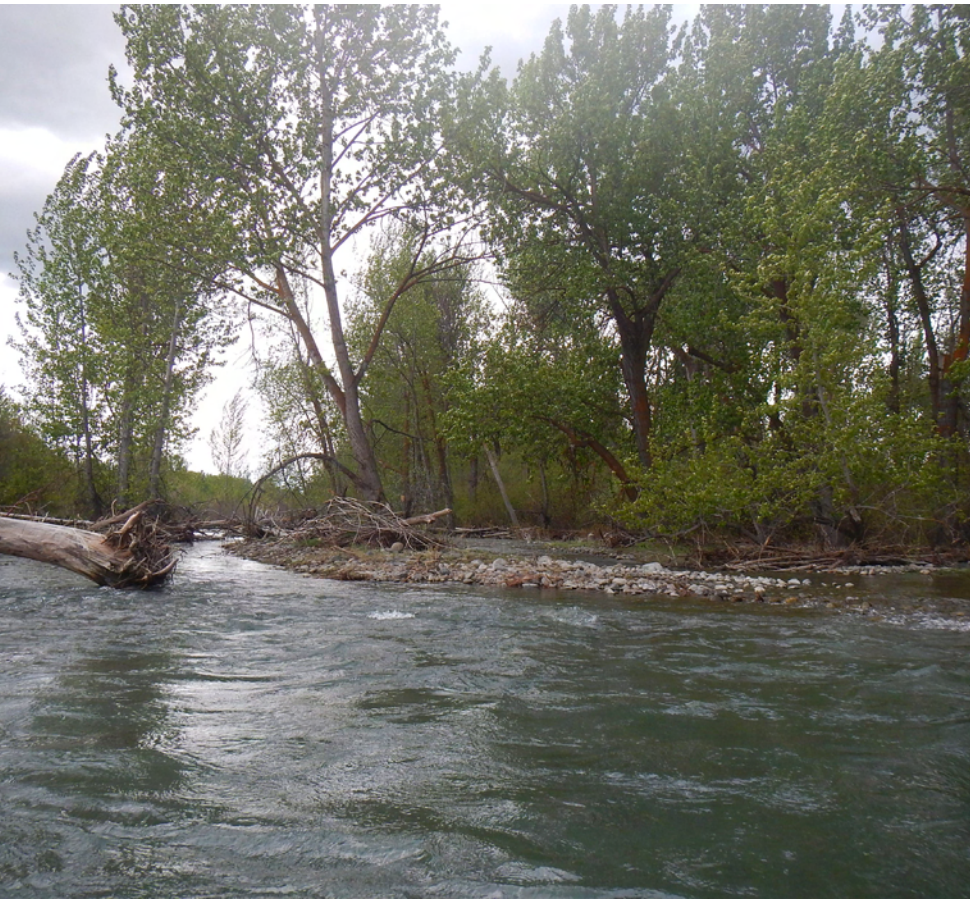
Enlarging floodplain avulsion channel at RM 11.15
